TECHNICAL BULLETIN

LTB00774NAS2 25 APR 2016

SECTION: 211-04

Heated Steering Wheel Not Operating Correctly

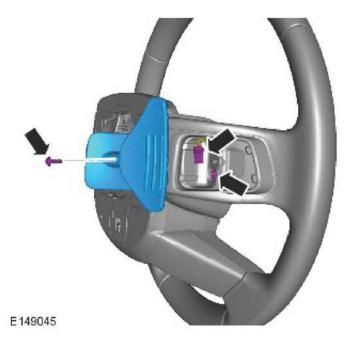
NOTE: Left-hand paddle switch shown; right-hand paddle shift similar.

Remove the transmission paddle switches.

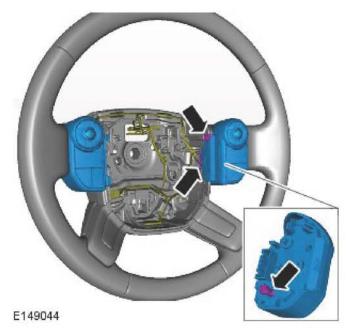
3. NOTE: Right-hand switch shown; left-hand switch similar.

Remove the steering wheel switches.
