TECHNICAL BULLETIN

LTB00916NAS2

SECTION: 303-01**Intake Camshaft Variable Cam Timing Actuator - Component Failure****AFFECTED VEHICLE RANGE:****Discovery Sport (LC)****Model Year:** 2015 Onwards**VIN:** 503863 Onwards**Assembly Plant:** Halewood**Engine:** GTDi 2.0L Petrol**Range Rover Evoque (LV)****Model Year:** 2012 Onwards**VIN:** 000447 Onwards**Assembly Plant:** Halewood**Engine:** GTDi 2.0L Petrol**LR2 (LF)****Model Year:** 2013-2015**VIN:** 311358-439912**Assembly Plant:** Halewood**Engine:** GTDi 2.0L Petrol**MARKETS:**

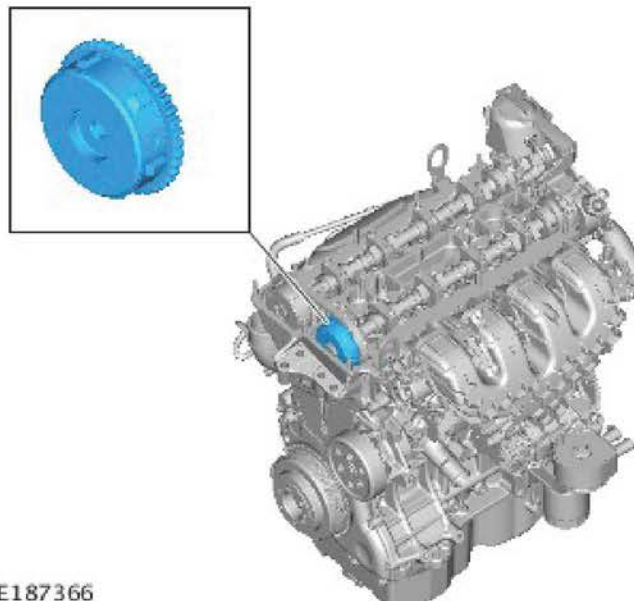
E187366

1. Intake camshaft Variable Camshaft Timing (VCT) actuator location

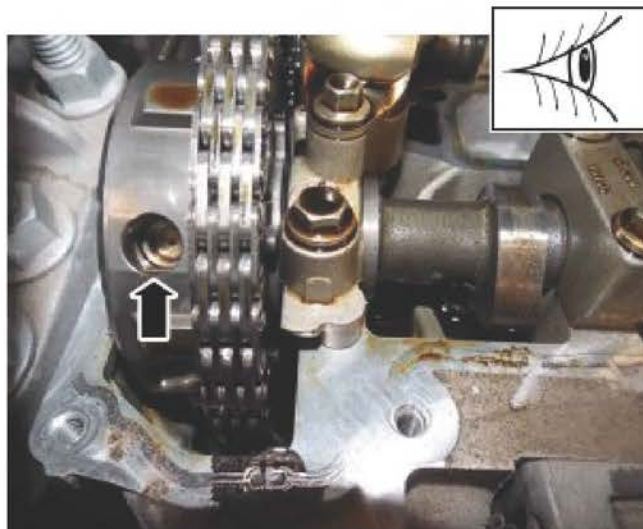
E186694

1. Remove the camshaft cover (see TOPIx Workshop Manual, section 303-01A / 303-01B: Engine).
2. Inspect the Variable Camshaft Timing (VCT) actuator.
 - If the VCT actuator is noisy but the 'stopper' is in place, proceed to step 3.
 - If the 'stopper' is not in place in the VCT actuator, proceed to step 4.

- 4. Renew the intake camshaft VCT actuator (see TOPIx Workshop Manual, section 303-01A / 303-01B: Engine).

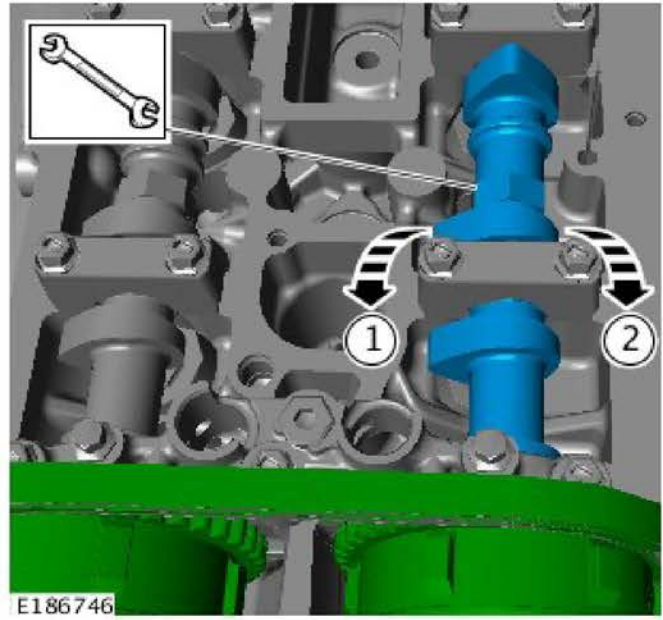
Fully rotate the camshaft anti-clockwise (1) and then attempt to rotate the camshaft clockwise (2).

- If no clockwise movement was possible without also rotating the engine, the VCT actuator is functioning correctly.
 - Reverse the removal procedure.
- If the camshaft rotates freely in both directions, the VCT actuator is NOT functioning correctly; proceed to step 4.
