TECHNICAL BULLETIN

LTB00923NAS1

Second Row Seat Rail Edge Exposed

Discovery Sport (LC)

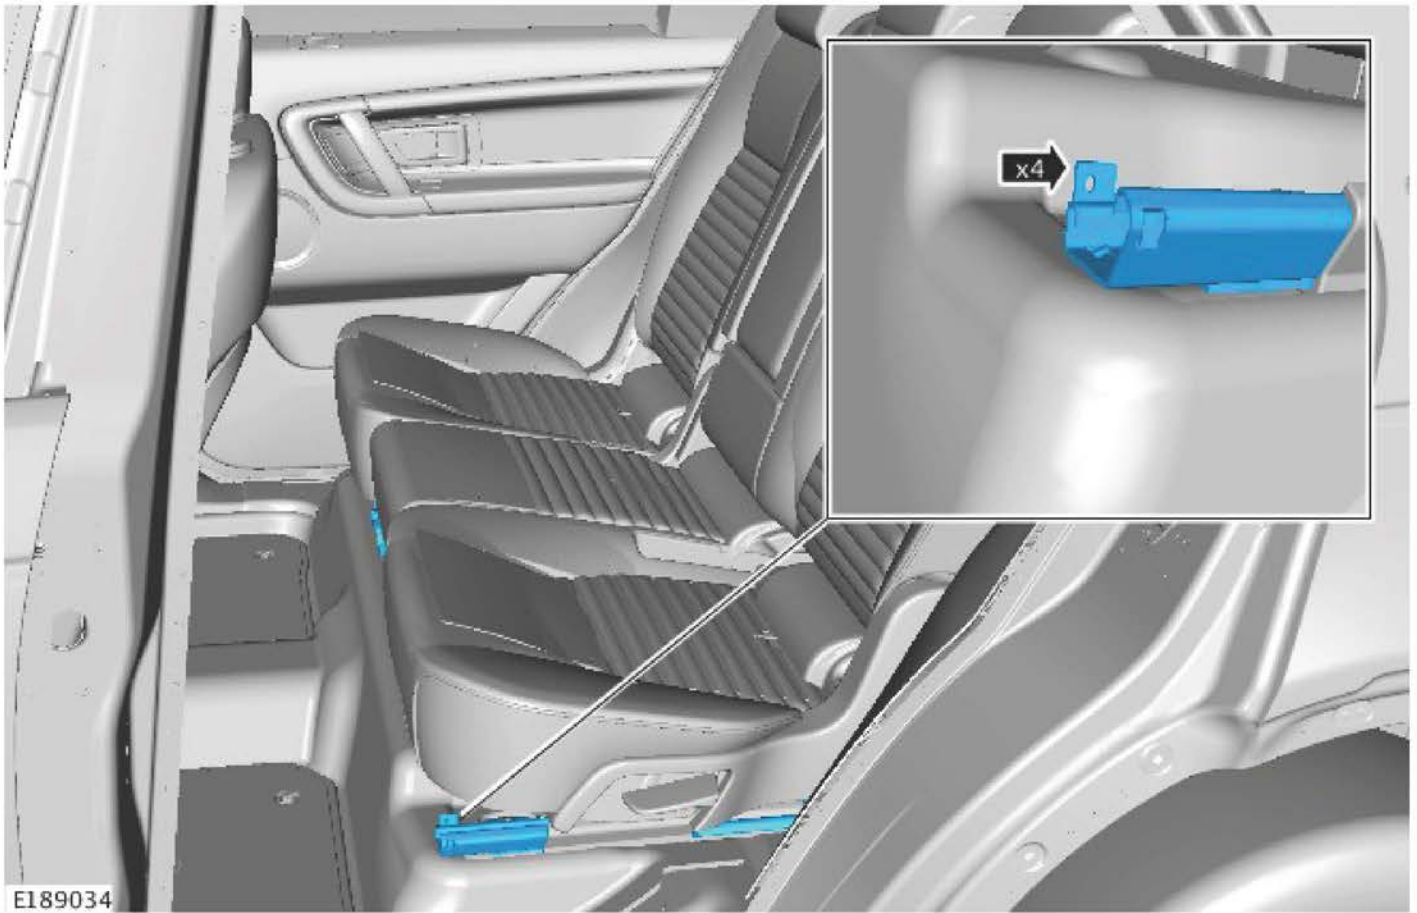
3.

Identify the area of the four second row seat rails to be modified.
