TECHNICAL BULLETIN

LTB00596NAS3
28 JAN 2016

SECTION: 412-00

Loss Of Audio System Functionality and/or Damp Front/Rear Footwell Carpets

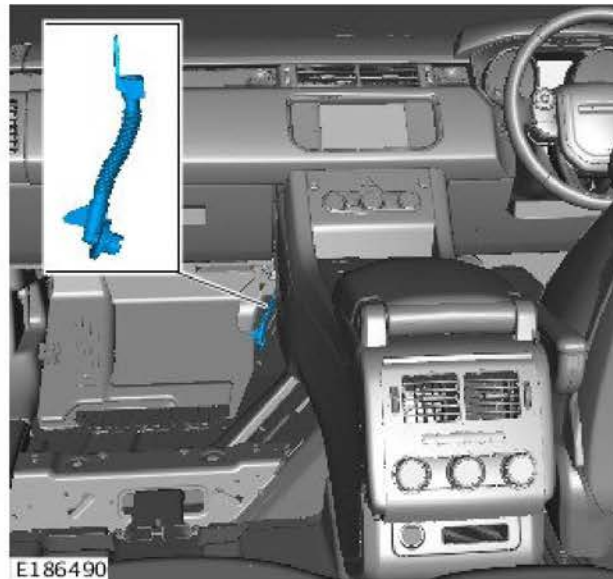
Component location.

Cause: This may be caused by the Climate Control system drain tube being incorrectly located in footwell causing water contamination to the carpets and possible water ingress into the Audio Amplifier Module.

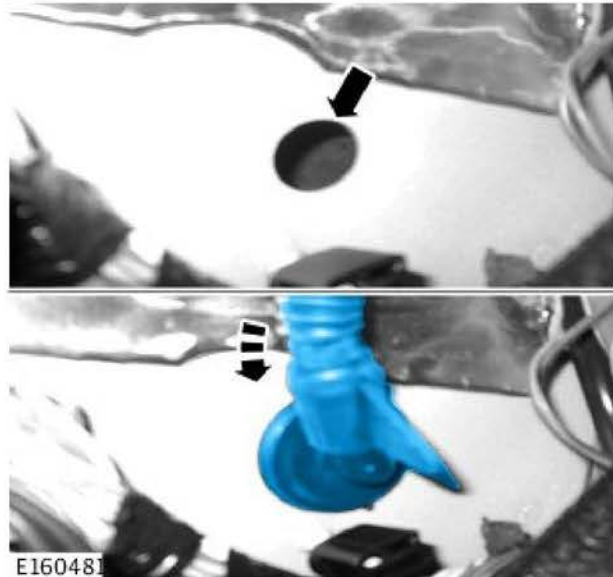
3 Check to see if the Climate Control system drain tube is connected correctly and that the retaining tabs are intact.

- If the drain tube is connected correctly and the tabs are intact, install drain tube into the hole.
 - Make sure both ends of the tube have a watertight seal.
- If the drain tube is not connected correctly and the tabs are not intact, replace the drain tube.

- Make sure both ends of the tube have a watertight seal.
