TECHNICAL BULLETIN
LTB00648NAS2
26 JAN 2016

Harness Repair Terminal Block C44-R2

Range Rover (LG)

Model Year: 2013-2014
VIN: 108006-127685
Assembly Plant: Solihull

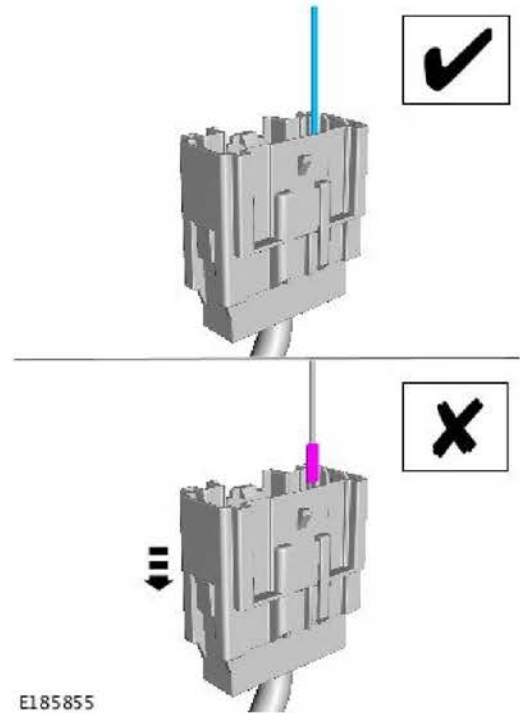
2 Hold the terminal and support the weight of the connector and harness.

- If the terminal holds in the connector (✓), the terminal is good.
- If the terminal separates from the connector (✗), the terminal in the connector must be replaced.

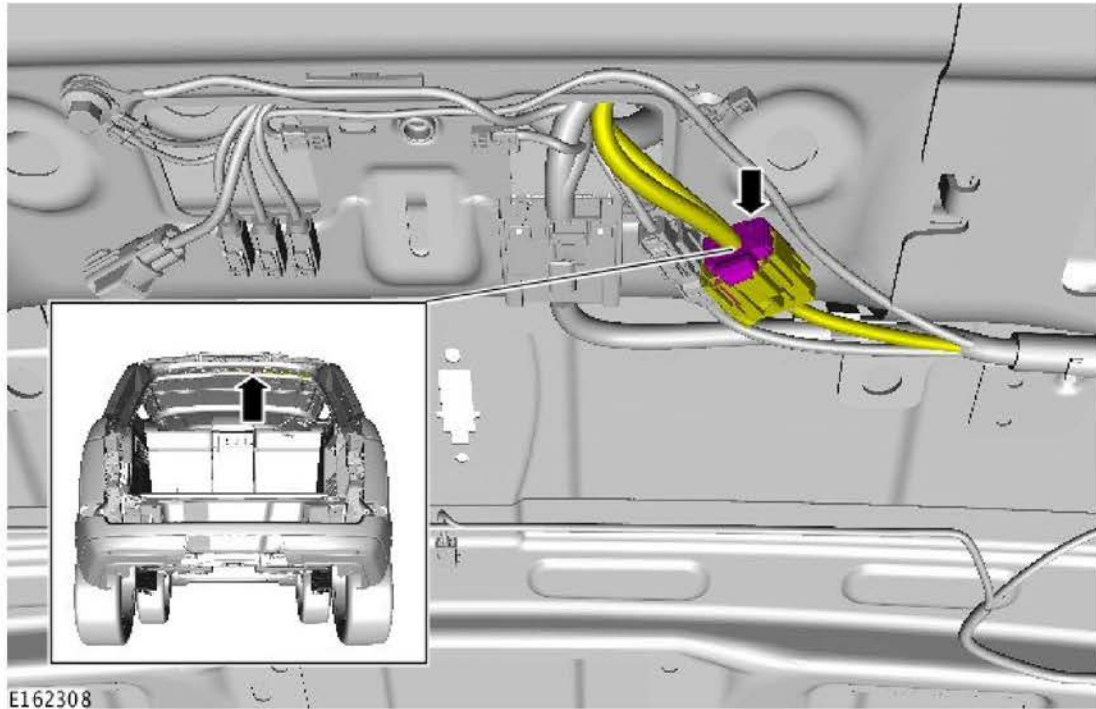
E162308

- 18 Disconnect the electrical connector C44-R2 from C44-R1.

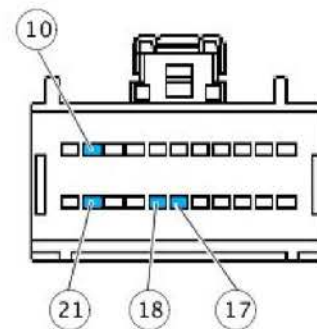
E162309

19 Remove the terminals in the positions 10, 17, 18, and 21 and carry out a pin drag test with each corresponding terminal of connector C44-R1 as per the Connector Test.

- If the connector fails (✗), the terminal in the connector must be replaced.
 - Continue to step 20.
- If the connector passes (✓), the terminal is good.
 - Refit the original terminals to connector C44-R2 and carry out a continuity test across the two connectors.
 - If the connector has good continuity, continue with further diagnosis with reference to TOPIx and the Jaguar Land Rover-approved diagnostic tool.
- If any of the terminals show no sign of resistance to movement during the test,
 - Continue to step 23.

**CAUTION: repair only one wire at a time to reduce the chance of incorrect wiring of the harness.**

Carry out the wiring repair (see TOPIx Workshop Manual, section 418-02: Wiring Harnesses).

- Remove any terminals found to be faulty by diagnosis in step 19 and install a new terminal as required (41841145). Make sure a sufficient length of wire is left on the electrical harness so the new terminal can be installed correctly using the recommended splice connector (418107).
- Make sure the correct black identification sleeve (418112) is fitted to the new terminal.
- Continue to step 23.

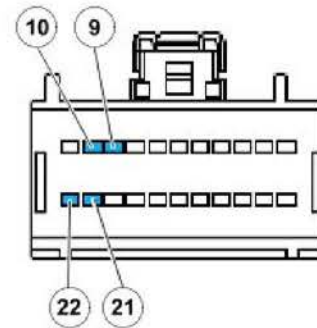
E185733

21 Remove the terminals in the positions 9, 10, 21, and 22 and carry out a pin drag test with each corresponding terminal of connector C44-R1 as per the Connector Test.

- If the connector fails (✗), the terminal in the connector must be replaced.
 - Continue to step 22.
- If the connector passes (✓), the terminal is good.
 - Refit the original terminals to connector C44-R2 and carry out a continuity test across the two connectors.
 - If the connector has good continuity, continue with further diagnosis with reference to TOPIx and the Jaguar Land Rover-approved diagnostic tool.
 - Continue to step 23.

**CAUTION: repair only one wire at a time to reduce the chance of incorrect wiring of the harness.**

Carry out the wiring repair (see TOPIx Workshop Manual, section 418-02: Wiring Harnesses).

- Remove any terminals found to be faulty by diagnosis in step 21 and install a new terminal as required (41841145). Make sure a sufficient length of wire is left on the electrical harness so the new terminal can be installed correctly using the recommended splice connector (418107).
- Make sure the correct black identification sleeve (418112) is fitted to the new terminal.
