TECHNICAL BULLETIN  
LTB00762NAS3  
28 JAN 2016

Door Pad / Quarter Trim Panel Insert 'Water Tideline' Evident

**Range Rover Evoque (LV)**

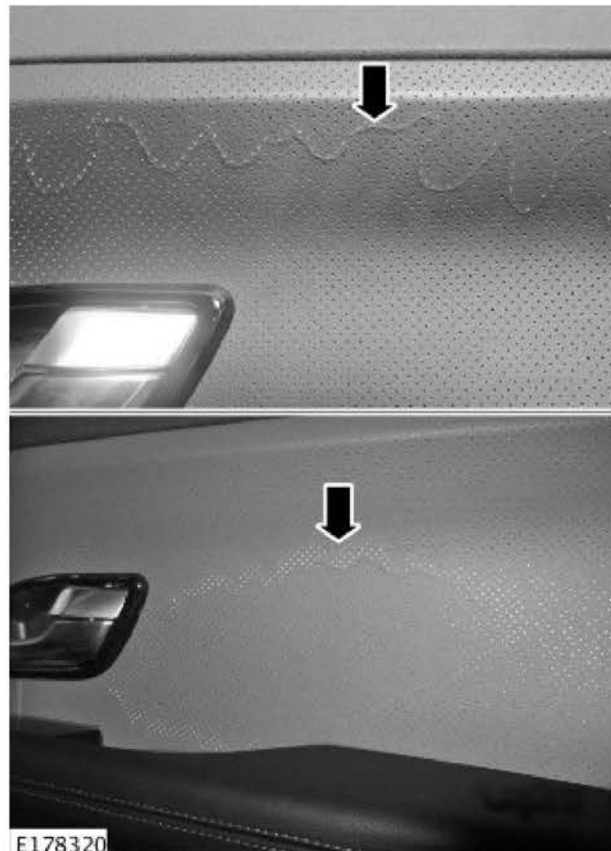
**Situation:** The perforated leather door pad(s) and/or rear quarter trim panel insert(s) (Coupe only) may exhibit a 'water tideline'.

**Cause:** This may be caused by water entering the door pad insert via the open pores in the perforations of the leather.

1 Check for evidence of a 'water tideline'.

Install a new front door trim panel (see TOPIx Workshop Manual section 501-05: Interior Trim and Ornamentation - Front Door Trim Panel).
