TECHNICAL BULLETIN
LTB00862NAS1
29 JAN 2016

Second Row Seating Center Arm Rest Operating Handle Adrift/Broken - Lower-Level Service Repair

Range Rover Sport (LW)

Range Rover (LG)

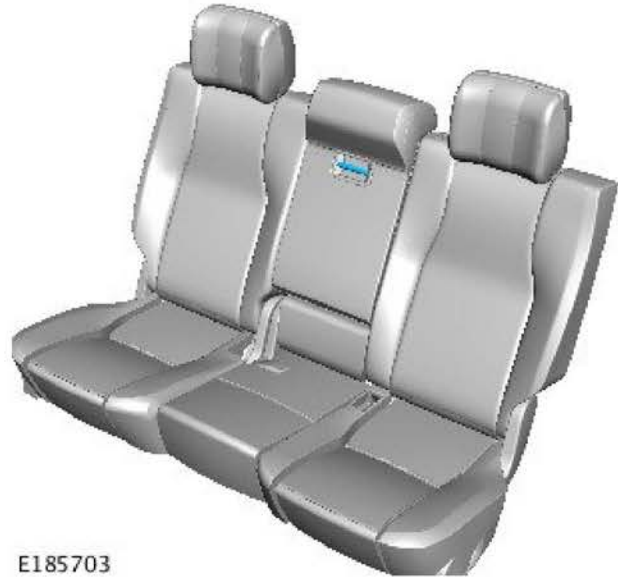
E185703

1 Component location.
