TECHNICAL BULLETIN
LTB00880NAS1
28 JAN 2016

SECTION: 501-11

'Creak' Noise When Lowering/Raising Door Window(s)

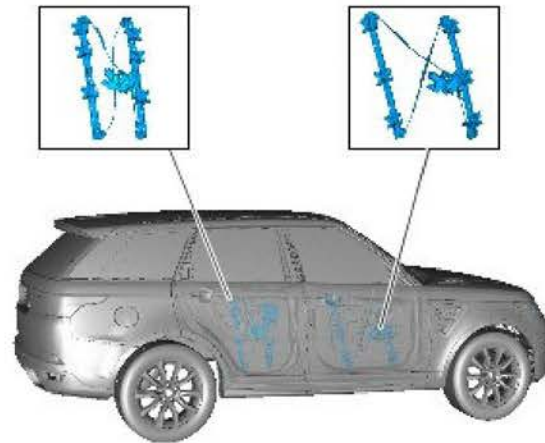
E185692

1 NOTE: Range Rover Sport (L494) right-side shown; all others similar.

Component location.

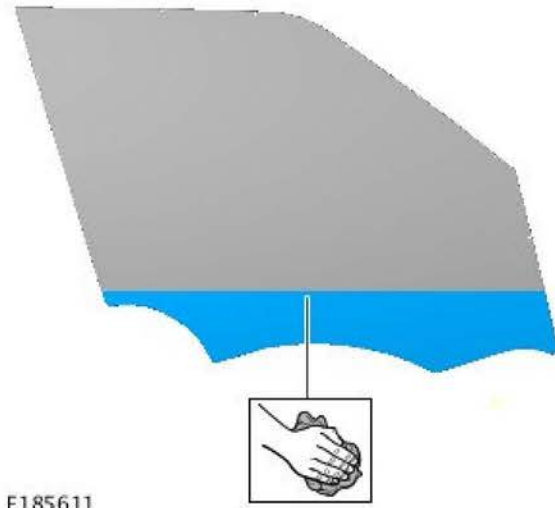
E185611

2 NOTE: front right door window shown; all others similar.

With a suitable glass cleaner, make sure the door window is clean.

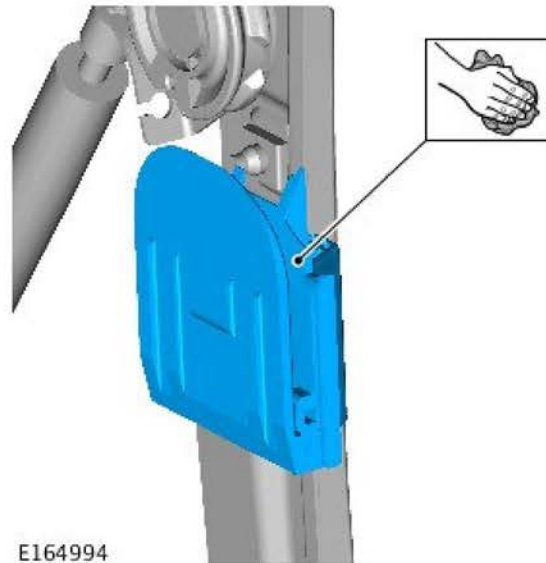
E164994

**NOTE: repeat this step for both door window retaining clips.**

Using a suitable cleaner, make sure the window retaining clips are clean and free from silicone.

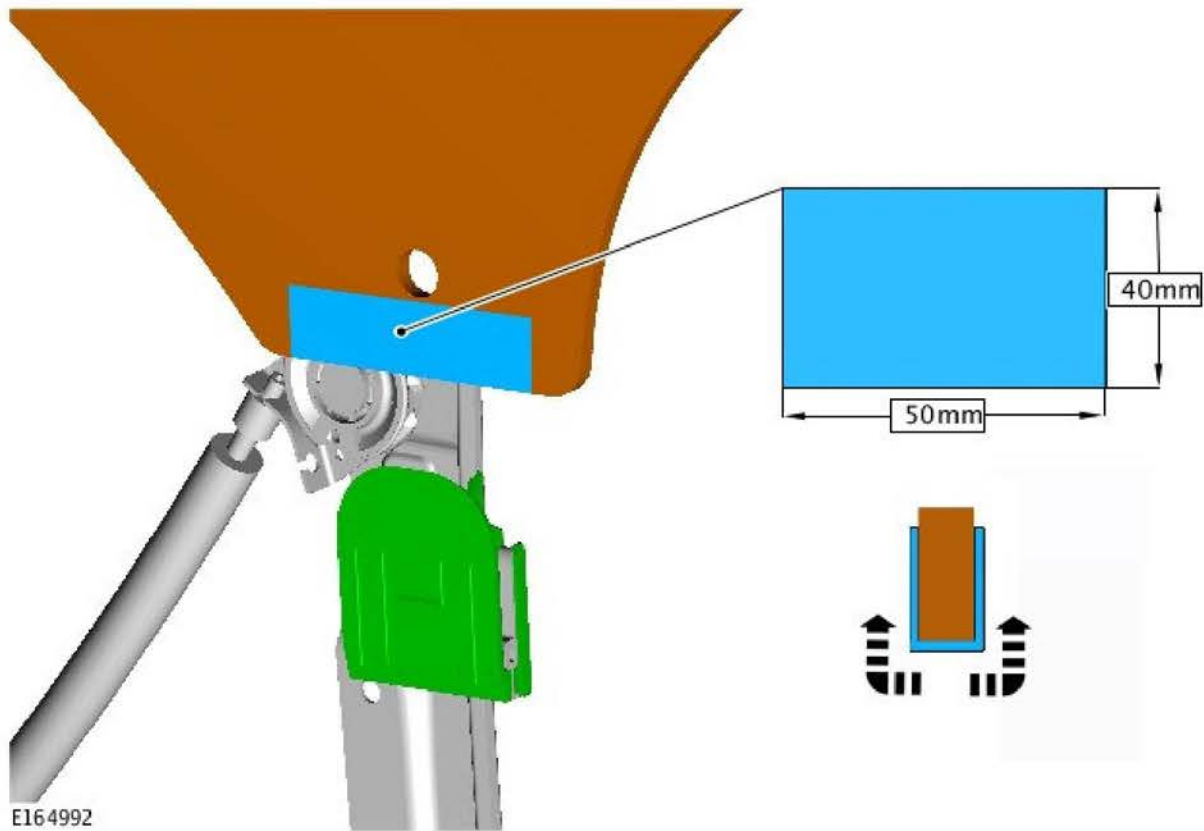
**NOTE: repeat this step for both door window retaining clips.**

Wrap the felt pad around the door window as shown to insulate the door window from the retaining clip.
