TECHNICAL BULLETIN

LTB00888NAS1
13 JAN 2016

'Creak' / 'Tizz' Noise From Instrument Panel Center Vent

Discovery Sport (LC)

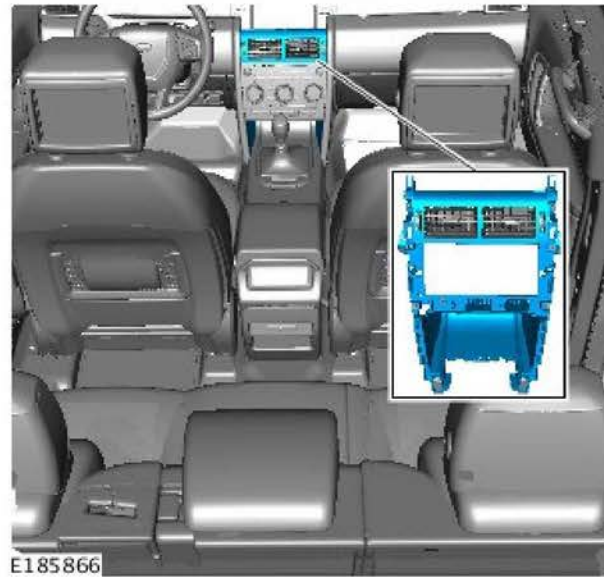
1Component location.

Situation: A 'creak' / 'tizz' noise may be evident from the instrument panel center console center stack and the navigation unit.

Cause: This may be caused by incompatible materials installed at the mating surfaces.
