TECHNICAL BULLETIN  
Q554NAS1  
13 JAN 2016

Service Action: Spare Wheel Lift Assist Strap Missing

**Range Rover Sport (LW)**

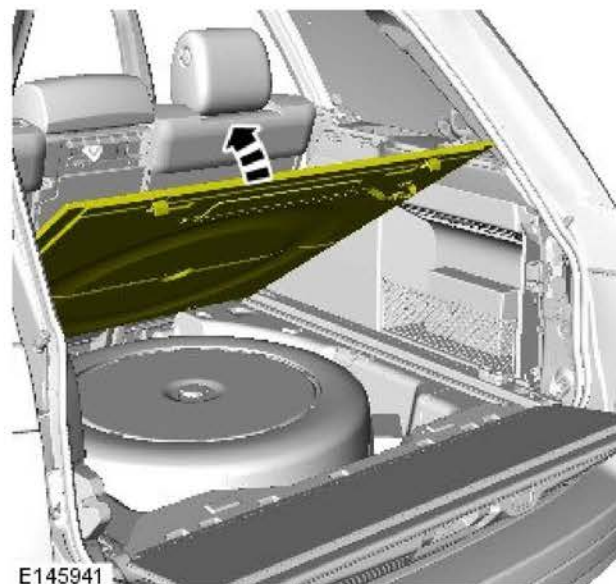
**Situation:** An issue has been identified on a limited number of 2016 model year Range Rover Sport (L494) vehicles, fitted with 21" wheels and a full-size spare wheel, where the spare wheel lift assist strap is missing from the vehicle.

**2**Lift the spare wheel cover.

**3**Place the spare wheel lift assist strap next to the spare wheel.
