Reference	SSM72584
Models	Discovery Sport / L550 Range Rover Evoque / L538
Title	2.0L GTDi Check Engine Light Illuminated with DTC P2096 and or P2097 Stored in PCM
Category	Driveability
Last modified	11-Jan-2016 00:00:00
Symptom	698298 Malfunction Indicator Lamp
Attachments	High-Pressure Diagnostic Leak Detector Information1.pdf (High-Pressure Diagnostic Leak Detector Information1.pdf)

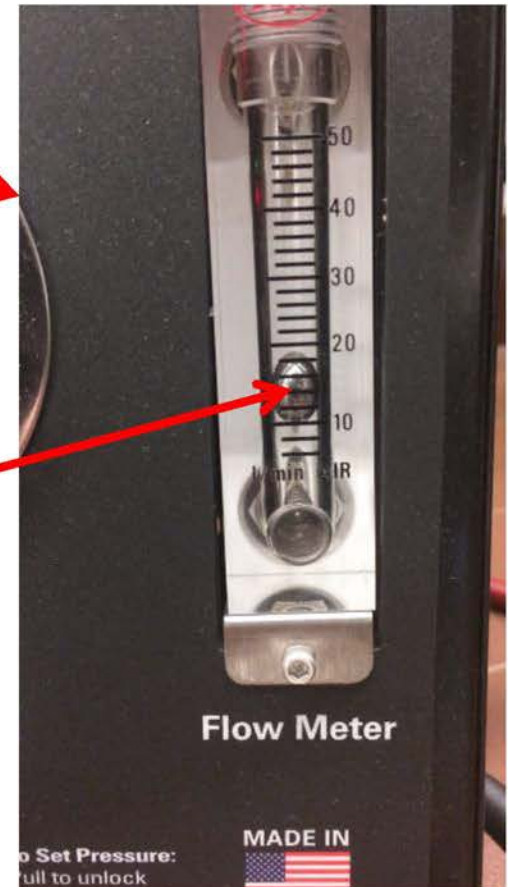
Flow Meter l/min AIR

Flow rate is visible on the test equipment on the front right hand side. The mid-point / widest point of the float, is the reference point to be used, when reading the value. Please record this value for submission on either TA or EPQR.
