TECHNICAL BULLETIN  
LTB00863NAS1  
10 FEB 2016

**SECTION: 307-02**

Transmission Fluid Leak

**Range Rover Evoque (LV)**

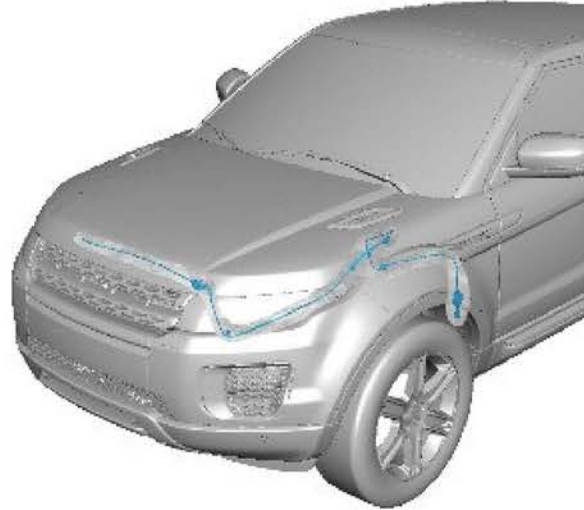
E184871

**Cause:** This may be caused by the hood release cable fouling the transmission fluid cooler.

1. Component location (hood release cable).

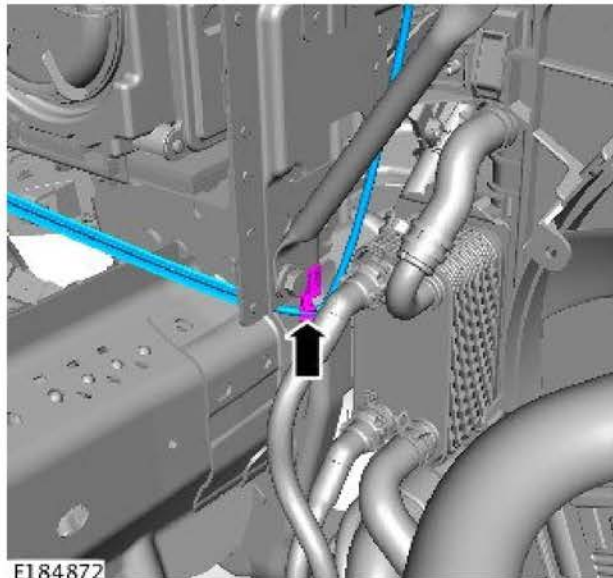
E184872

1. Open the hood.
2. Inspect the position of the hood release cable retaining clip for possible fouling of the transmission fluid cooler.
