TECHNICAL BULLETIN  
LTB00868NAS1  
01 FEB 2016

**SECTION: 501-20A**

Front Seatbelt(s) Slow to Retract

**LR4 (LA)**

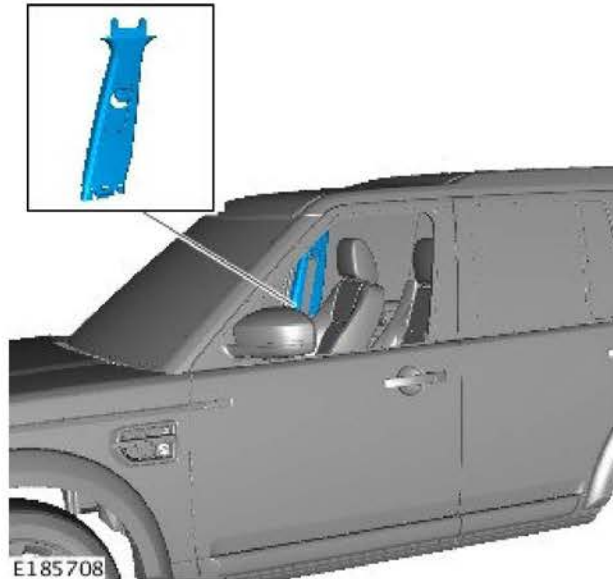
Component location.

**Situation:** The front seatbelt(s) may be slow to retract.

**Cause:** This may be caused by the design of the upper B-pillar trim, allowing the seatbelt to drag on the upper B-pillar trim.

**NOTE: right-side B-pillar shown; left-side B-pillar similar.**

4 Install the new B-pillar trim finisher (see TOPIx Workshop Manual, section 501-05: Interior Trim and Ornamentation).
