TECHNICAL BULLETIN

Q561NAS1

SECTION: 501-08

Service Action: Windshield Finisher Coming Loose - Detaching

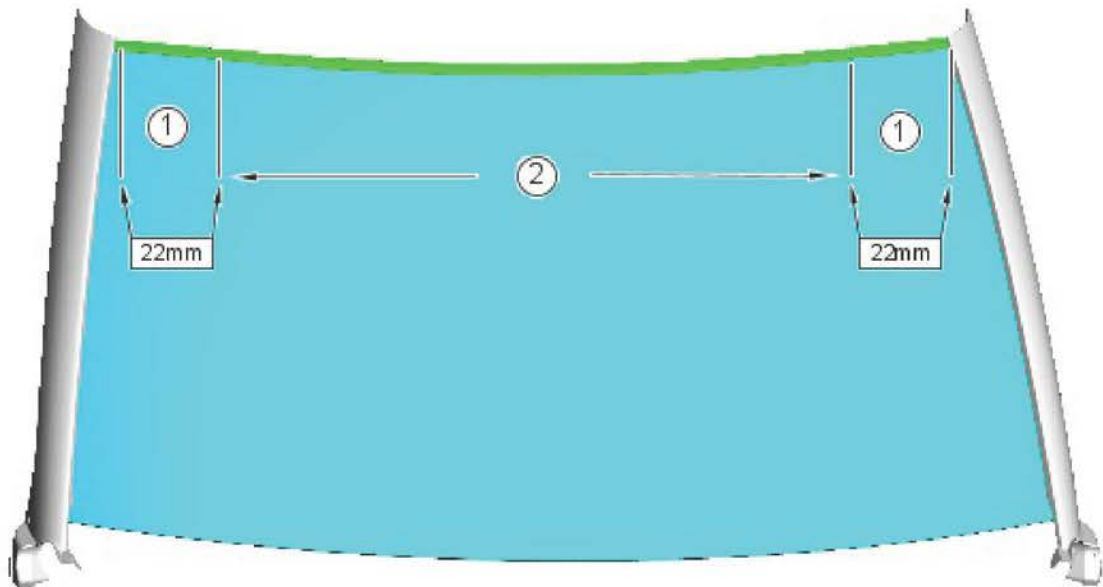
E180679

1. Check the upper windshield finisher for potential wind noise/leak paths (2).

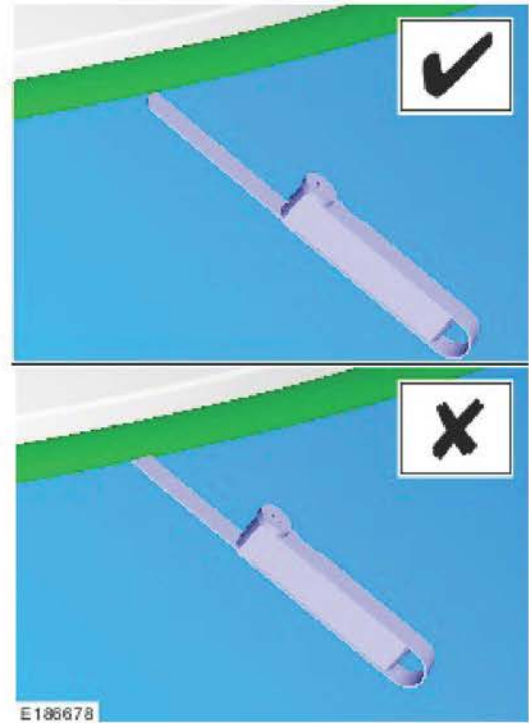
2.

**NOTE: at least 5mm of the tip of the plastic feeler gauge or more needs to pass under the finisher to be considered a fail.**

Using a 0.1mm plastic feeler gauge (or similar), probe perpendicular to the finisher at equally spaced increments.

- If the tip of the feeler gauge (or similar) passes less than 5mm under the finisher at equally spaced increments, release the vehicle.

- If the tip of the feeler gauge (or similar) passes more than 5mm under the finisher at equally spaced increments, continue to Step 3.
