TECHNICAL BULLETIN  
Q561NAS2  
16 FEB 2016

Service Action: Windshield Finisher Coming Loose - Detaching

LR4 (LA)

Model Year: 2015

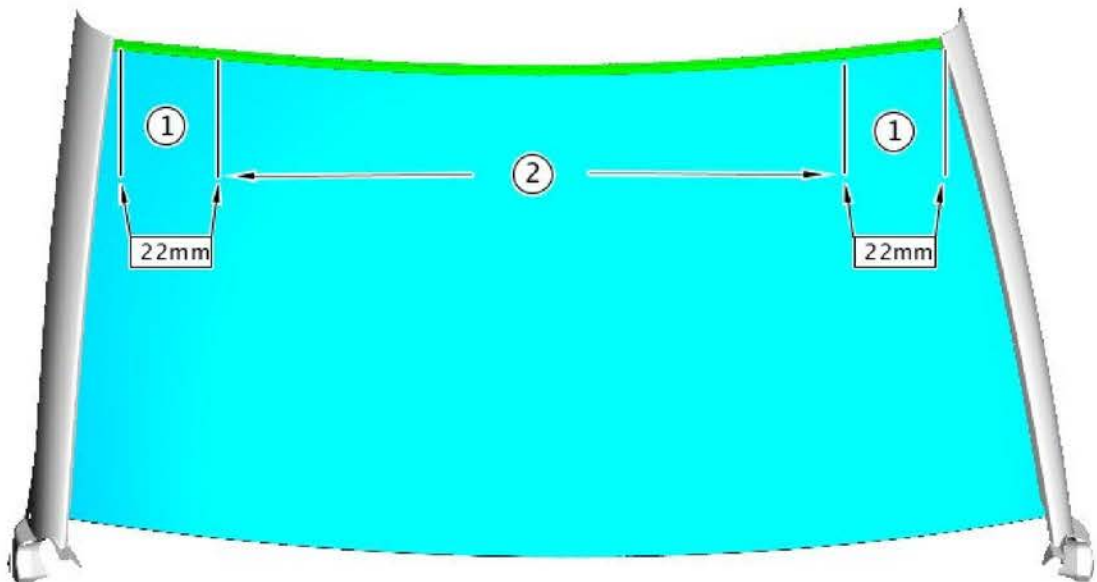
E186679

1. Check the upper windshield finisher for potential wind noise/leak paths (2).

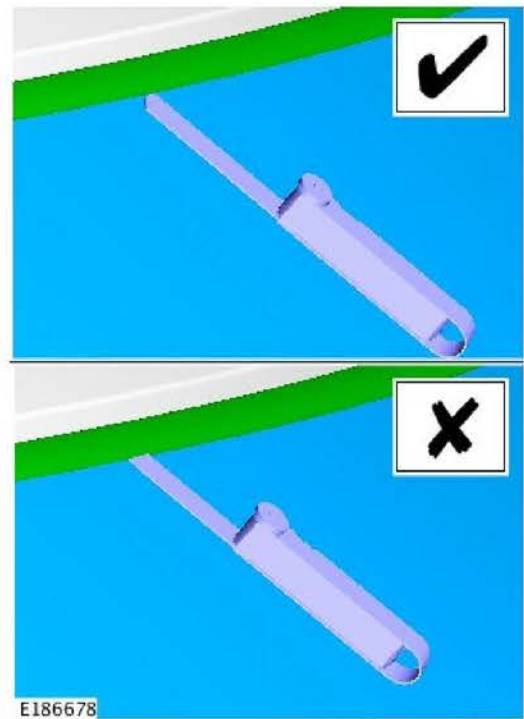
**NOTE: at least 5mm of the tip of the plastic feeler gauge or more needs to pass under the finisher to be considered a fail.**

Using a 0.1mm plastic feeler gauge (or similar), probe perpendicular to the finisher at equally spaced increments.

- If the tip of the feeler gauge (or similar ) passes less than 5mm under the finisher at equally spaced increments, release the vehicle.
- If the tip of the feeler gauge (or similar) passes more than 5mm under the finisher at equally spaced increments, continue to Step 3.
