<b>Reference</b>	SSM72543
<b>Models</b>	Discovery Sport / L550 Range Rover / L405 Range Rover Evoque / L538 Range Rover Sport / L494
<b>Title</b>	Panoramic Roof Damage on Land Rover vehicles
<b>Category</b>	Body
<b>Last modified</b>	08-Feb-2016 00:00:00
<b>Symptom</b>	102000 Window/Glass
<b>Attachments</b>	1Panoramic roof damage1.pdf (1Panoramic roof damage1.pdf)

# Panoramic roof damage

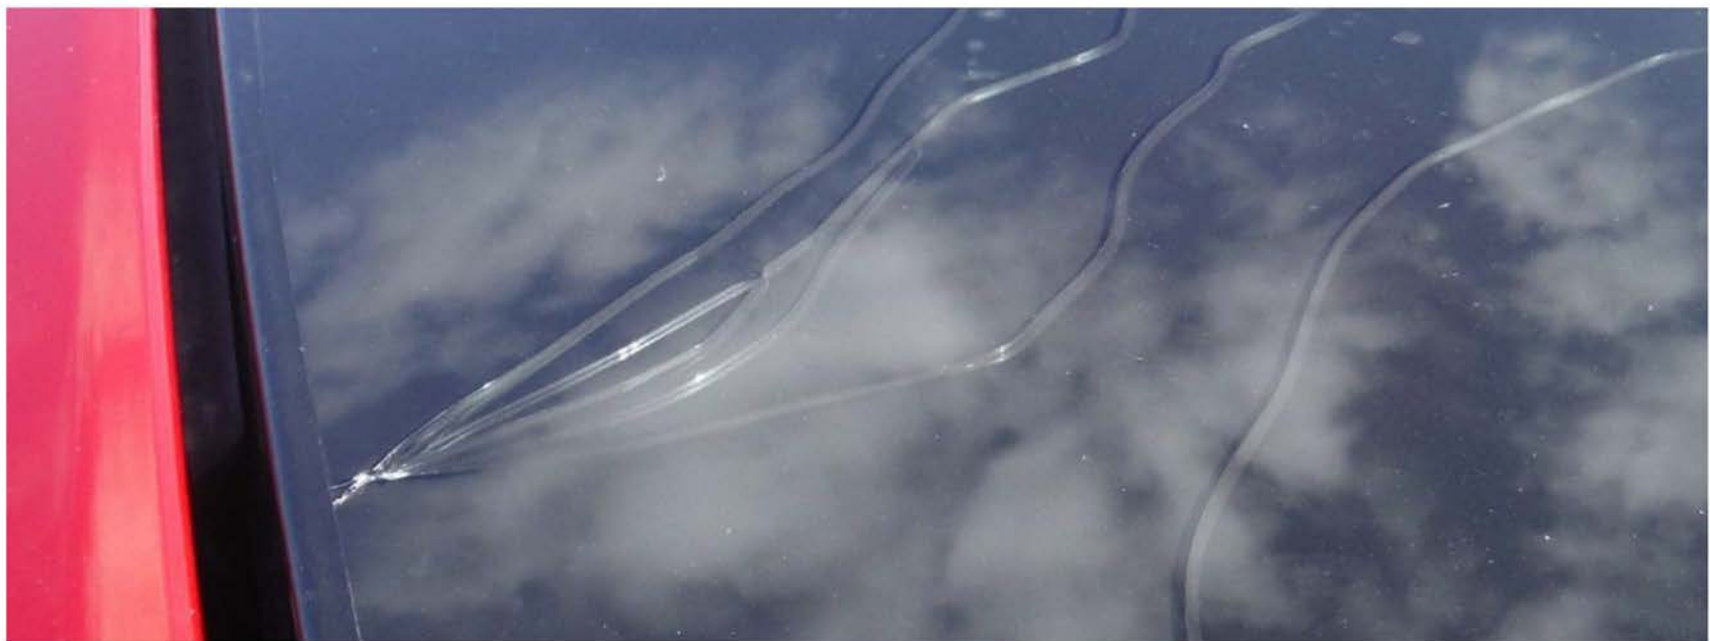
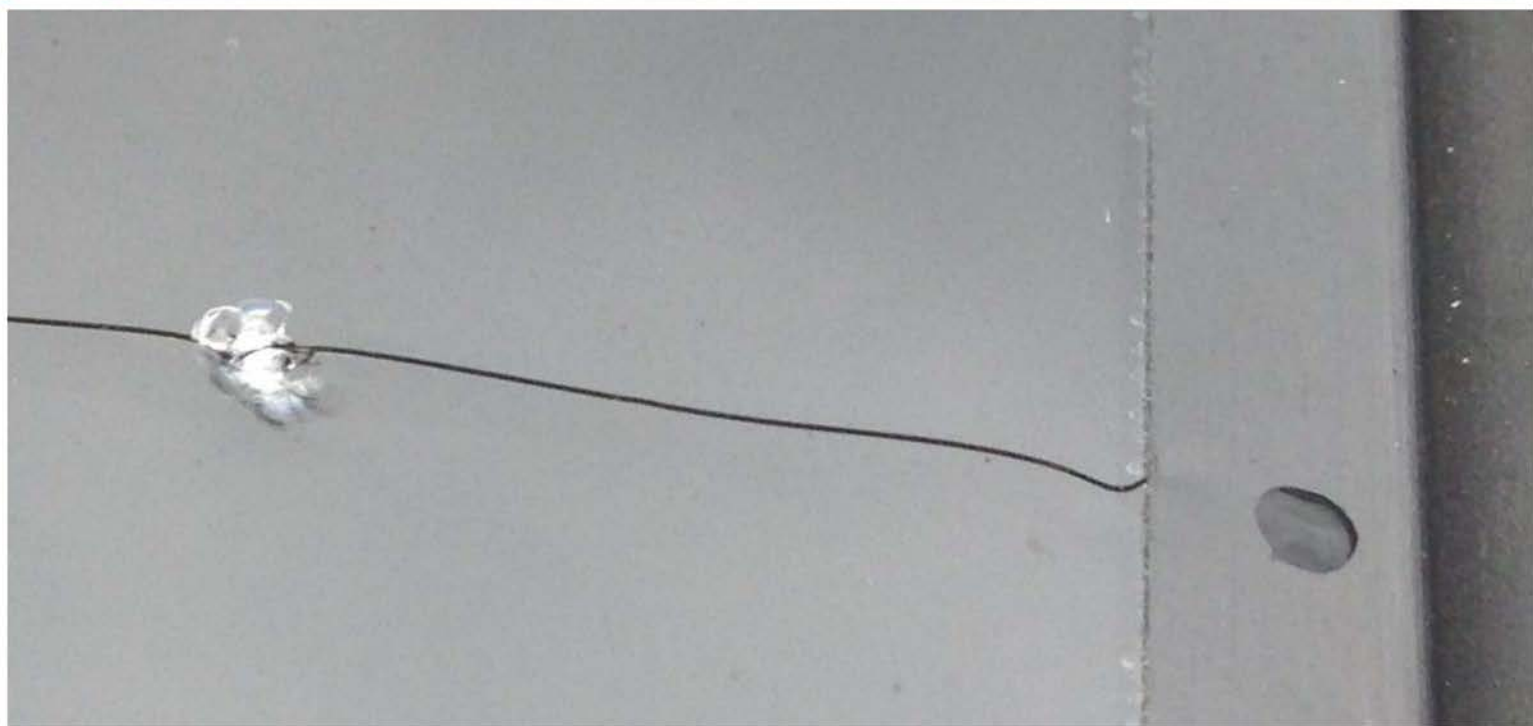
- Fig. 1 – clear impact marks can be seen. These would appear to be from a small or sharp object.
- Fig. 2 – clear impact marks can be seen that may have been caused by a large or blunt object.
- Fig. 3 – impact marks are not so evident. Careful examination with a magnifying glass would be preferable to identify the point of impact. This could have originated from a small, sharp object that has propagated over time and further shock.
- Fig. 4 – shows small yet clear impact marks. It also shows the propagation that follows from such an impact.

1. Refer to the attached images (for reference).
2. Inspect the roof to identify any impact marks.
3. If an impact mark is found, please do NOT submit a warranty claim.

Once the cause of the crack can be identified as an external impact, the customer is to be informed that this will not be covered under normal warranty.
