Reference	SSM71883
Models	Range Rover / L405 (197041 → 100000) Range Rover Sport / L494 (504510 → 300000)
Title	Right First Time repair for DTCs:C0031/C0033/C0036/C0037/C0039
Category	Chassis
Last modified	29-Feb-2016 00:00:00
Symptom	304000 Suspension System
Attachments	1Remove Debris.pdf (1Remove Debris.pdf)

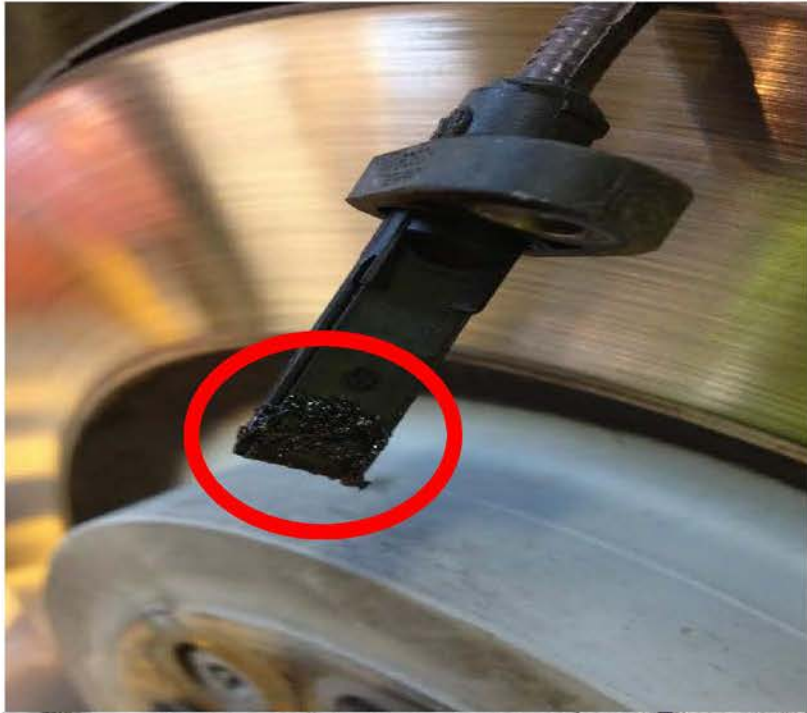
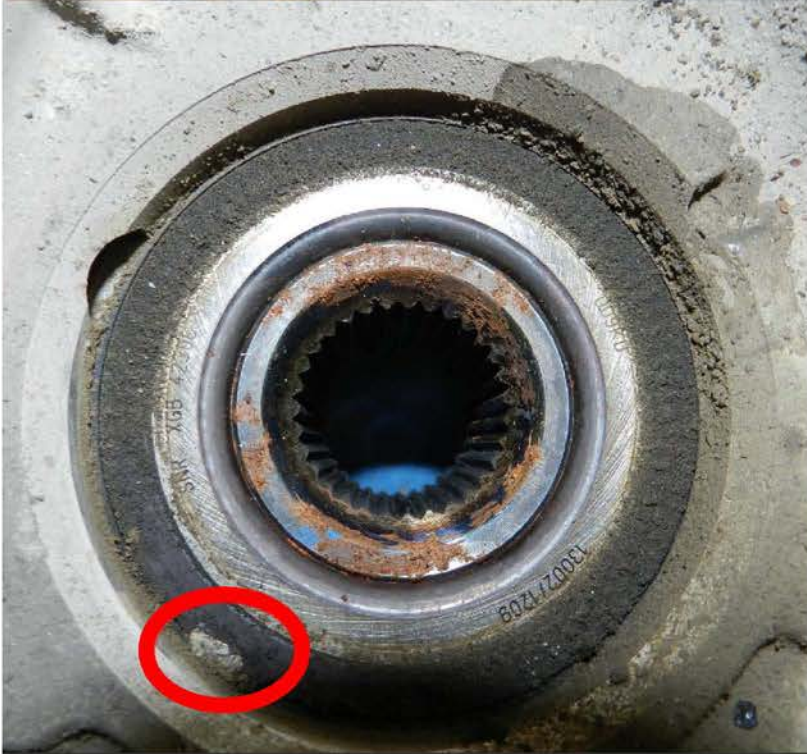
Contamination between the ABS wheel speed sensor and the wheel bearing tone wheel could lead to the above DTC's being set. Please view attached pictures for examples.

-Remove the relevant wheel speed sensor (Workshop manual: 206-09), remove any debris and re-install.

-Remove the half-shaft retaining nut, with the corner assembly supported, then slide the shaft towards the vehicle to gain access to the tone wheel. Clean any debris from the tone wheel.

-Clear fault codes and carry out an extended road test to confirm the issue has been rectified.
