TECHNICAL BULLETIN

LTB00780NAS4

23 MAY 2016

Accessory Drive Belt Idler Pulley Humming Noise

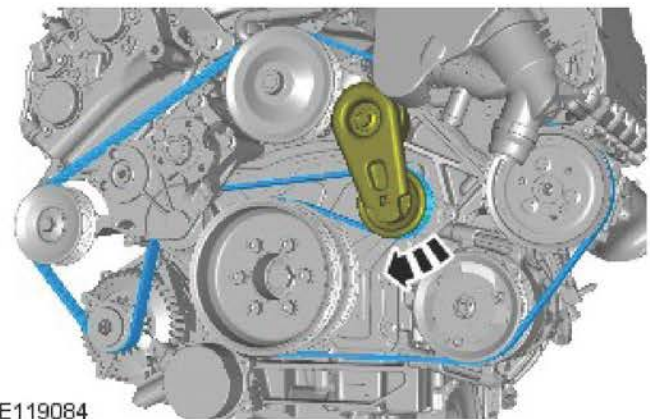
**NOTE:** Note the fitted position of the accessory drive belt.

Loosen the accessory drive belt and remove from the idler pulley.
