TECHNICAL BULLETIN

LTB00814NAS2

SECTION: 501-02

Underhood Lower NVH Pads Freezing

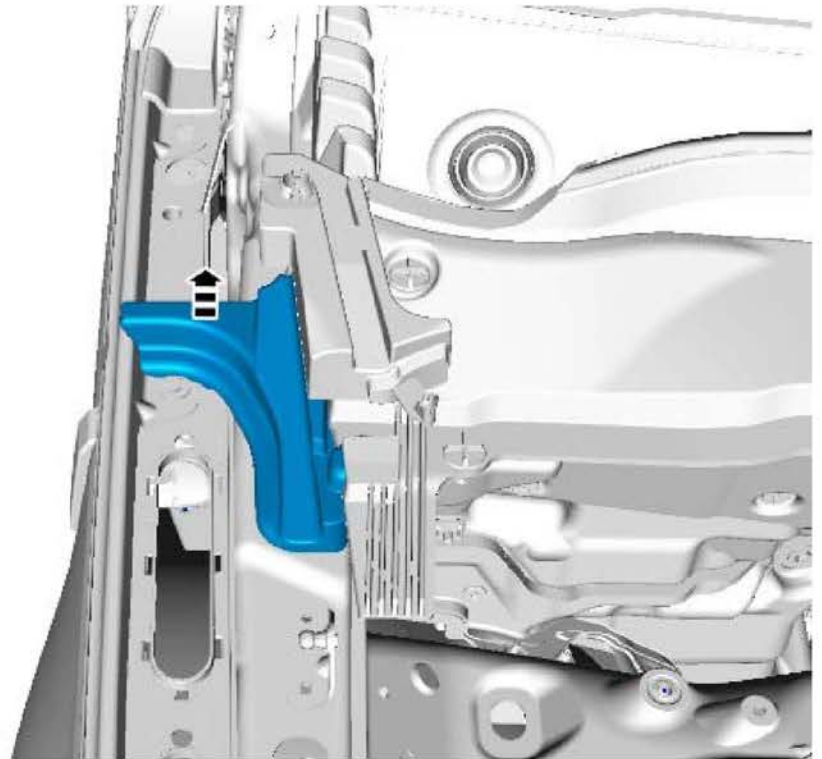
E191495

Remove and
discard the
underhood lower
right-hand Noise
Vibration
Harshness (NVH)
pad.
