TECHNICAL BULLETIN
LTB00891NAS2
31 MAY 2016

SECTION: 501-08

Roof Opening Panel Rear Glass Seal Loose

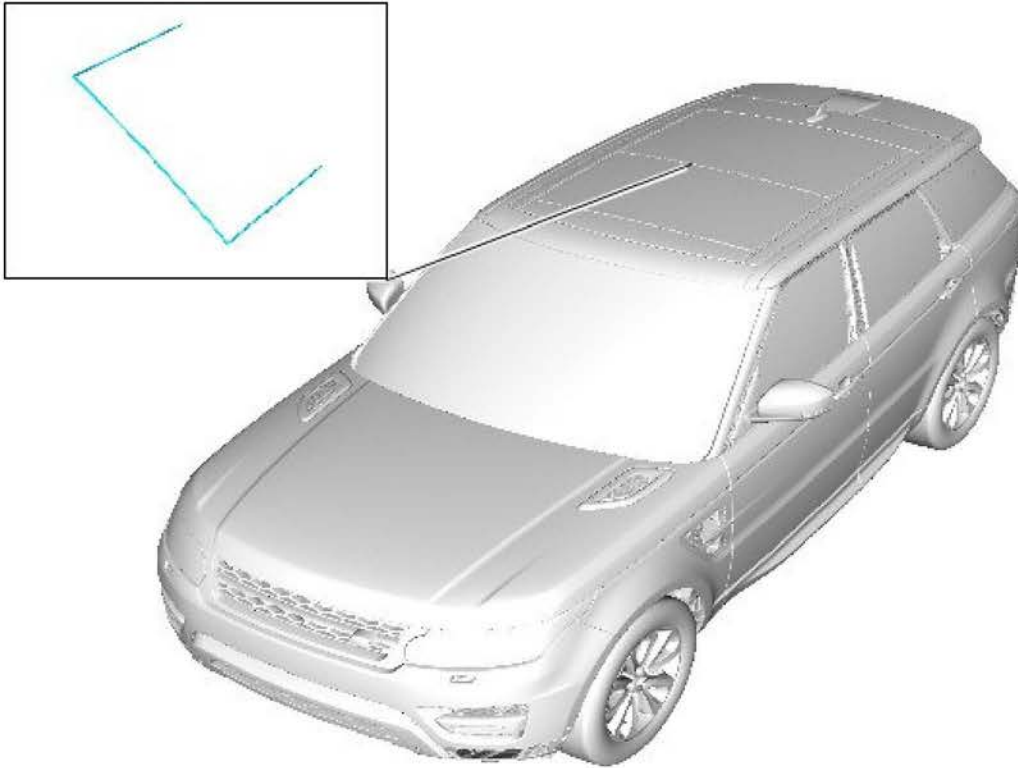
E186000

**NOTE: Range Rover Sport (L494) shown; Range Rover (L405) similar.**
Component location.
