TECHNICAL BULLETIN LTB00955NAS1 27 MAY 2016

SECTION: 412-00

Air Conditioning Service Port Valve Leaks

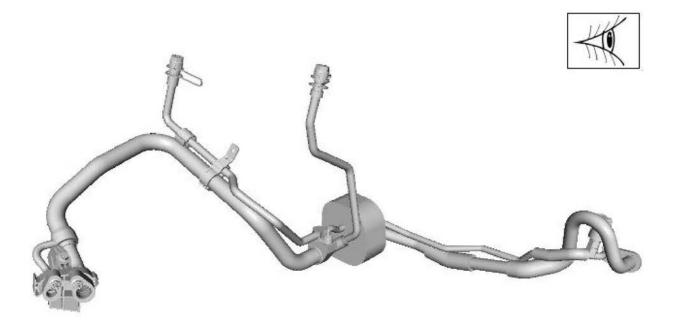
E192164

1. All with Internal Heat Exchanger (IHX) Air Conditioning pipes: install LR088548.

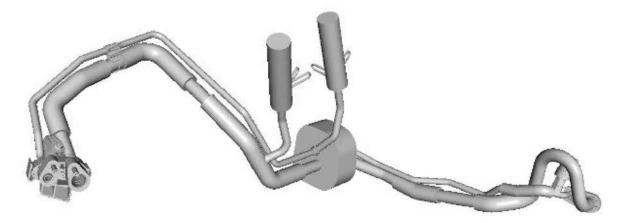
E192165

- 2. Pre 16MY with Non-Internal Heat Exchanger (IHX) Air Conditioning pipes: - install LR002940.
 - Discovery Sport (L550) up to VIN 544576
 - Range Rover Evoque (L538) up to VIN 077911
- 3. Post 16MY with Non-Internal Heat Exchanger (IHX) Air Conditioning pipes: - install LR088548.
 - Discovery Sport (L550) from VIN 544577
 - Range Rover Evoque (L538) from VIN 077912
- 3. Post 16MY with Non-Internal Heat Exchanger (IHX) Air Conditioning pipes: - install LR088548.
 - Discovery Sport (L550) from VIN 544577
 - Range Rover Evoque (L538) from VIN 077912

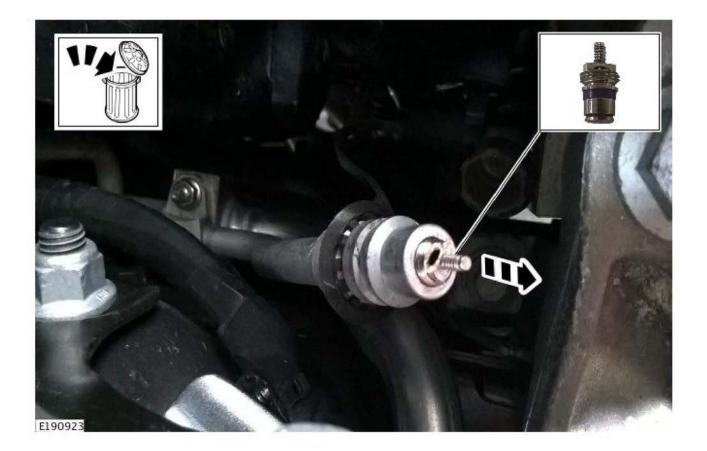
Cause: This may be caused by a leaking A/C charge port valve.

Using a suitable tool, remove and discard the Air Conditioning charge port Schrader valve (turn anticlockwise).
