TECHNICAL BULLETIN
LTB00956NAS1
27 MAY 2016

SECTION: 501-10

Unsatisfactory Second Row Seat Comfort

Discovery Sport (LC)

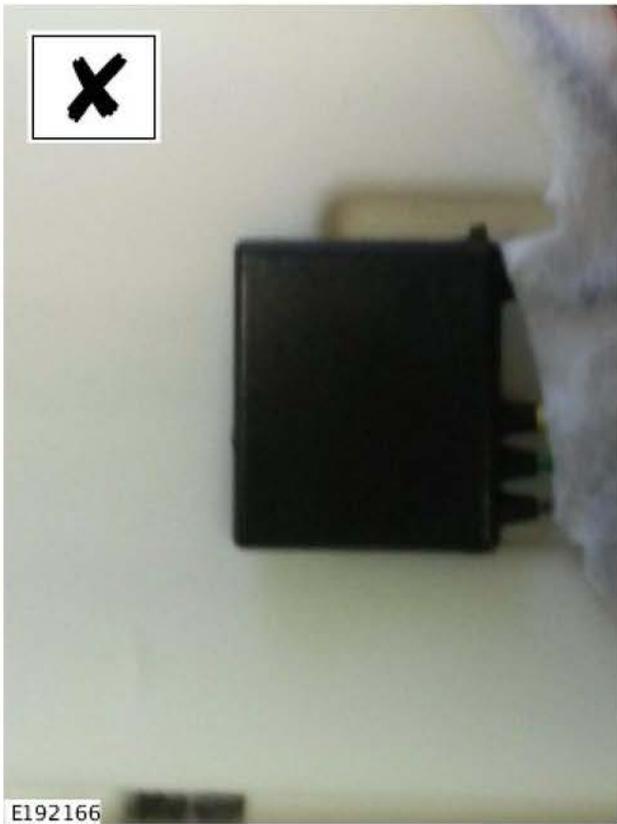
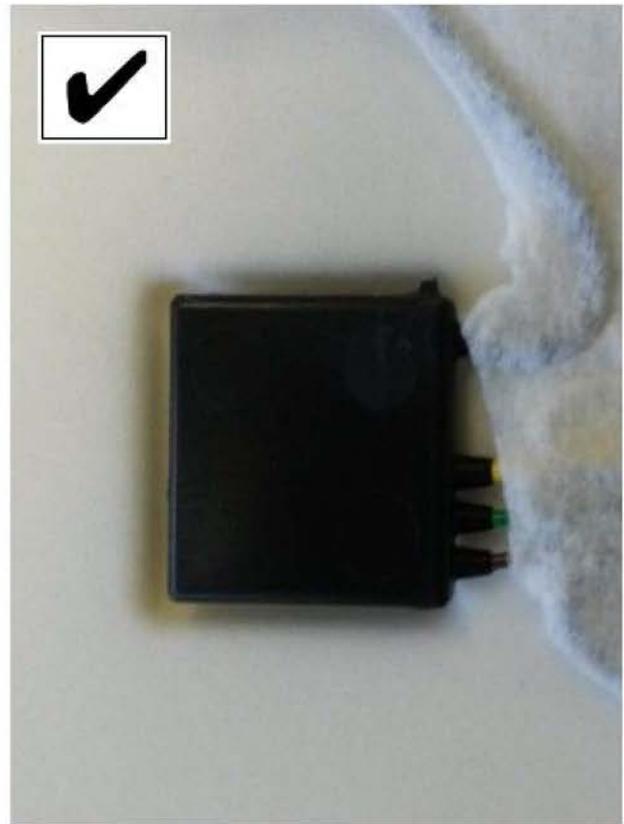
Situation: On vehicles fitted with heated second row seating, a hard 'lump' may be felt through the surface of the second row seat cushion cover while sitting on the seat

Cause: This may be caused by incorrect positioning of the heater mat within the second row seat cushion.

1. Remove the affected second row seat cushion heater mat (see TOPIx Workshop Manual section 501-10: Seating - Rear Seat Cushion Heater Mat).
2. Visually check that the heater mat is installed correctly (✓) with the control unit positioned within the foam cut-out as shown.

- If the heater mat is installed correctly (✓) with the control unit positioned within the foam cut-out, continue to the next step.
- If the heater mat is not installed correctly (✗) with the control unit positioned within the foam cut-out, reposition as necessary.
 - Continue to the next step.
