TECHNICAL BULLETIN  
LTB00814NAS3  
21 JUN 2016

**Underhood Lower NVH Pads Freezing**

**Range Rover Sport (LW)**

**Range Rover (LG)**

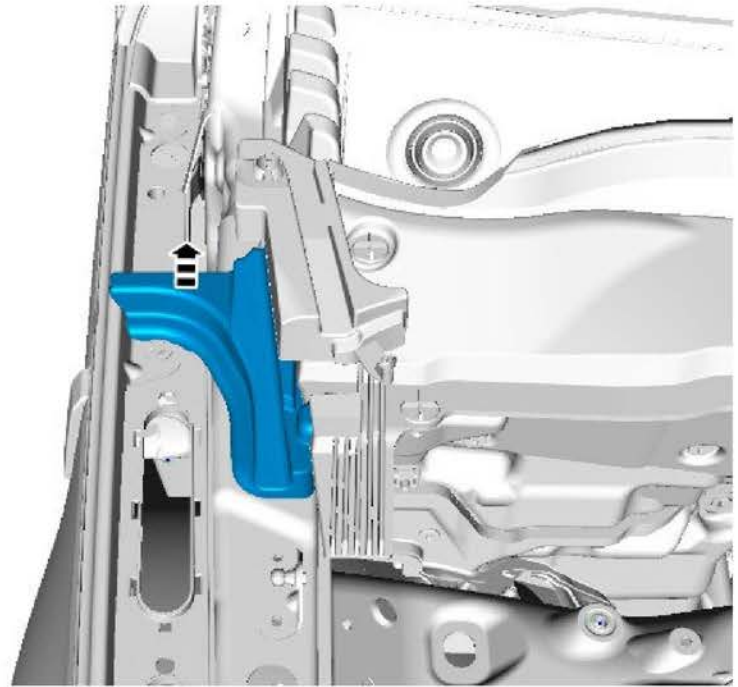
E191495

**Situation:** The underhood lower Noise Vibration Harshness (NVH) pad(s) may show signs of ripping, tearing, and/or has a poor finish.

**Cause:** This may be caused by ice build up between the foam surfaces and the hood, causing penetration into the foam.

2. **NOTE:** Right-hand shown; left-hand similar.

Remove and discard the underhood lower right-hand Noise Vibration

Harshness (NVH) pad.
