TECHNICAL BULLETIN  
LTB00965NAS1  
27 JUN 2016

Rear Side Door Difficult To Open

**Range Rover (LG)**

**Model Year:** 2013 Onwards  
**VIN:** 001171 Onwards  
**Assembly Plant:** Solihull

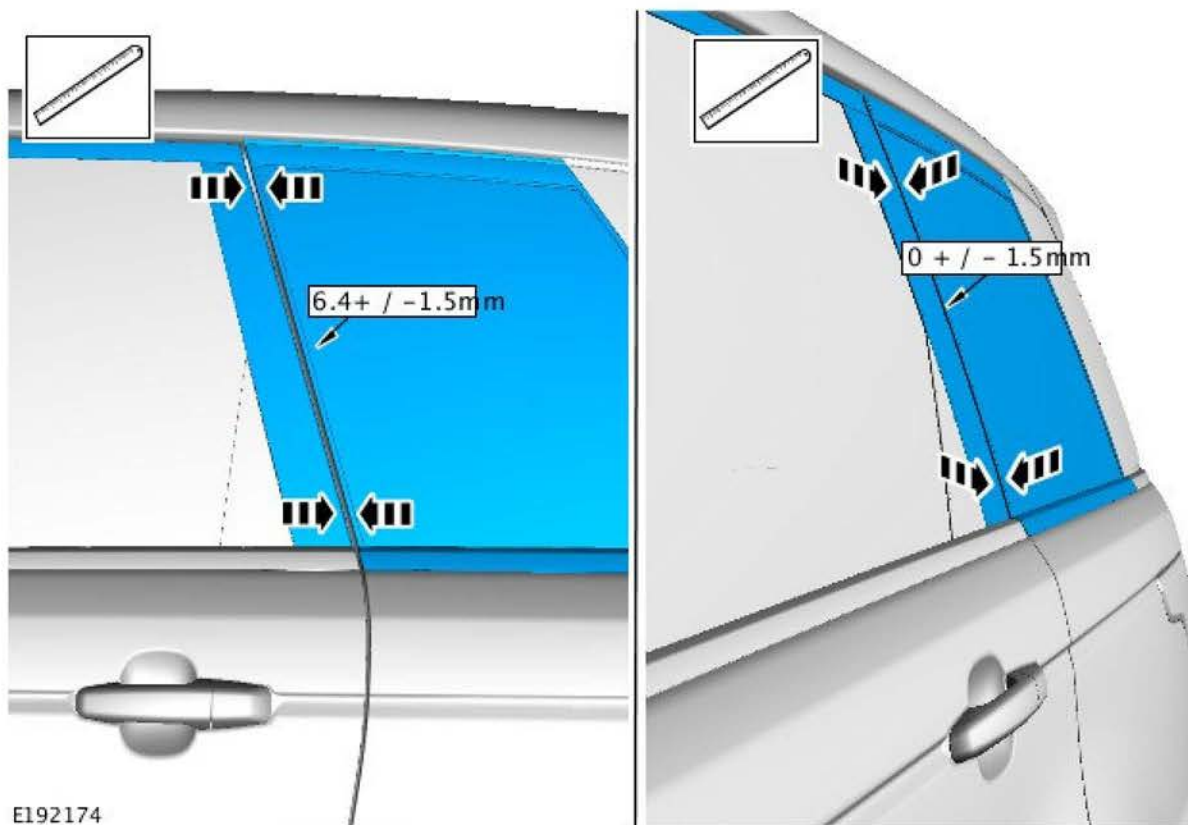
E192174

Measure the alignment between the rear door and rear quarter window (record measurement).

1. If the alignment does not meet the specifications shown, go to Step 2.
2. If the alignment does meet the specifications, apply slip coating (as supplied in the Squeak & Rattle kit) to the margin seal flock coating and front edge of the rear quarter window.
  - Apply 6-8 times, allowing approximately 5 minutes between applications for each coat to dry.

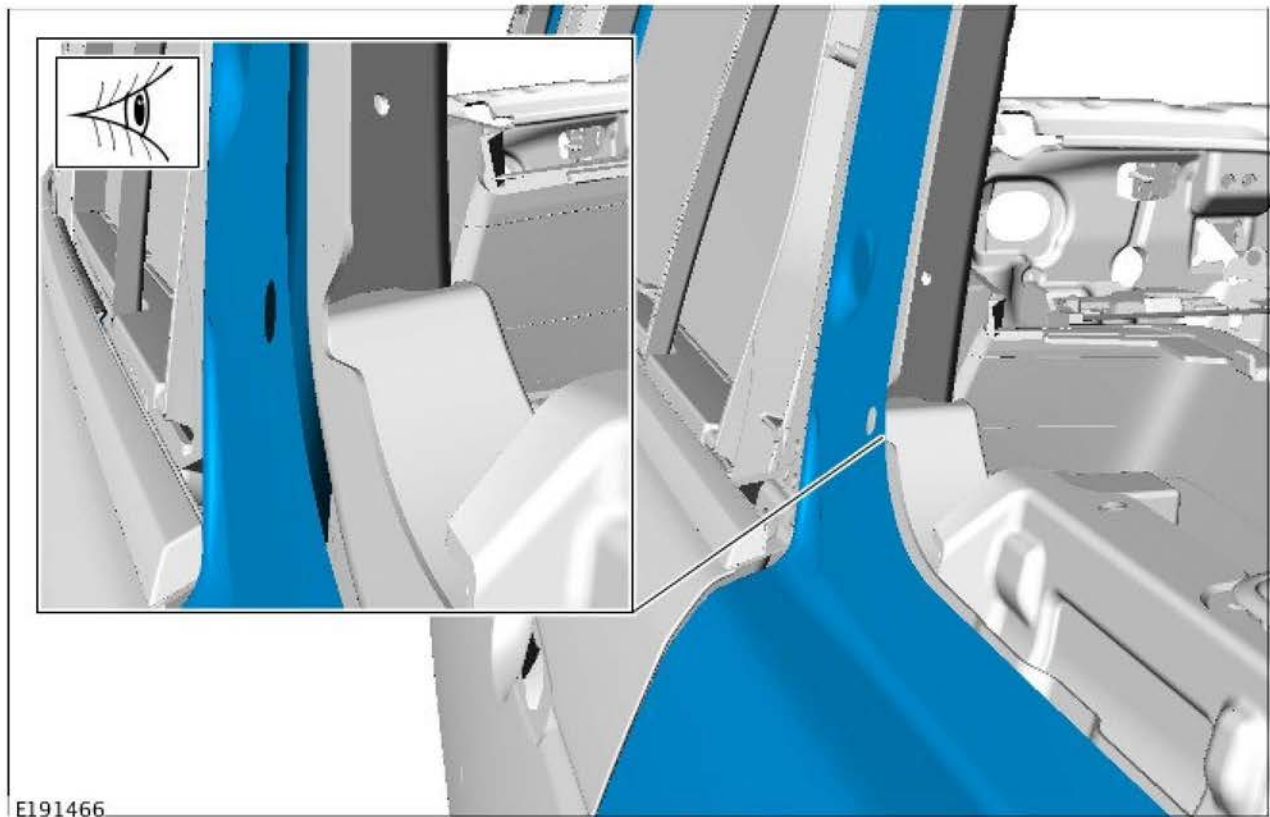
Visually check the body panel.

1. If there is a gap between the body panel and reinforcement panel, go to Step 7.
2. If there is no gap between the body panel and reinforcement panel, go to Step 8.
