TECHNICAL BULLETIN
 LTB00955NAS2
 15 JUL 2016

Air Conditioning Service Port Valve Leaks

Discovery Sport (LC)

Range Rover Evoque (LV)

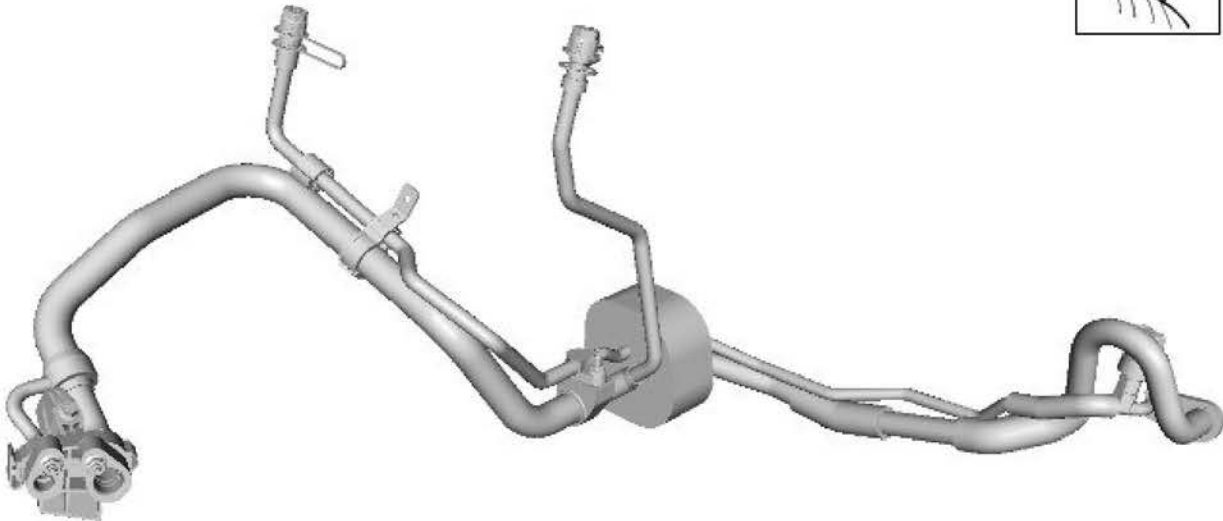
E192164

- All with Internal Heat Exchanger (IHX) Air Conditioning pipes:** install LR088548.

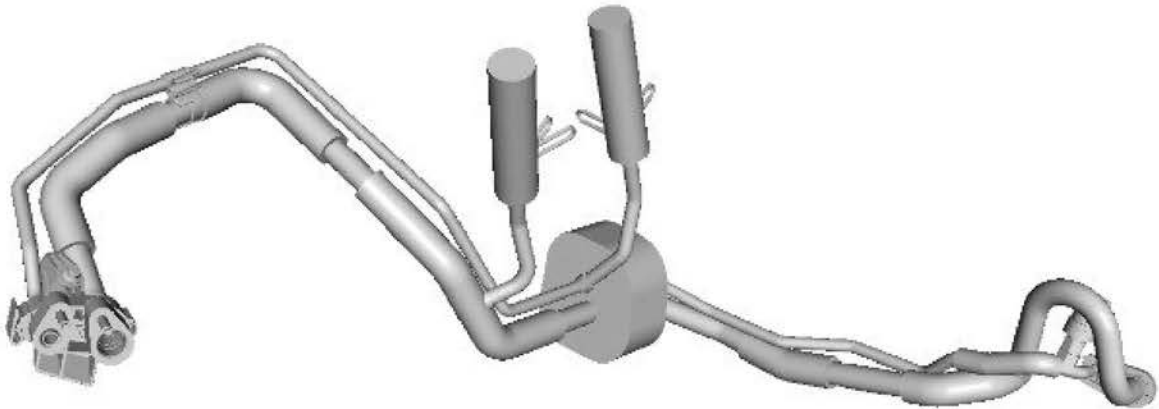
E192165

- Post 16MY with Non-Internal Heat Exchanger (IHX) Air Conditioning pipes:** - install LR088548.

- Discovery Sport (L550) from VIN 544577
- Range Rover Evoque (L538) from VIN 077912
