Reference	SSM72901
Models	LR4 / L319 Range Rover / L405 Range Rover Sport / L494
Title	8HP70 Automatic Transmission Oil Leak 15-16MY
Category	Driveline
Last modified	28-Jul-2016 00:00:00
Symptom	501000 Automatic Transmission Concerns
Attachments	Porous Transmission Housing.pdf (Porous Transmission Housing.pdf)

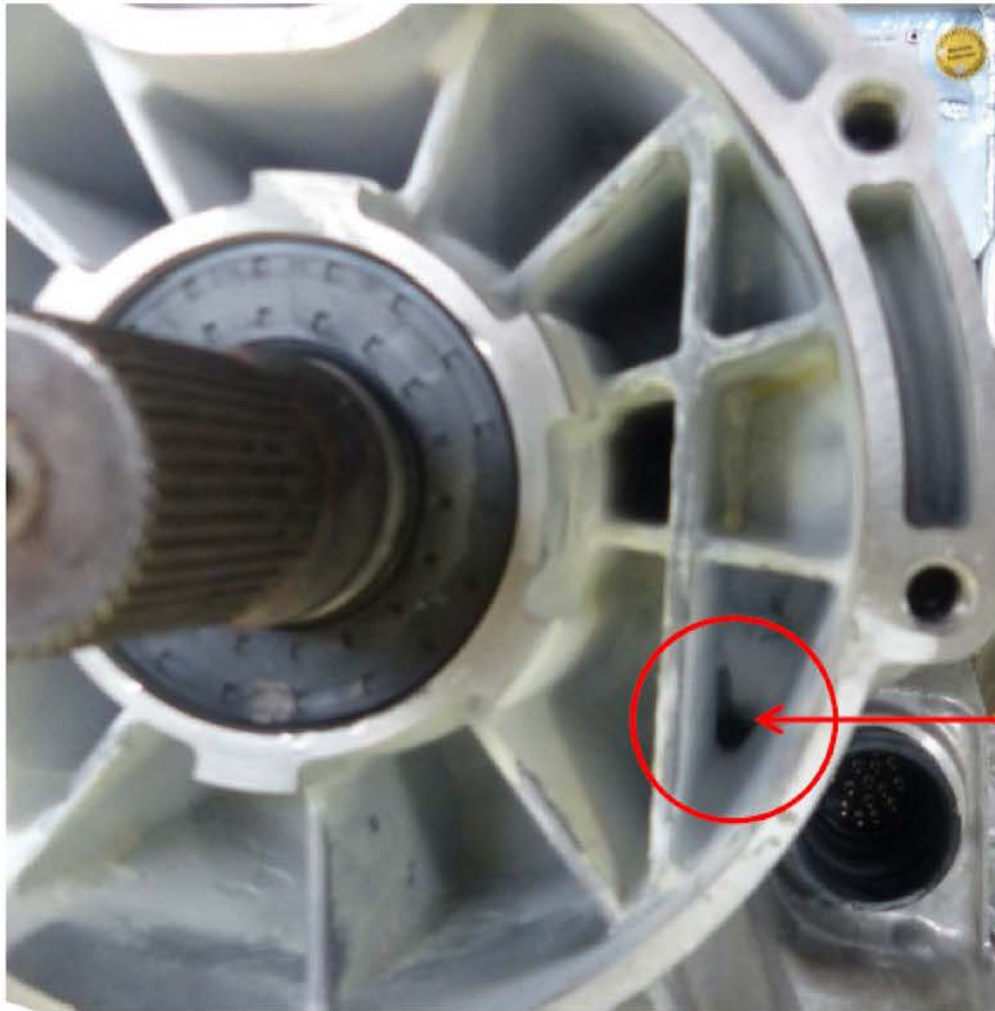
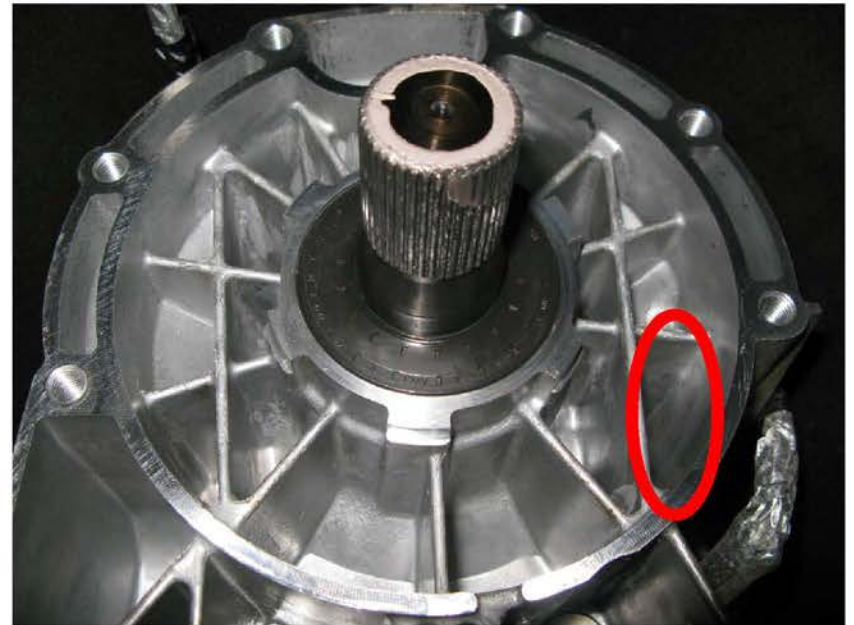
Oil weeps through the aluminium of the casing in the base of the pocket around where the steel D clutch tube is embedded, refer to attached file.

Internal porosity in the area of the extension casing allows oil to reach the end of the small pocket under the tube where it is prone to casting skin damage during casting. Oil then drips from the drain hole in the space between the transmission and transfer box.

Area of leak

Remove the transfer case and inspect the area as shown in the attached file. If a leak is confirmed in this area, submit a FRED for an automatic transmission replacement attaching clear photos confirming the issue.
