Technical Service Bulletin

48M3 UPDATE – Checking Seal (NVLW)

May 11, 2016

Model(s)	Year	VIN Range	Vehicle-Specific Equipment
A6, A7, A8, Q5, A5 Cabriolet, A4, A5, allroad	2016	See Campaign/Action screen in Elsa	None
Q7	2017

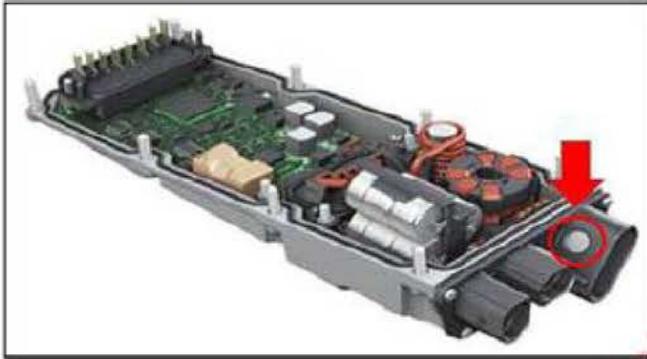
Power steering control unit with seal (arrow).

1st Check (Visual Inspection)

- Check that seal is clean.
- Perform visual check with mirror.
- If the seal is completely clean, continue to 2nd check.
- If the seal is dirty, clean with a dry cloth and check again.
- If the seal cannot be completely cleaned, it must be replaced.

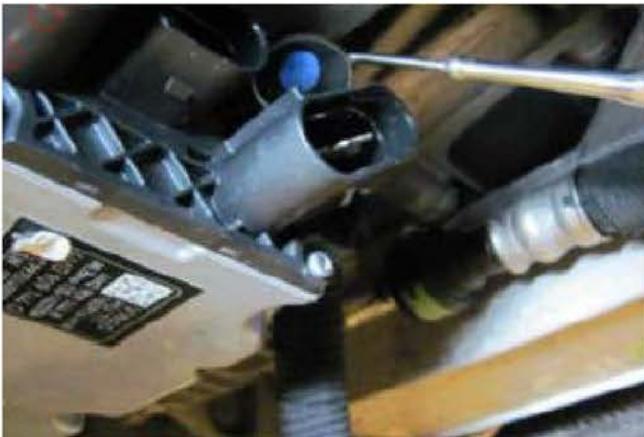
- Perform visual check with mirror.
- If the seal is still white no further work is required.
- If the seal has taken the color of the test liquid it must be replaced.

- Wipe off test liquid with a clean lint-free cloth.

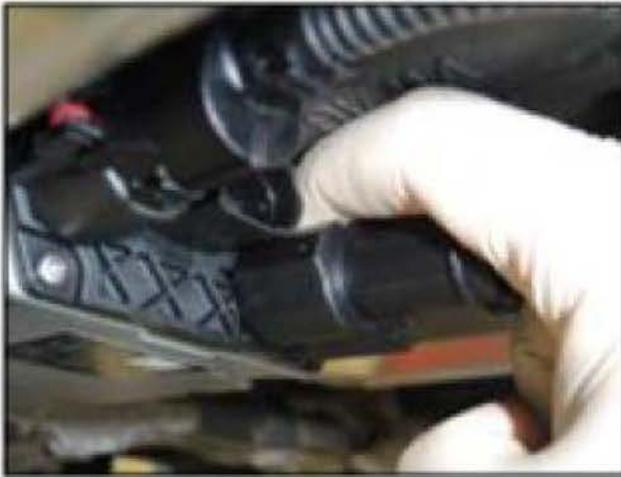
- Perform a visual inspection.
- If the seal is not centered it must be replaced again.

- Push the installation connector onto the control unit until it stops.
- Press the seal on to the connector housing using your finger.
- Remove the installation connector.
- Press seal again with your finger to fully secure.
