Technical Service Bulletin

48M3 UPDATE – Checking Seal (NVLW)

May 10, 2016

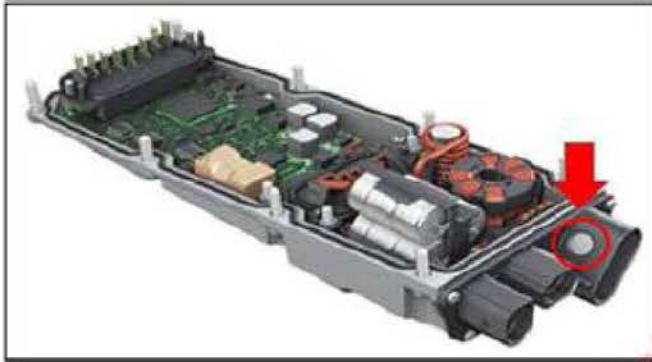
Power steering control unit with seal (arrow).

- Check that seal is clean.
- Perform visual check with mirror.
- If the seal is completely clean, continue to 2nd check.
- If the seal is dirty, clean with a dry cloth and check again.
- If the seal cannot be completely cleaned, it must be replaced.

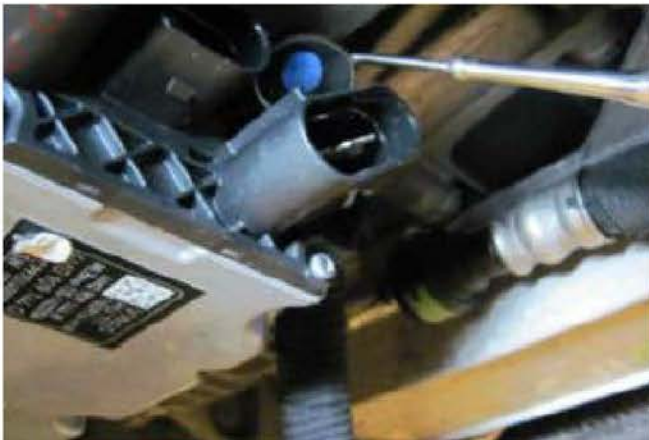
- Perform visual check with mirror.
- If the seal is still white no further work is required.
- If the seal has taken the color of the test liquid it must be replaced.

- Wipe off test liquid with a clean lint-free cloth.

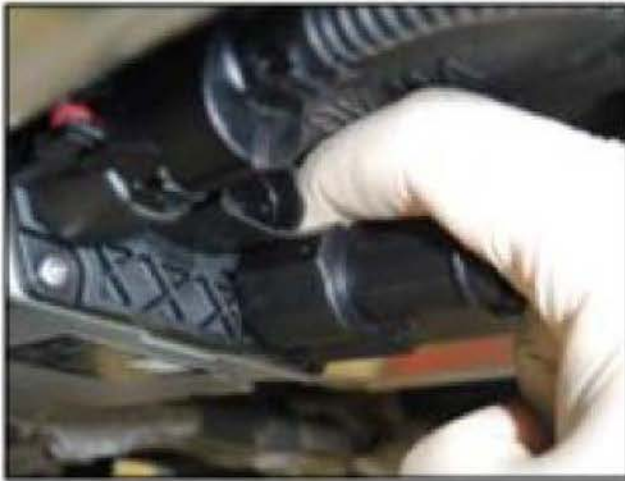
- Perform a visual inspection.
- If the seal is not centered it must be replaced again.

- Push the installation connector onto the control unit until it stops.
- Press the seal on to the connector housing using your finger.
- Remove the installation connector.
- Press seal again with your finger to fully secure.
