Service Bulletin

Bulletin No.: 16-NA-235

Subject: Rear Seat Entertainment System Does Not Deploy/Stow Fully

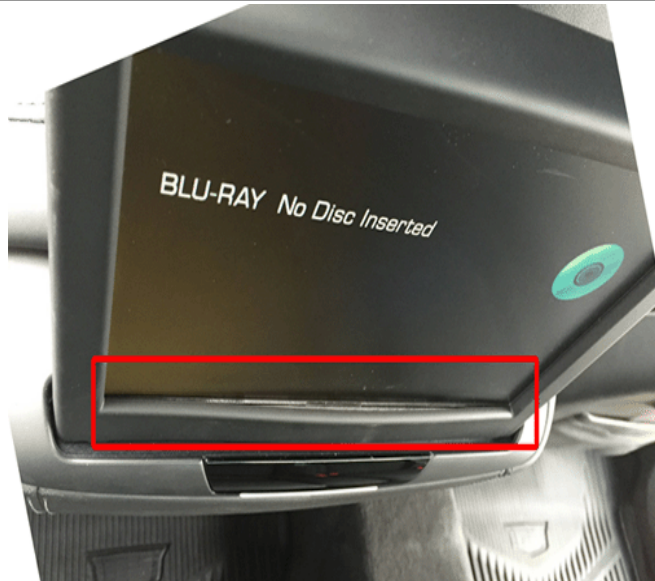
| Cause | <p style="text-align: right;">4559633</p> <p>This condition may be due to the snaps on the rear video display plastic housing not being fully seated and interfering with the screen deploying and/or stowing.</p> |

Inspect for a snap that is not fully seated along the bottom of the display. If the display's bezel appears to be misaligned, snap the display bezel together with your hands.
