Service Bulletin

Bulletin No.: 16-NA-078

Subject: Rattle Noise from Manual Transmission Shifter

Brand:	Model:	Model Year:		VIN:		Engine:	Transmission:
		from	to	from	to		
Chevrolet	Camaro	2016	2017	SOP	G0122915		All Manual

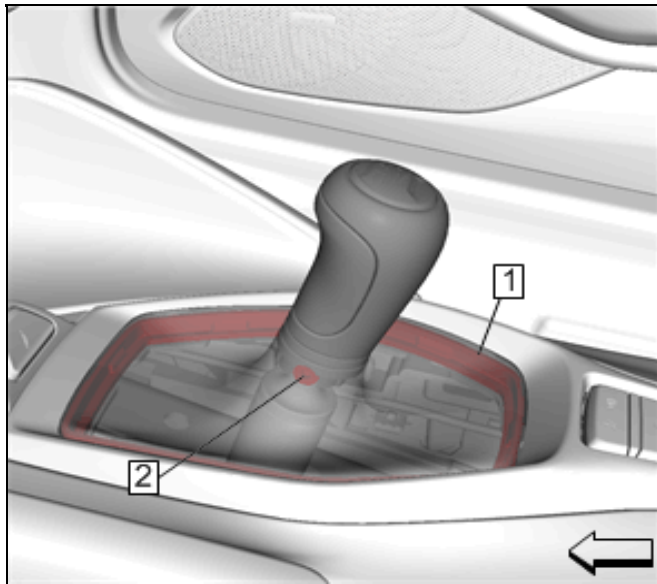
4177183

Involved Region or Country	North America and N.A. Export Regions
Condition	Some customers may comment that the shifter knob is rattling.
Cause	This condition may be caused by a loose shifter knob retaining screw.

- Using a flat-bladed trim tool, detach the transmission control lever boot (1) from the console.
- Lift the transmission control lever boot to access the shift knob fastener (2).

- Remove the fastener.
- Apply thread locker, GM P/N 19333511 (In Canada, use 10953489), to the shift knob fastener and install.

Tighten the fastener to 7 N•m (62 lb in).

- Install the transmission control lever boot to the console.
