# TECH TALK

Volume 227 - January, 2017

2017 Full Line

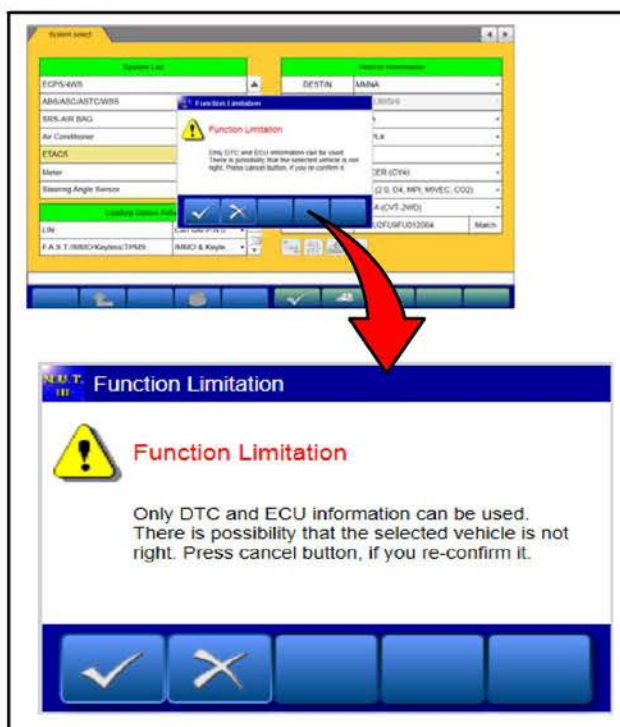
In the example below, the technician was attempting to perform ETACS copy coding and ran across the Function Limitation screen. If the improper selection is not corrected in the loading option box and the technician clicks on the check mark to continue, he will get to screens where some of the buttons will be grayed out or not be displayed at all.

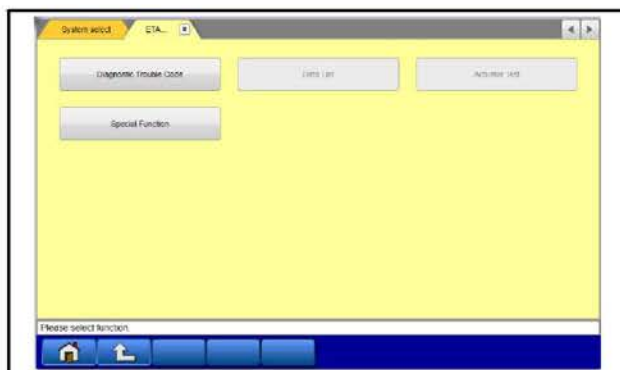
In the example below, when the incorrect ETACS is selected, only 2 buttons are available and 2 are grayed out (not available). The Copy Coding and Data List buttons are not displayed at all.

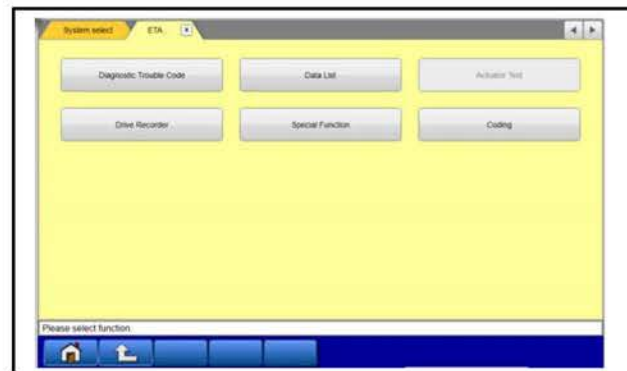
When the correct ETACS selection is made in the loading option box, all available buttons will appear.

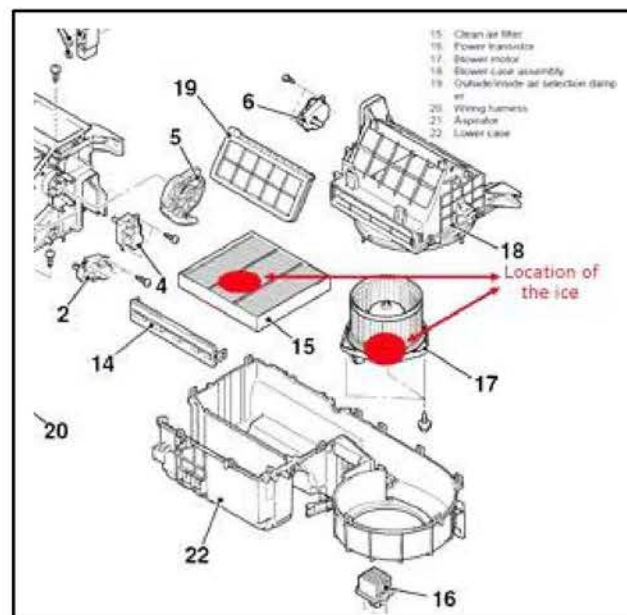
### **BLOWER MOTOR NOT OPERATING DUE TO ICE IN MOTOR CASE — 2014-17 Outlander.**

MMNA is currently investigating incidents of ice in the blower case preventing the blower motor from operating. If you have a vehicle with this condition, please take photos of the condition. Try not to let the ice melt by leaving the vehicle outside the dealer shop during cold ambient temperatures to try and preserve the condition. Open a Techline case, attach the photos to the Techline case, and then contact Techline. The situation will then be reviewed for a possible scramble investigation.

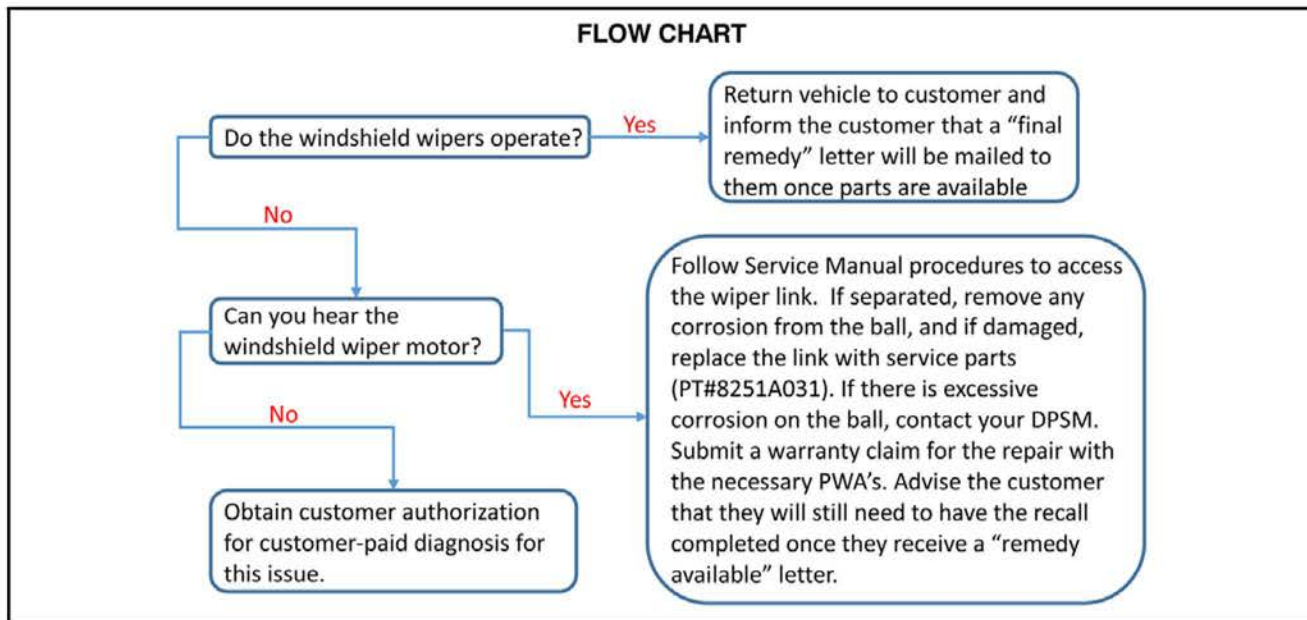
In the event that water drops down through the back side of the front deck garnish (the body piece between the hood and windshield), the front wiper link ball joint may experience excessive moisture and corrode. If this occurs, the resin case of the ball joint will wear prematurely due to the ball joint corrosion and the wiper link may ultimately separate causing the windshield wipers to stop operating. If wiper link separation occurs, the windshield wipers will become inoperative which could reduce driver visibility under certain conditions and increase the risk of a vehicle crash.

If a customer calls inquiring about this recall, or to set an appointment to have the recall completed, please ask the customer if their front windshield wipers are operational. If they are, please advise the customer that they will receive another letter informing them that final remedy parts are available and to contact your dealership at that time to set an appointment to have the recall completed.

If a customer informs you that their vehicle’s windshield wipers have become inoperative and they believe that it is due to a windshield wiper link separation, please verify that the customer’s vehicle has open campaign C1613R and inspect the vehicle to verify the customer’s concern by turning the vehicle ignition to “ACC” or “ON” and operate the windshield wipers in “LO” and “HI” mode.

- If the front windshield wipers operate normally, no further inspection is required. Return vehicle to customer and inform the customer that a “final remedy” letter will be mailed to them once parts are available, and call to make an appointment at that time.

- Listen for the windshield wiper motor (located under the front deck cover, below the driver’s side wiper shaft) for audible wiper motor operation.
  - If the wiper motor operation can be heard, but the wipers do not move, the wiper link may have separated from the motor due to ball joint corrosion. Follow Service Manual procedures to access the wiper link. If separated, remove any corrosion from the ball, and if damaged, replace the link with service parts (PT#8251A031). If there is excessive corrosion on the ball, contact your DPSM. Submit a warranty claim for the repair with the necessary PWAs. Advise the customer that they will still need to have the recall completed once they receive a “remedy available” letter.

- If the wiper motor operation cannot be heard, a wiper link separation is an unlikely cause, and normal diagnostic procedures should be followed upon receiving customer authorization for additional diagnosis. Any repair unrelated to this recall will be the customer’s responsibility. Authorization must be obtained from the customer.
