## Multiple Indicators and MIL On with A/T DTC P26C3

2016–17 MDX, 2017 NSX, 2014–17 RLX Sport Hybrid, and 2015–17 TLX

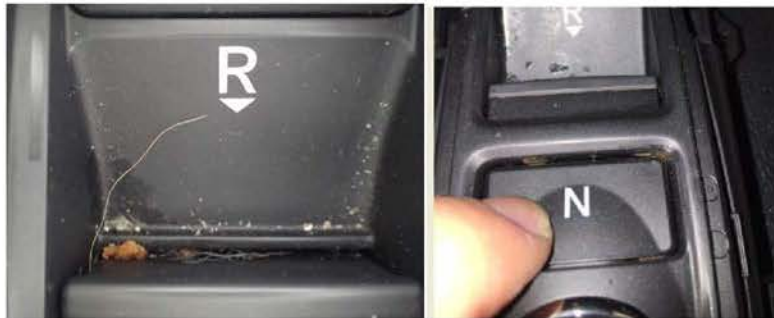
Do you have a vehicle that has multiple indicators on or won't go into gear and the MIL is on with A/T DTC P26C3 (internal control module transmission range sensor performance)? There may be debris in the Reverse or Neutral shift buttons of the shift by wire (SBW) shifter assembly that's causing them to stick. Typical debris are particles in the Reverse shift button or sticky residue in the Neutral shift button from something that spilled.

1. Check for debris in either shift button.
  - If you see debris, push back the affected shift button and remove the debris either with a vacuum or a pair of tweezers. Avoid using liquids, chemicals, or pressurized air to clean out the debris; you could damage the button. When you're done, go to step 3.

- If any shift button is hard to press, slow to return, or doesn't fully return, replace the SBW shifter assembly, then go to step 3.
  - If all of the shift buttons work OK, go to step 3.

3. Clear the DTC, start the engine, and with the parking brake set and the brake pedal pressed, work the Park, Reverse, Neutral, and Drive shift buttons one at a time, waiting **15 seconds** between each gear change. Then, repeat this three more times, and wait **2 minutes** before shutting off the engine.

- If the DTC doesn't reset and the transmission shifts normally, you're done.
  - If the DTC resets or the transmission fails to shift normally, replace the SBW shifter assembly.
