Vantage Mobility International

2017 Toyota Sienna Transmission Line Repositioning

Document Number: OP-W-0426

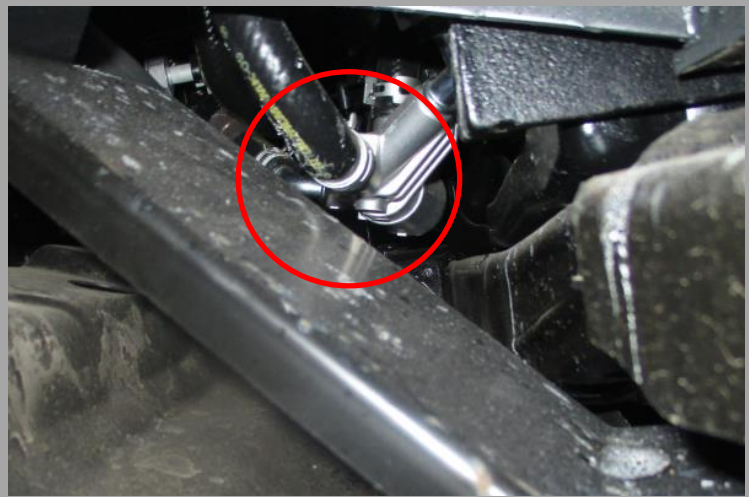
1. Make a visual inspection of the transmission cooler hose as it is positioned directly above the left front shear plate. If the hose is contacting the shear plate or has less than 3/8" clearance follow the steps in the bulletin. If there is adequate clearance (3/8" or greater) there is no further action required
