LTB00868NAS2

TECHNICAL BULLETIN

SUBJECT/CONCERN:Front Seatbelt(s) Slow to Retract

MODEL:	MODEL YEAR:	VIN:	ASSEMBLY PLANT:
LR4 (LA)	2010-2014	510178-747648	Solihull

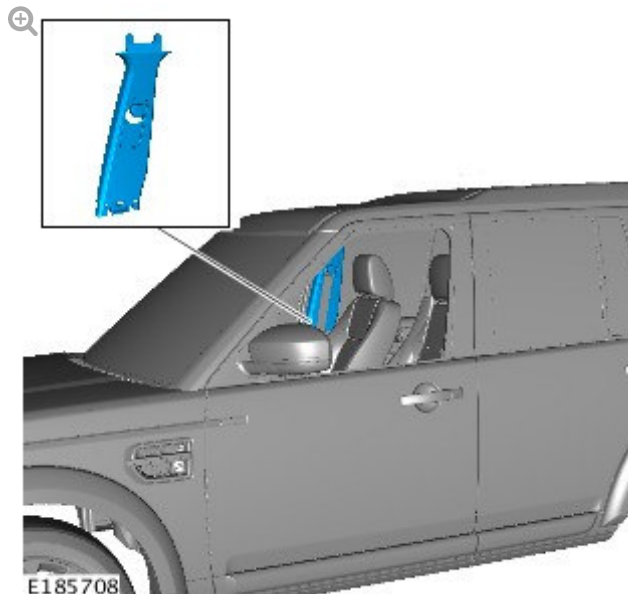
Component location.

This may be caused by the design of the upper B-pillar trim, allowing the seatbelt to drag on the upper B-pillar trim.

right-side B-pillar shown; left-side B-pillar similar.

4 Install the new B-pillar trim finisher (see TOPIx Workshop Manual, section 501-05: Interior Trim and Ornamentation).
