LTB00927NAS2

TECHNICAL BULLETIN

Parking Aid System Rear Harness Corrosion

MODEL:	MODEL YEAR:	VIN:	ASSEMBLY PLANT:
Discovery Sport (LC)	2015-2017	500429-640975	Halewood

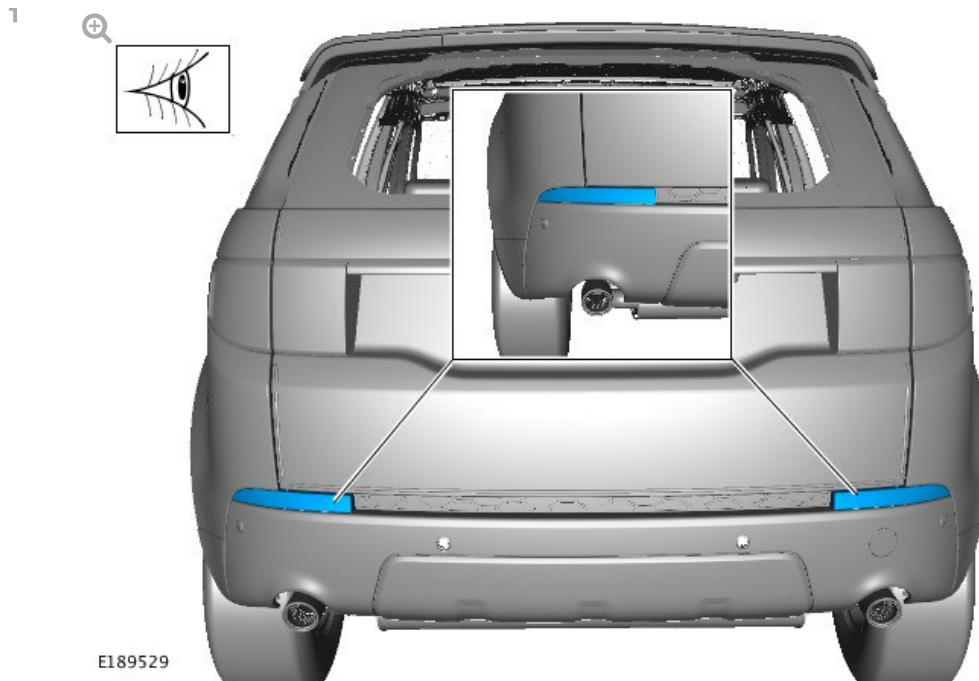
Inspect the rear left and right fog lamps for cracking and water ingress.

- If no fault is found with the fog lamp(s), this is not the cause of the fault.
- If the fog lamp(s) is found to be cracked or has water ingress, go to Step 2.

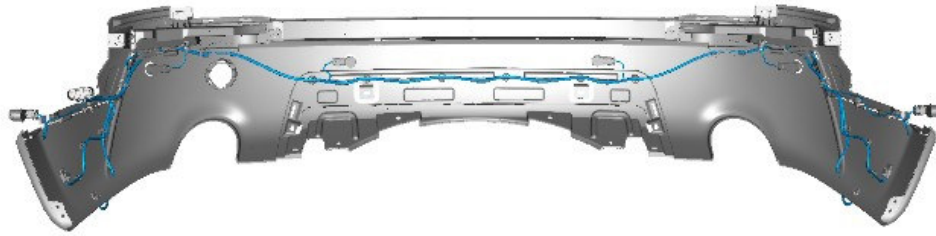
E189513

Inspect the Parking Aid system wiring harness for damage and/or corrosion.

- If the Parking Aid system wiring harness is not damaged or corroded, go to Step 5.
- If the Parking Aid system wiring harness is damaged or corroded, go to Step 4.

4 Renew the Parking Aid system wiring harness (see TOPIx Workshop Manual section 501-19: Bumpers - Rear Bumper Cover - Steps 15 and 16).
