N008NAS2

TECHNICAL BULLETIN

Service Action: Sport Badge Not Fitted

MODEL:	MODEL YEAR:	VIN:	ASSEMBLY PLANT:
Range Rover Sport (LW)	2017	124082-135805	Solihull
Range Rover Sport (LW)	2017	666892-671630	Solihull

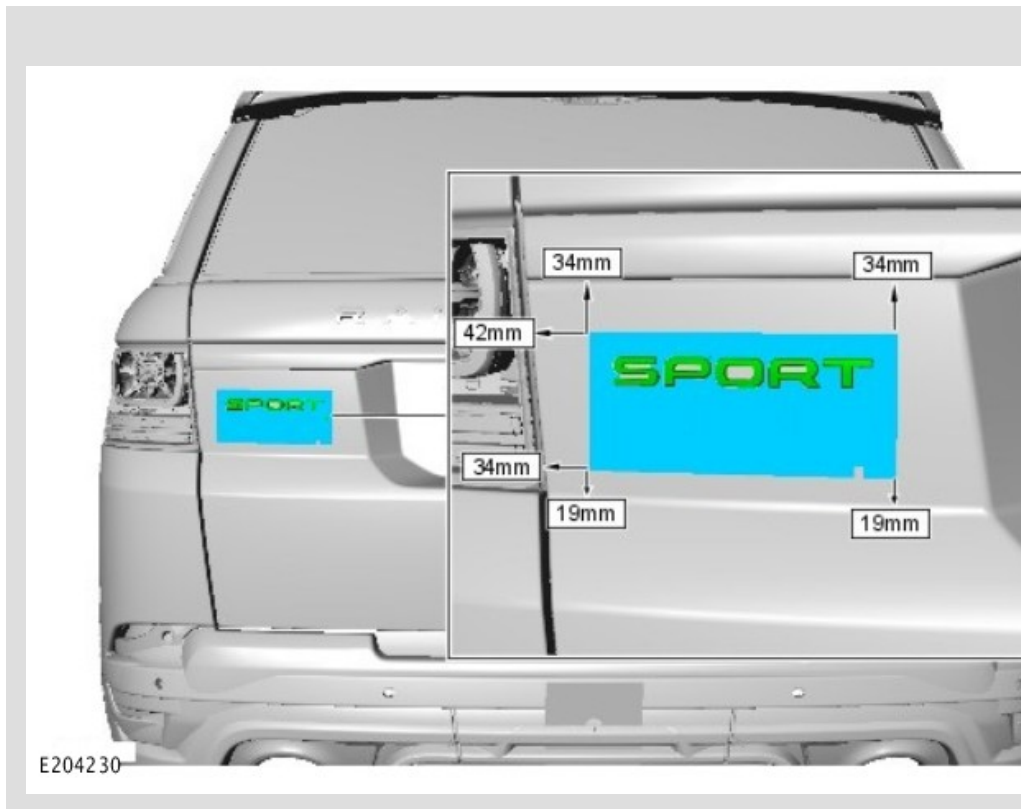
- 2

An issue has been identified on certain vehicles within the listed Affected Vehicle Range have been manufactured away from process where the 'SPORT' badge is not fitted to the tailgate.

- The new tailgate SPORT badge is supplied on a cassette (highlighted in blue).
- All dimensions shown are to the edge of the new badge cassette.

Install the tailgate SPORT badge in the position shown.
