05806 Version 4

Product Update: Roof Molding

HONDA

Year	Model	Trim	VIN Range	
2016	Pilot	LX, EX, EX-L	Check the iN VIN status for eligibility

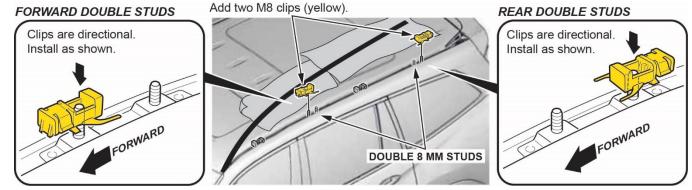
- 3. Install the two M6 clips (natural color) in the same location as the original clips (the single 6 mm studs).
- 4. Install the front M8 roof clip (yellow color) on the first stud of the double 8 mm stud as shown, then install the second M8 roof clip on the second double 8 mm stud.

NOTE: Make sure the clips are installed facing the correct direction.
