2016–17 Pilot: Judder from the Torque Converter Lock-Up Clutch After Software Update

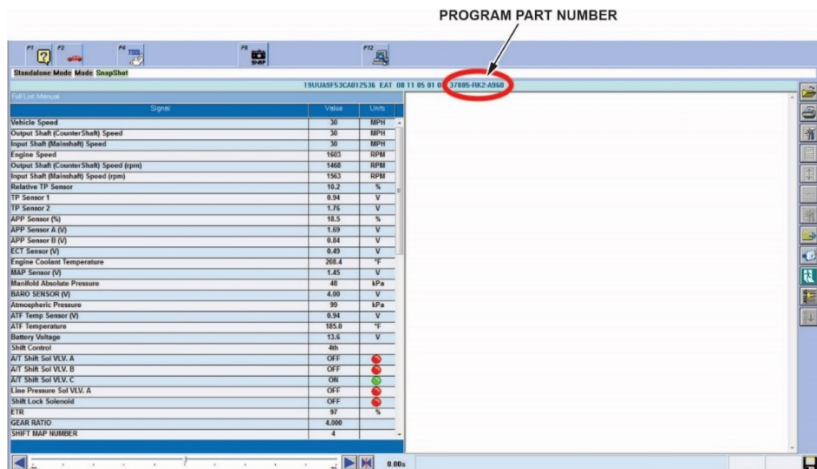
1. Connect the i-HDS, and go to the A/T Data List. Check to see if the software has been updated by comparing the program P/N against the table below.
