June 20, 2017

06540 Version 1

2013–15 Crosstour V6: Judder from the Torque Converter Lock-Up Clutch After Software Update

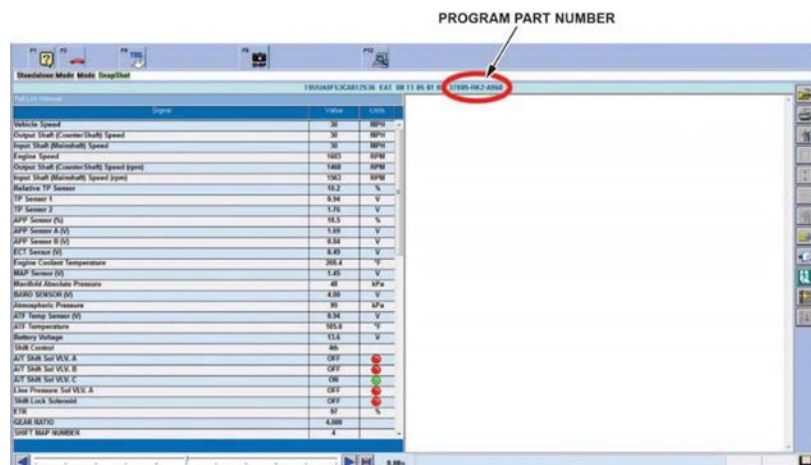
1. Connect the i-HDS, and go to the **AT Data List**. Check to see if the software has been updated by comparing the program P/N against the table below.

- If the program P/N is listed below (or later), the vehicle has been updated. Go to step 2.

- If the program P/N is not listed, the vehicle has not been updated. Go to service bulletin 17-041, 2013–15 Crosstour V6: Judder from the Torque Converter Lock-Up Clutch.
