## SERVICE POLICY LETTER

| Reference number: | SPL-03-0594V2 | Issued: 15 February 2017 |
| Subject: | Engine Oil Leaks for Vehicles still in Manufacturer's Warranty | |

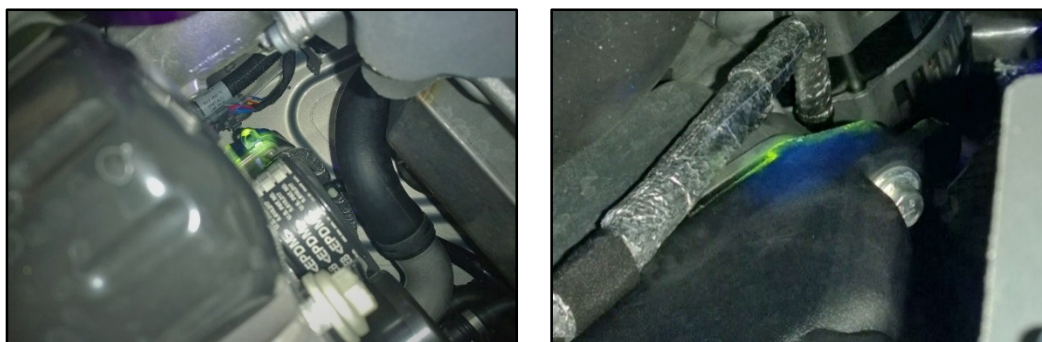
When you use the correct lamp, the dye in the oil of new AML engines will glow bright green (refer to Figure 1).

Figure 1 - Examples of dye in engine oil

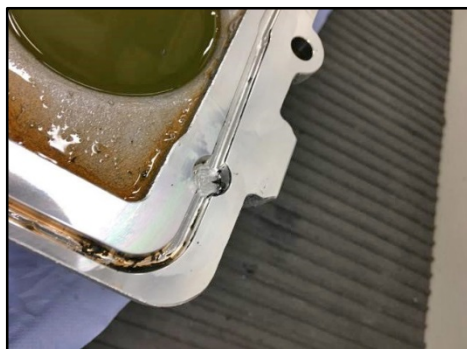
After we have given the approval to do the repair, during the repair process, please take more photographs. We ask you to do this to give us more information about why the leak occurred. This will help us to increase reliability and quality in the future. For examples, refer to Figure 2 thru Figure 5. The photographs must show data about the cause of the leak.
