## QUARANTINE NOTICE

| Reference number: | QN-15-0047V2 | Issued: 08 March 2017 |
| Subject: | AMi III Apple CarPlay | |
| Model(s): | All 17MY and 17.5MY vehicles but not DB11 | |

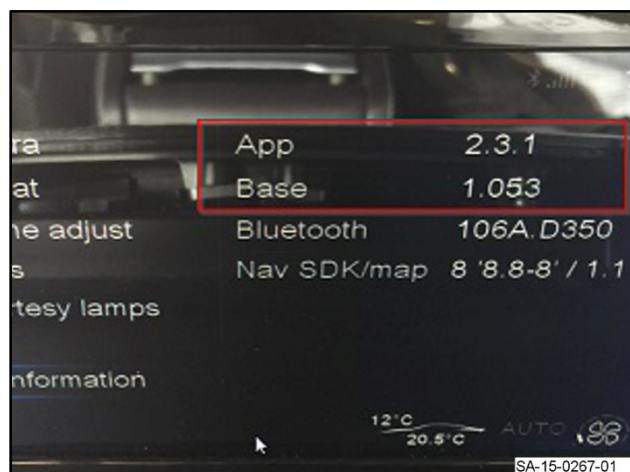
Figure 1

9. Set the ignition to Off.
10. Get out of the vehicle and lock it.
11. Wait for a minimum of two minutes. The Infotainment Control Unit will go into full sleep.
12. Unlock the vehicle.
13. Set the ignition to On.
14. Use the joystick to navigate to the System Information page. The page will display the updated Part Numbers for the App and for the Base (refer to Figure 1).
