SERVICE CAMPAIGN BULLETIN

NTB17-002

VOLUNTARY EMISSIONS SERVICE CAMPAIGN 2016-2017 ALTIMA ENGINE CONTROL MODULE REPROGRAM

CAMPAIGN ID #: PC514

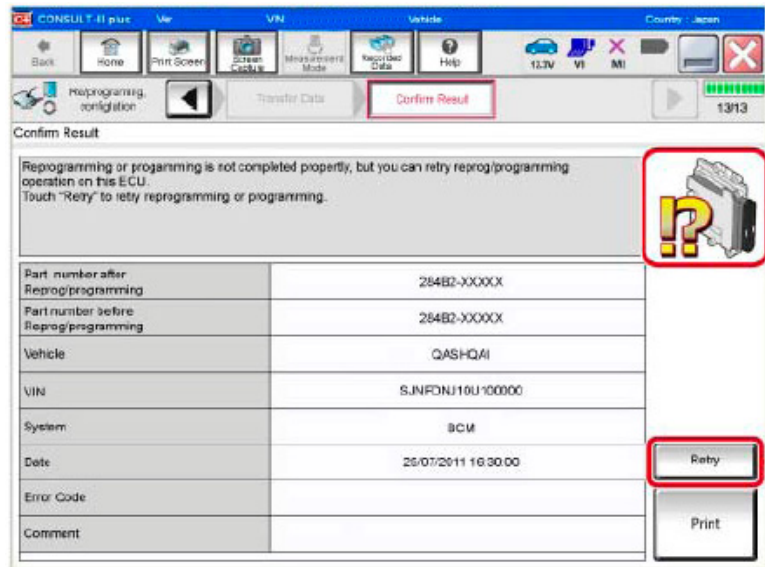
Figure 6

If reprogramming does not complete and the “!?” icon displays as shown in Figure 6:

- Check battery voltage (12.0–15.5 V).
- Ignition is ON, engine OFF.
- External Bluetooth® devices are OFF.
- All electrical loads are OFF.
- **Select retry and follow the on screen instructions.**
- “Retry” may not go through on first attempt and can be selected more than once.

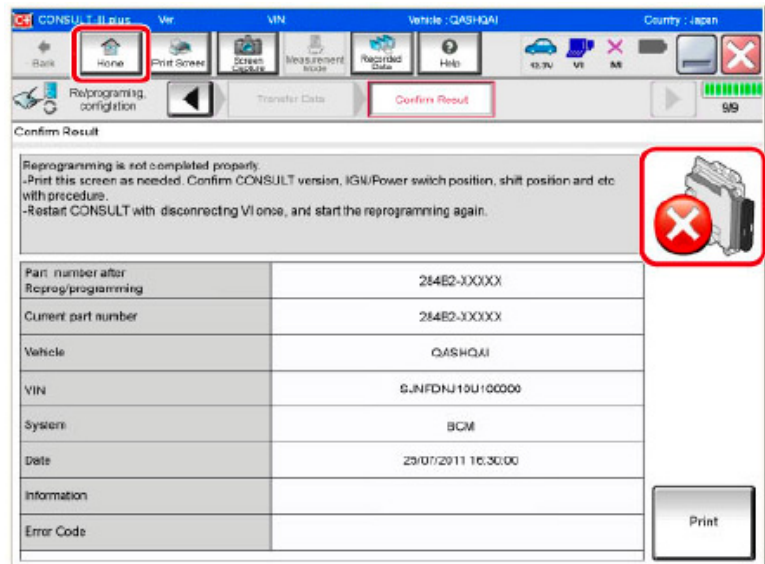
Figure 7

If reprogramming does not complete and the “X” icon displays as shown in Figure 7:

- Check battery voltage (12.0 – 15.5 V).
- CONSULT A/C adapter is plugged in.
- Ignition is ON, engine OFF.
- Transmission is in Park.
- All C-III plus / VI cables are securely connected.
- All C-III plus updates are installed.
- **Select Home, and restart the reprogram procedure from the beginning.**
