SERVICE BULLETIN

Classification: EC13-003b	Reference: NTB13-021b	Date: March 9, 2017
------------------------------	--------------------------	------------------------

2010-2015 FRONTIER, 2010-2012 PATHFINDER AND XTERRA; VIBRATION WHILE IDLING

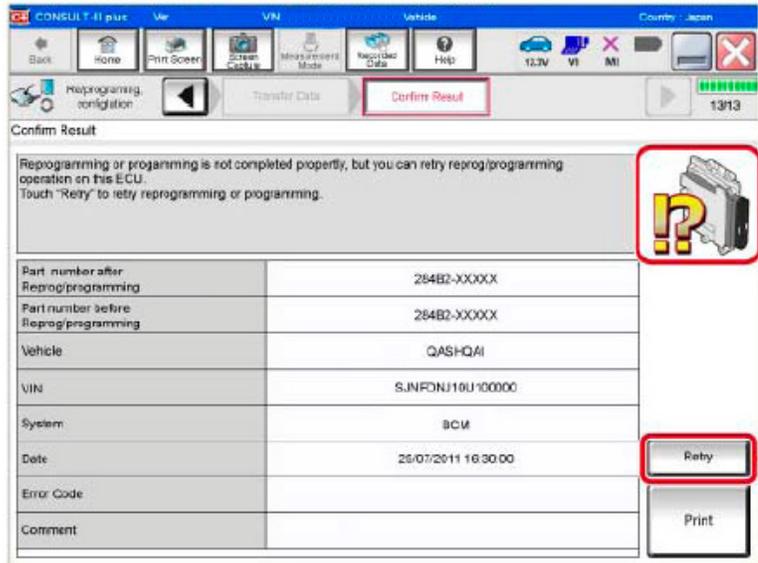
Figure 5

If reprogramming does not complete and the “!?” icon displays as shown in Figure 5:

- Check battery voltage (12.0–15.5 V).
- Ignition is ON, engine OFF.
- External Bluetooth® devices are OFF.
- All electrical loads are OFF.
- **Select retry and follow the on screen instructions.**
- “Retry” may not go through on first attempt and can be selected more than once.

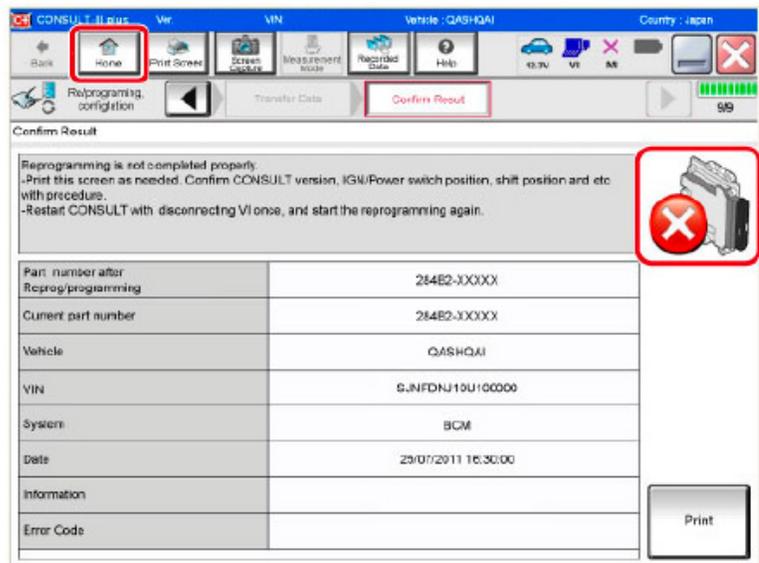
Figure 6

If reprogramming does not complete and the “X” icon displays as shown in Figure 6:

- Check battery voltage (12.0 – 15.5 V).
- CONSULT A/C adapter is plugged in.
- Ignition is ON, engine OFF.
- Transmission is in Park.
- All C-III plus / VI cables are securely connected.
- All C-III plus updates are installed.
- **Select Home, and restart the reprogram procedure from the beginning.**
