SERVICE BULLETIN

| Classification: AT17-001a | Reference: NTB17-016a | Date: March 1, 2017 |

2017 ARMADA; SHIFT SHOCK WITH DOWN SHIFT

APPLIED VEHICLES: 2017 Armada (Y62)

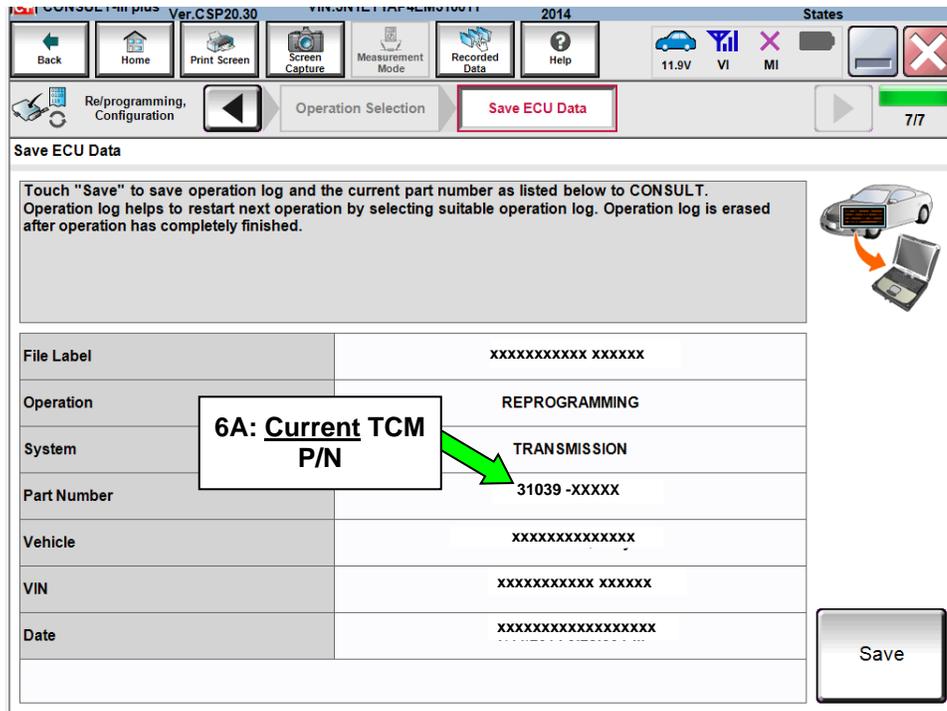
Figure 2

6. When you get to the screen shown in Figure 2, confirm this bulletin applies as follows.

A. Find the TCM **Part Number** and write it on the repair order.

NOTE: This is the current TCM Part Number (P/N).

B. Compare the P/N you wrote down to the numbers in the **Current TCM Part Number** column in **Table A** below.

- If there is a match, continue with the reprogramming procedure.
- If there is not a match, this bulletin does not apply. Refer to ASIST for further diagnosis.

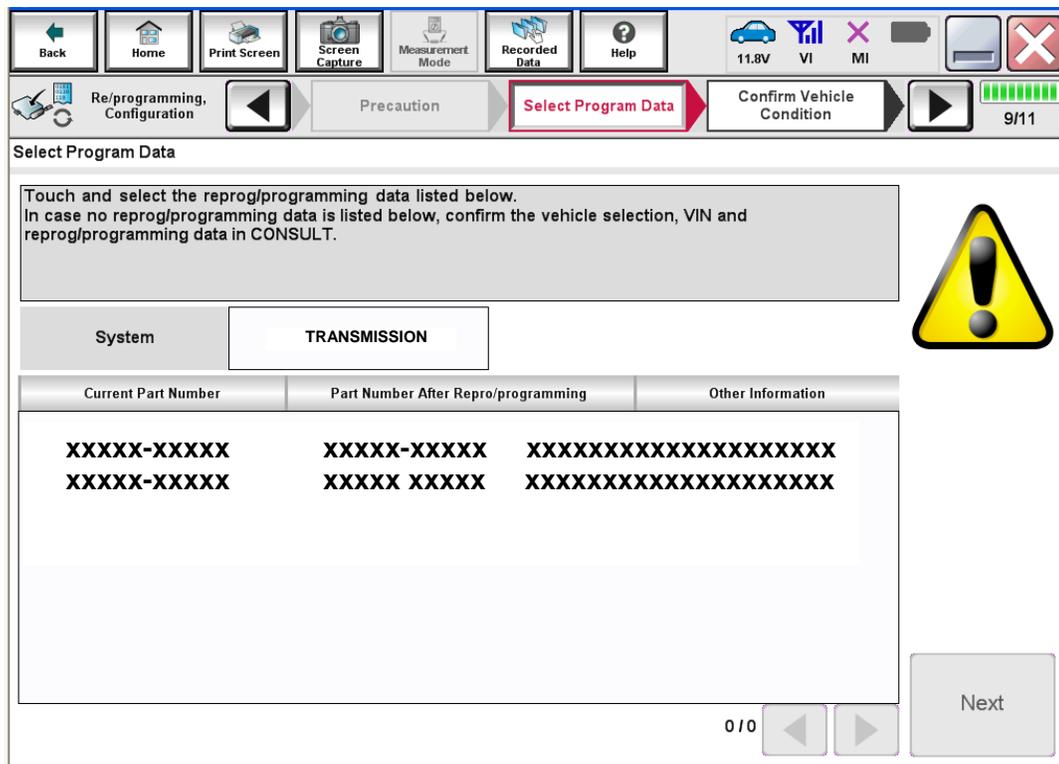
- In some cases, more than one new P/N for reprogramming is available.
 1. If more than one new P/N is available, the screen in Figure 3 displays.
 2. Select and use the reprogramming option that **does not** have the message “Caution! Use ONLY with NTBXX-XXX”.
- If you get this screen and it is blank (no reprogramming listed), it means there is no reprogramming available for this vehicle. Close C-III plus and refer back to ASIST for further diagnosis.

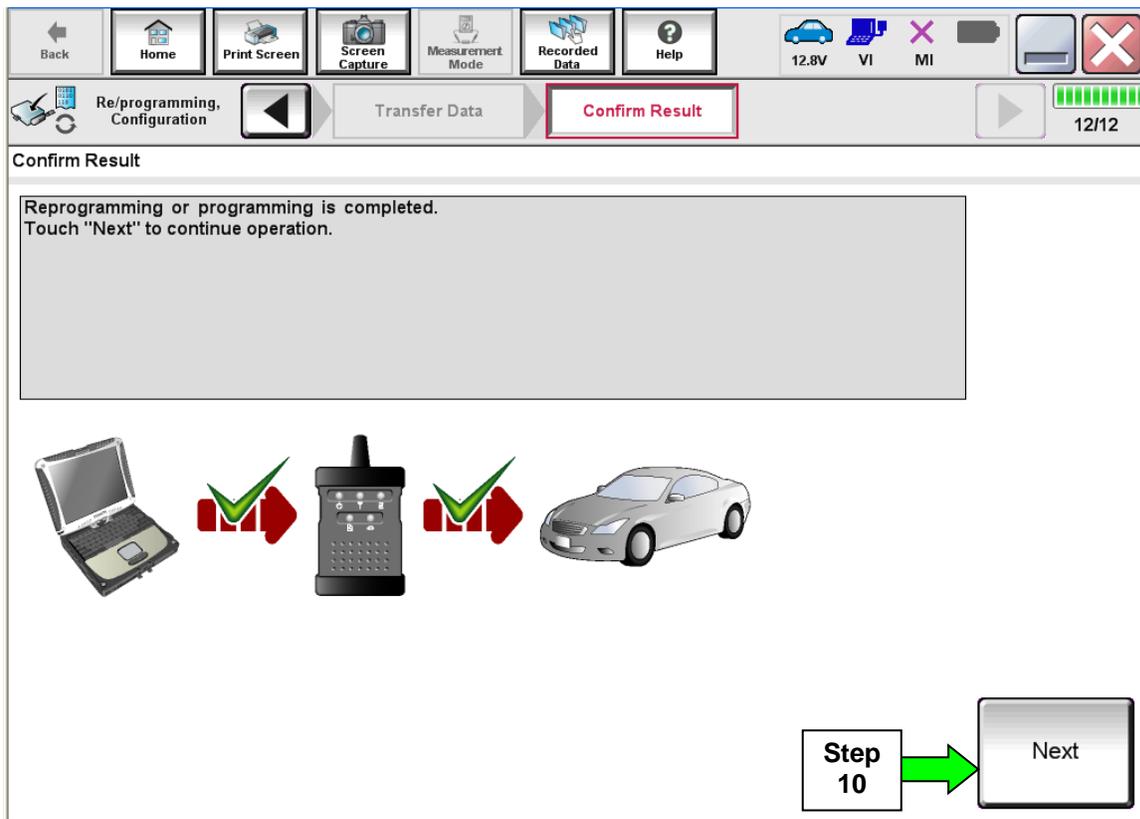
8. When the screen in Figure 4 displays, reprogramming is complete.

NOTE: If the screen in Figure 4 does not display (indicating that reprogramming did not complete), refer to TCM recovery on the next page.

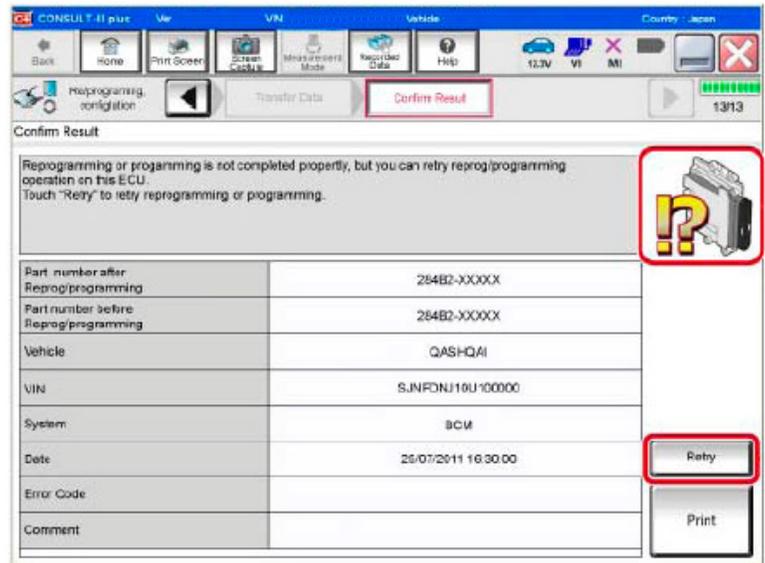
Figure 5

If reprogramming does not complete and the “!” icon displays as shown in Figure 5:

- Check battery voltage (12.0 - 15.5 V).
- Ignition is ON, engine OFF.
- External Bluetooth® devices are OFF.
- All electrical loads are OFF.
- **Select retry and follow the on screen instructions.**
- **“Retry” may not go through on first attempt and can be selected more than once.**

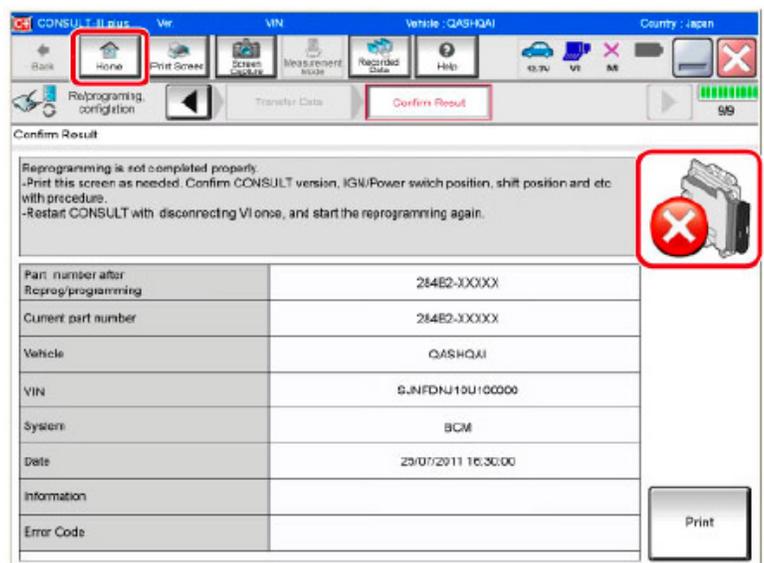
Figure 6

If reprogramming does not complete and the “X” icon displays as shown in Figure 6:

- Check battery voltage (12.0 - 15.5 V).
- CONSULT A/C adapter is plugged in.
- Ignition is ON, engine OFF.
- Transmission is in Park.
- All C-III plus / VI cables are securely connected.
- All C-III plus updates are installed.
- **Select Home, and restart the reprogram procedure from the beginning.**

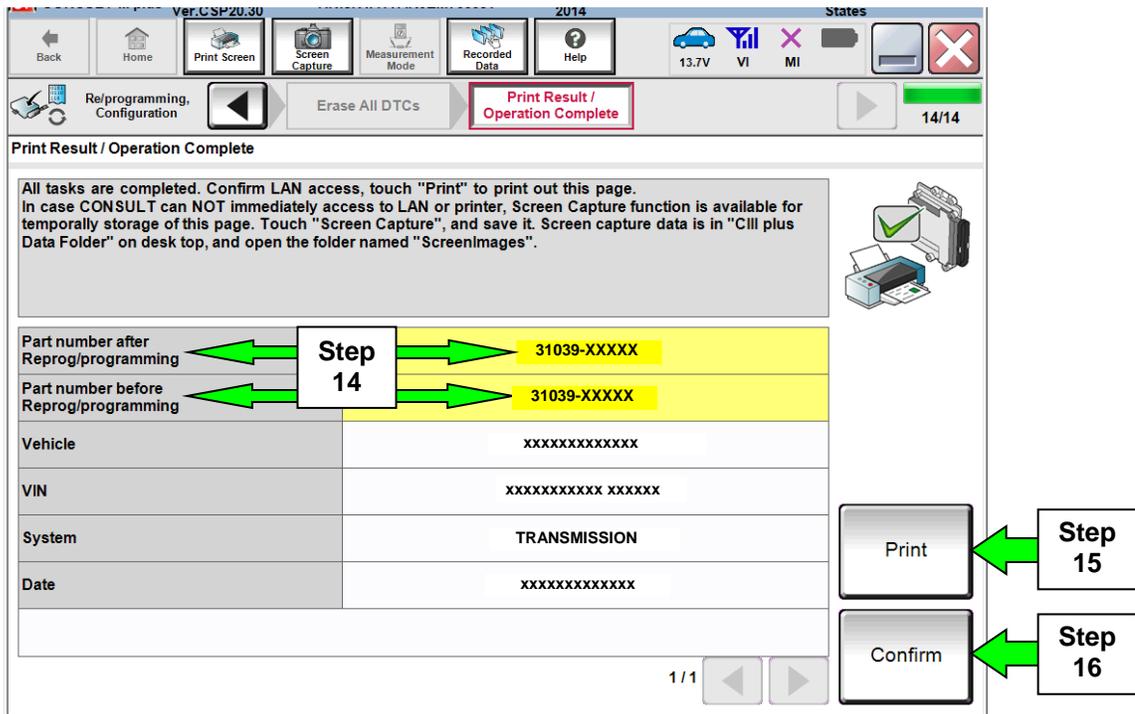
11. Follow the on-screen instructions to **Confirm Shift Lever Position Display**.
12. Follow the on-screen instructions to **Erase DTCs**.
13. When the entire reprogramming process is complete, the screen in Figure 7 will display.
14. Verify the before and after part numbers are different.
15. Print a copy of this screen (Figure 7) and attach it to the repair order for warranty documentation.
16. Select **Confirm**.
