INFINITI

## CAMPAIGN BULLETIN

### Body Seal Retailer Inventory

Reference: PG7B3

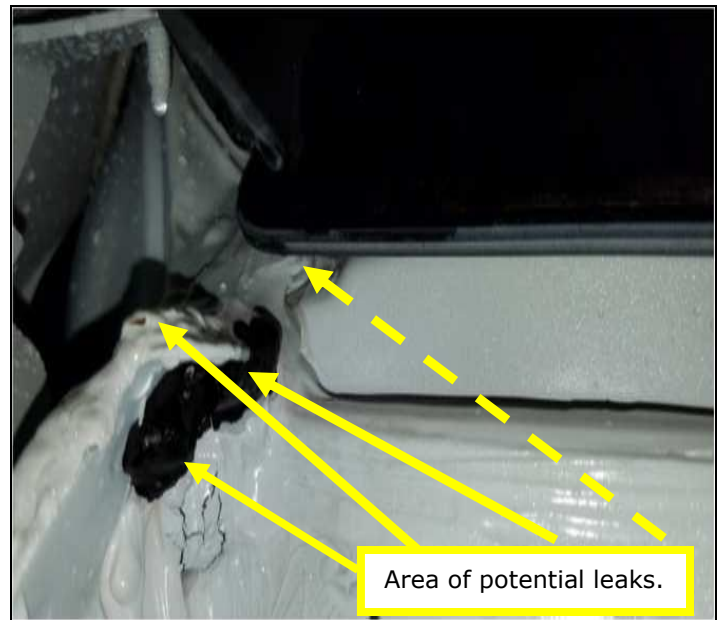
**Figure 9**

11. Figure 9 displays the passenger side showing areas of potential leaks.
- In this area is where you will apply sealer.

- The dashed arrow on the far right of the picture is under the corner of the windshield, this is the area of greatest concern.
- Apply sealer to all areas where the arrows are pointing, on both sides of the vehicle.
- **IMPORTANT:** Use 3M 540 Polyurethane Sealant for this repair and allow 60 minute for the sealer to harden before reassembling the car.

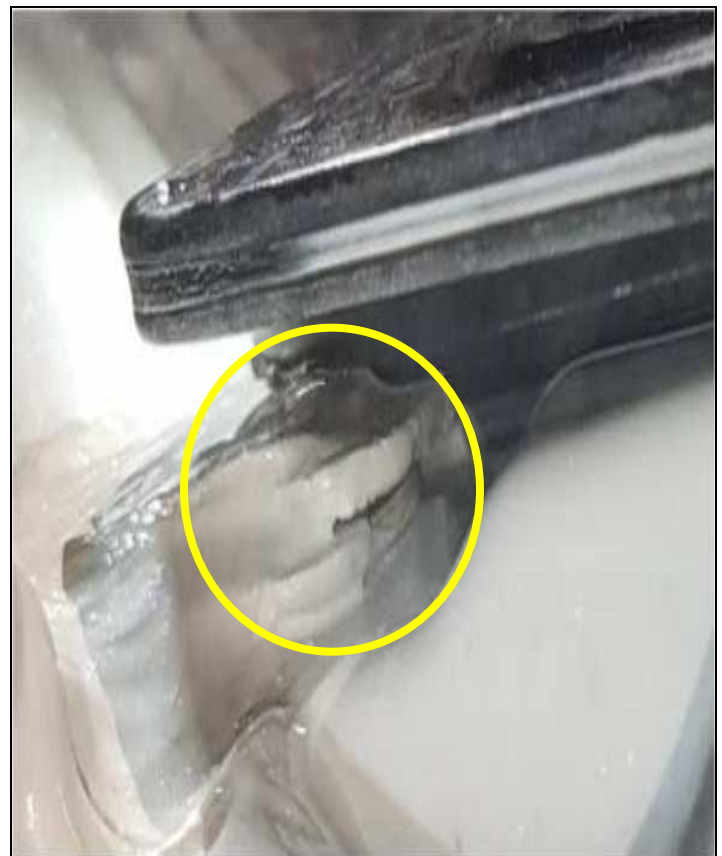
**Figure 10**

12. Figure 10 is a close up of a potential leak area under passenger side windshield.

- Apply sealer to this area on both sides of the car, driver and passenger.

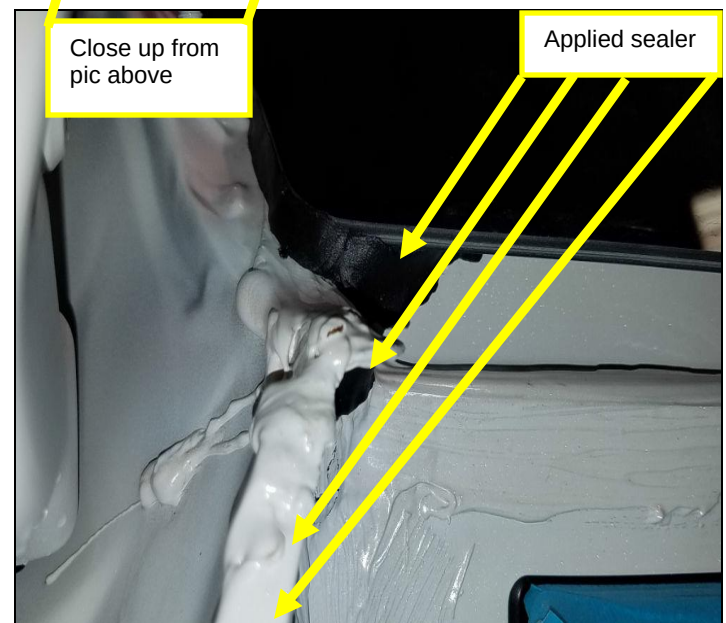
**Figure 12**

14. Figure 12 shows sealer applied to areas of concern, passenger side.

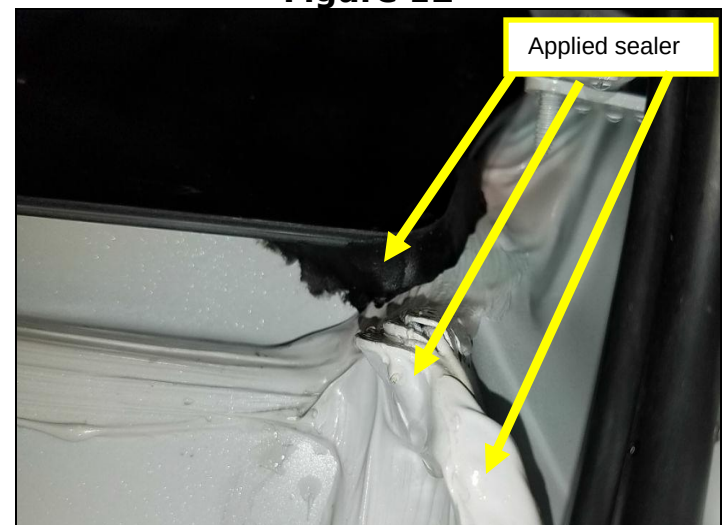
**Figure 13**

15. Figure 13 shows sealer applied to driver's side of the vehicle.

- **IMPORTANT:** Use 3M 540 Polyurethane Sealant for this repair and allow 60 minute for the sealer to harden before reassembling the car.
- **NOTE:** In this picture, the black lower corner windshield trim is removed for the picture.
