SERVICE CAMPAIGN

Air Bag Control Unit (ACU) Liquid Intrusion
Voluntary Service Campaign

Reference: PM674
Date: March 15, 2017

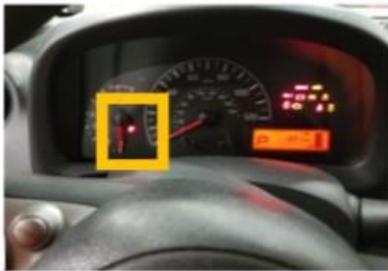
1. **DO NOT** power wash any interior portion of this vehicle;
2. Be careful to avoid spills near the center console, and immediately wipe any spilled liquids;
3. **DO NOT** place uncovered or uncapped liquids, such as drinks, in the cup holders;
4. Confirm the **red** air bag light (see picture below) in the meter illuminates for seven (7) seconds right after you start your vehicle
 - If the **red** air bag light does not illuminate at start, contact your dealer immediately
 - The Owner's Manual further describes normal air bag system warning operation and if any abnormality is observed the consumer should contact their dealer right away
 - If the SRS light stays continuously illuminated after seven (7) seconds, contact your dealer immediately
