CAMPAIGN BULLETIN

Body Seal Retailer Inventory

Reference: PG7B3
Date: March 27, 2017

PG7B3 - 2017 Q30/QX30 (H15) BODY SEAL REPAIR

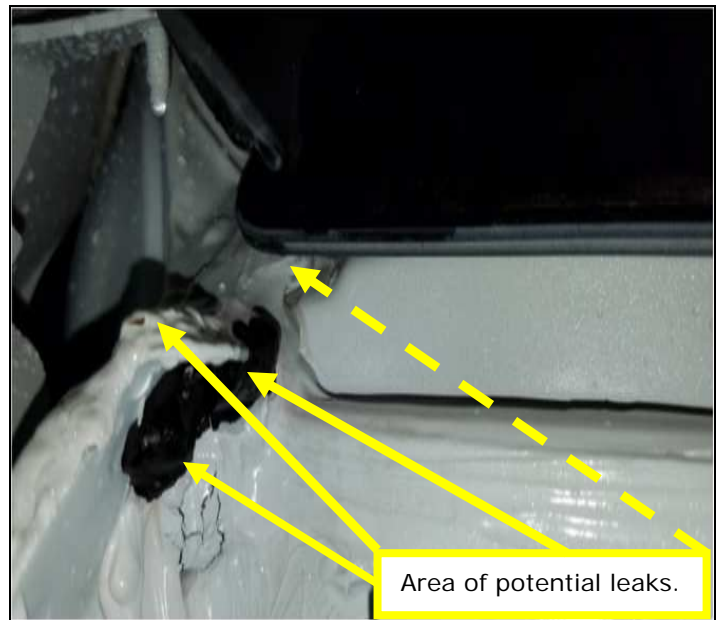
13. Figure 9 displays the passenger side showing areas of potential leaks.
- In this area is where you will apply sealer.
- NOTE:**
- The dashed arrow on the far right of the picture is under the corner of the windshield, this is the area of greatest concern.
 - Apply sealer to all areas where the arrows are pointing, on both sides of the vehicle.
 - **IMPORTANT:** Use 3M 540 Polyurethane Sealant for this repair and allow 60 minutes for the sealer to harden before reassembling the car.

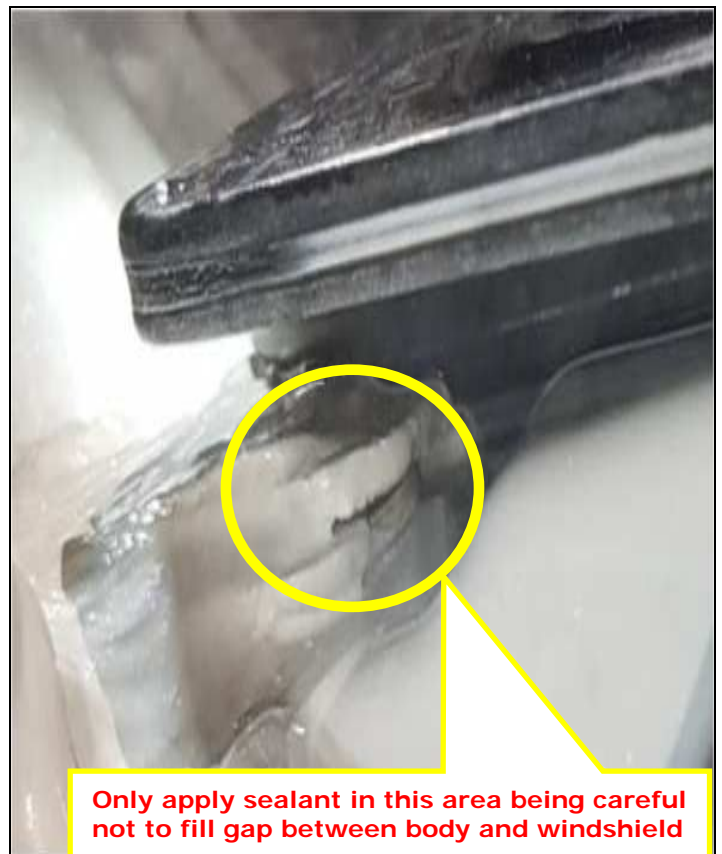
14. Figure 10 is a close up of a potential leak area under passenger side windshield.
- Apply sealer to this area on both sides of the car, driver and passenger.

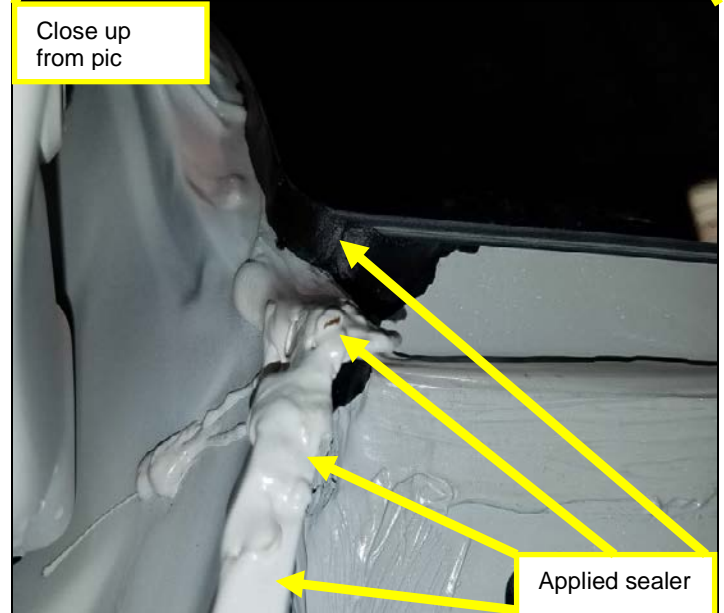
17. Figure 12 shows sealer applied to areas of concern, passenger side.

- **IMPORTANT:** only place sealant in the areas designated in Figures 12 & 13.
- **NOTE:** In this picture, the lower corner windshield trim is removed for the picture.

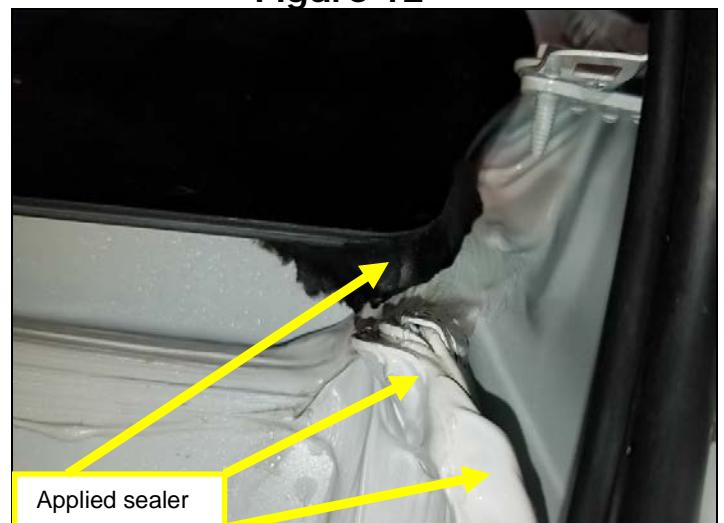
18. Figure 13 shows sealer applied to driver's side of the vehicle.

- **IMPORTANT:** Use 3M 540 Polyurethane Sealant for this repair and allow 60 minutes for the sealer to harden before reassembling the car.
- **NOTE:** In this picture, the black lower corner windshield trim is removed for the picture.

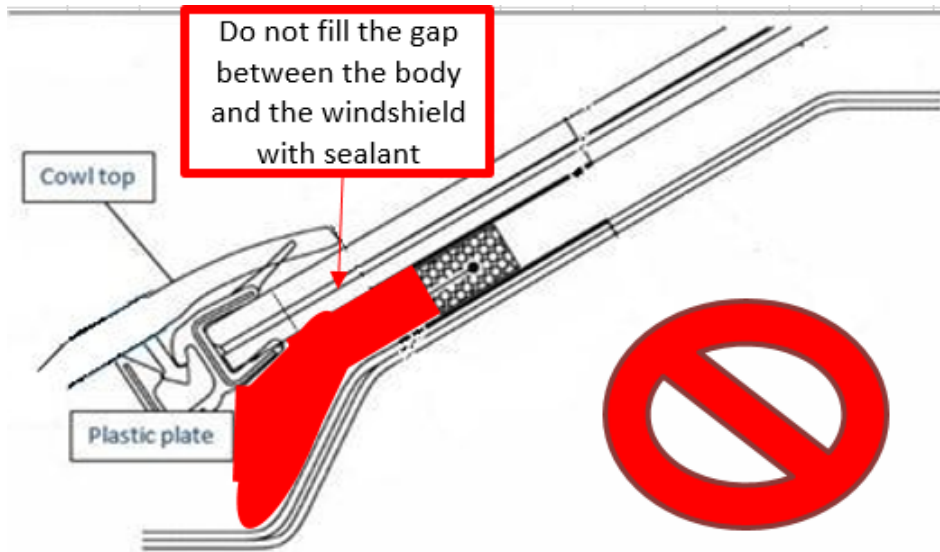
BELOW ARE EXAMPLES OF WHERE NOT TO APPLY SEALANT. SEALANT APPLIED IN AREAS CIRCLED IN RED WILL CAUSE DAMAGE TO THE WINDSHIELD

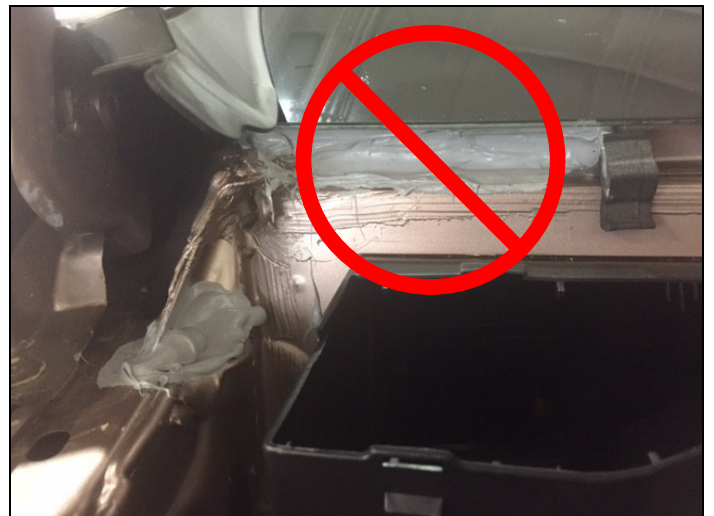
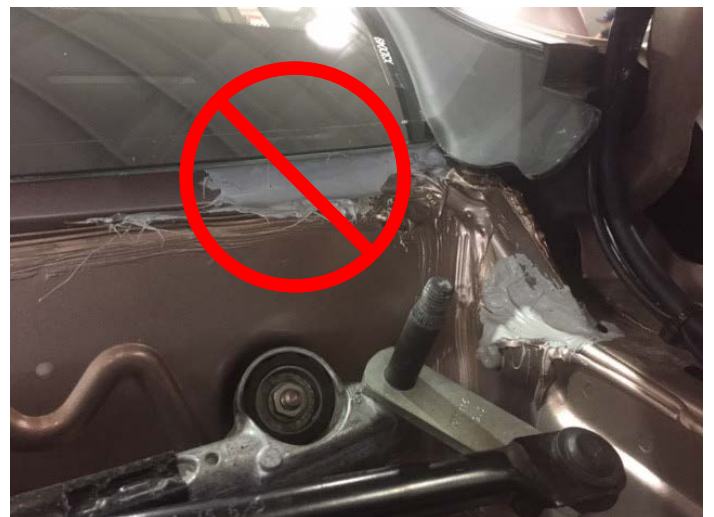
- **IMPORTANT:** Do not apply any sealant along the bottom edge of the windshield on either side of the vehicle. Doing so will cause windshield breakage when reinstalling the cowl top cover!
