SERVICE BULLETIN

Classification: EL15-016b	Reference: NTB15-066b	Date: April 20, 2017
------------------------------	--------------------------	-------------------------

2015 MURANO; AV CONTROL UNIT AND A/C SWITCH ASSEMBLY SERVICE INFORMATION

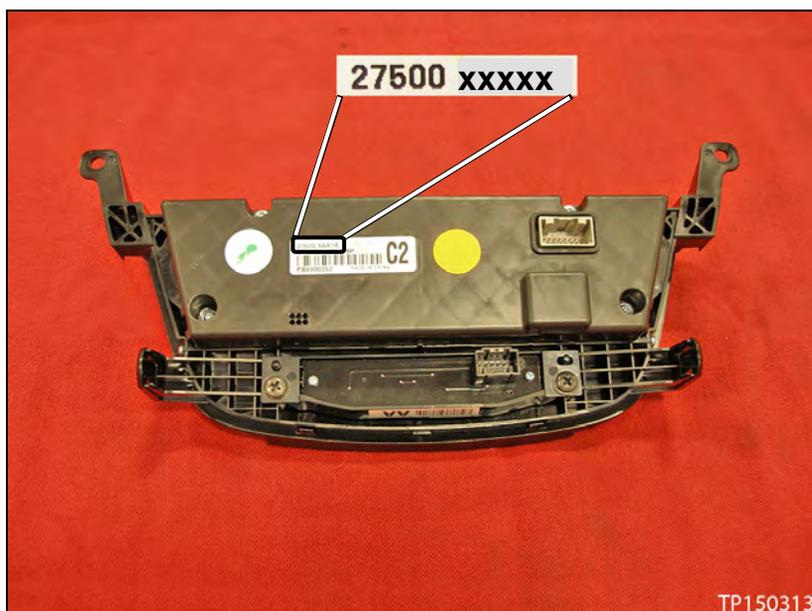
Figure 1: Location of A/C switch assembly P/N

Whenever an AV control unit on an applied vehicle is replaced for any reason, check the part number (P/N) of the A/C switch assembly (A/C Controller Assembly).

- If the P/N is 27500-5AA1**A**, replace the A/C switch assembly with 27500-5AA1**C**.
- If the P/N is NOT 27500-5AA1**A**, do NOT replace the A/C switch assembly.

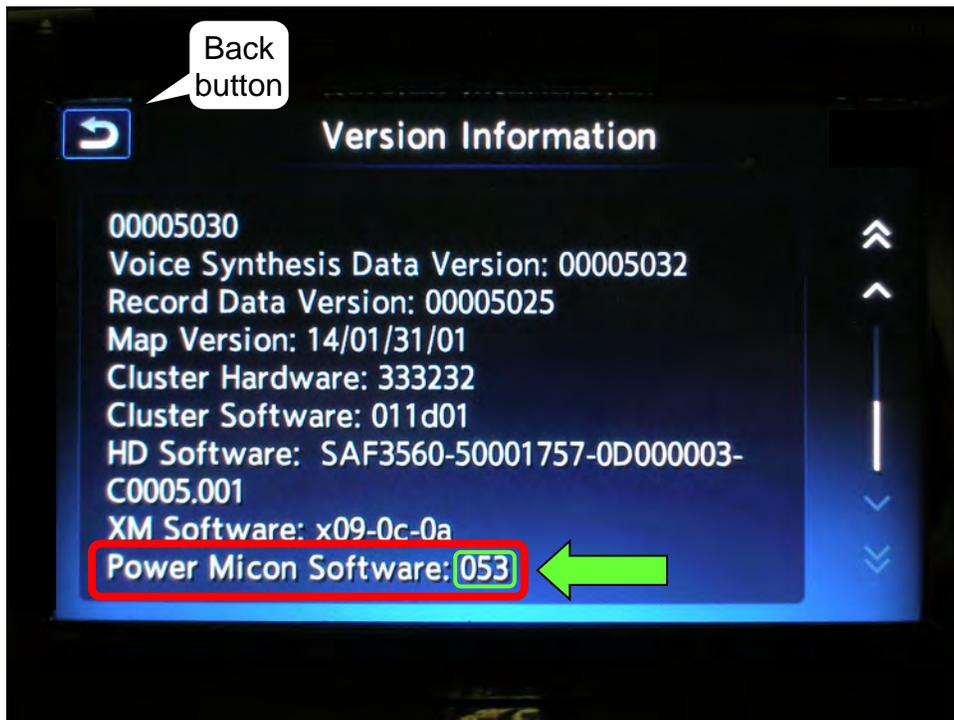
Figure 5

6. Check the software number next to **Power Micon Software**.
- If **054** or higher, a software update is not needed, or has been successfully performed.
 - If less than **054**, a software update needs to be performed.
 - If a software update needs to be performed, leave the screen as is, and then go to page 6, **AV Control Unit Software Update with Software Update SD Card**.
