CAMPAIGN BULLETIN

Automatic Transmission Dealer Inventory

Reference: PC562
Date: April 6, 2017

PC562 – TITAN (A61G, 4WD) MULTI-POINT INSPECTION

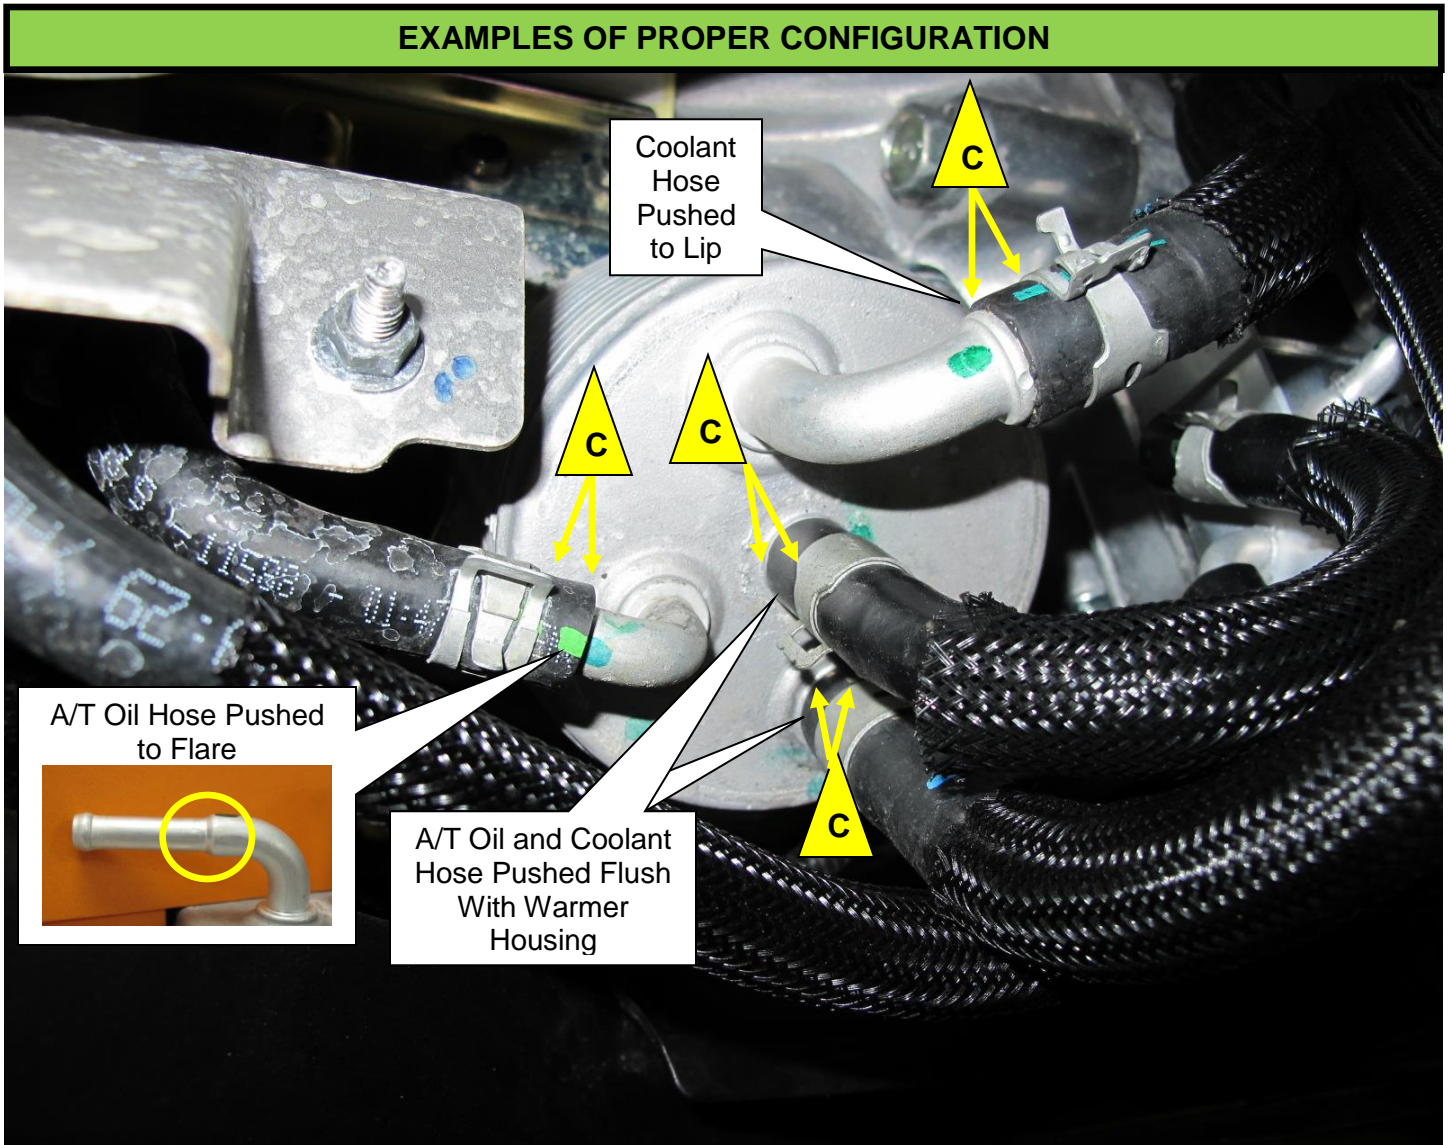
Figure 6

6. Inspect **four** A/T Warmer Hoses for proper configuration (Figure 6).

A. Straight tube hose placement: hose pushed all the way until flush with warmer housing.

B. Bent tube hose placement: hose pushed all the way to stop/lip or outward flare.

C. Clamp placement

; clamp located 5MM +or- 2MM (1/8th to 1/4 inch) from end of hose.

8. CORRECT ANY HOSES NOT PROPERLY INSTALLED, REFERENCE STEP 6 (FIGURE 6).

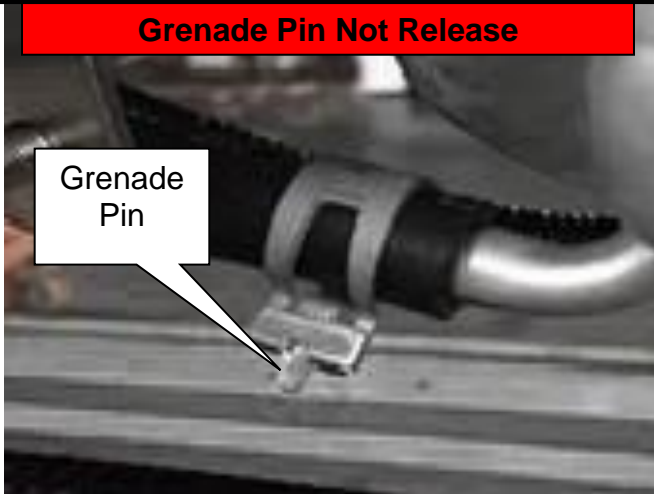
Figure 7

Grenade Pin Not Release

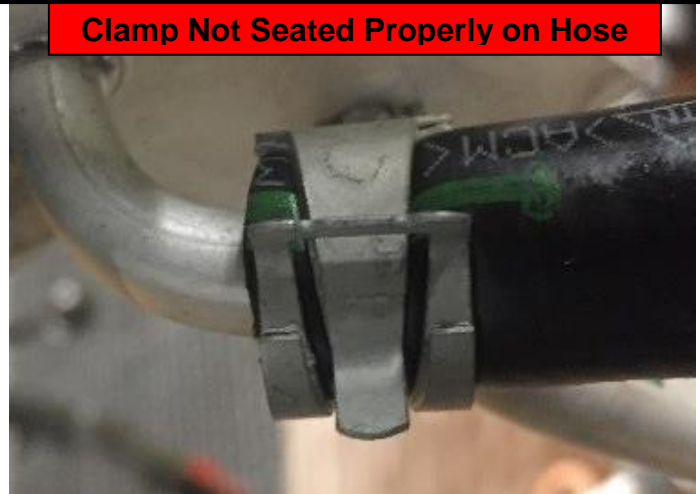
Figure 8

Clamp Not Seated Properly on Hose

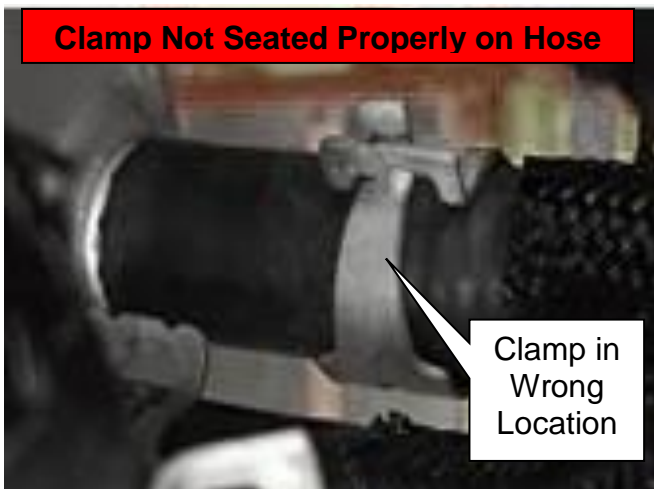
Figure 9

Clamp Not Seated Properly on Hose

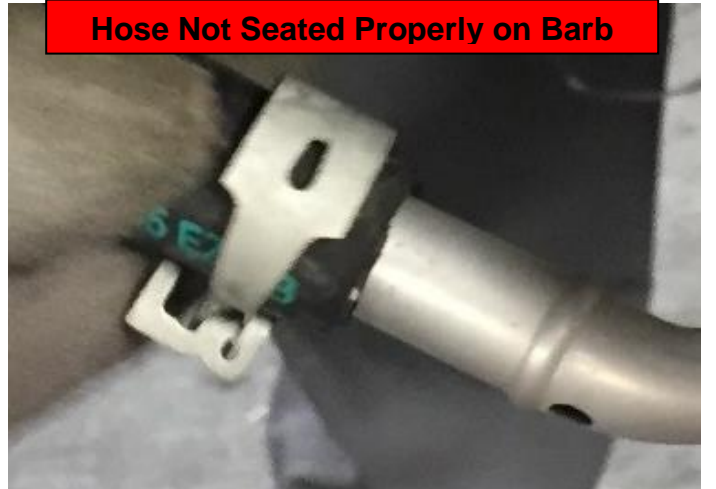
Figure 10

Hose Not Seated Properly on Barb

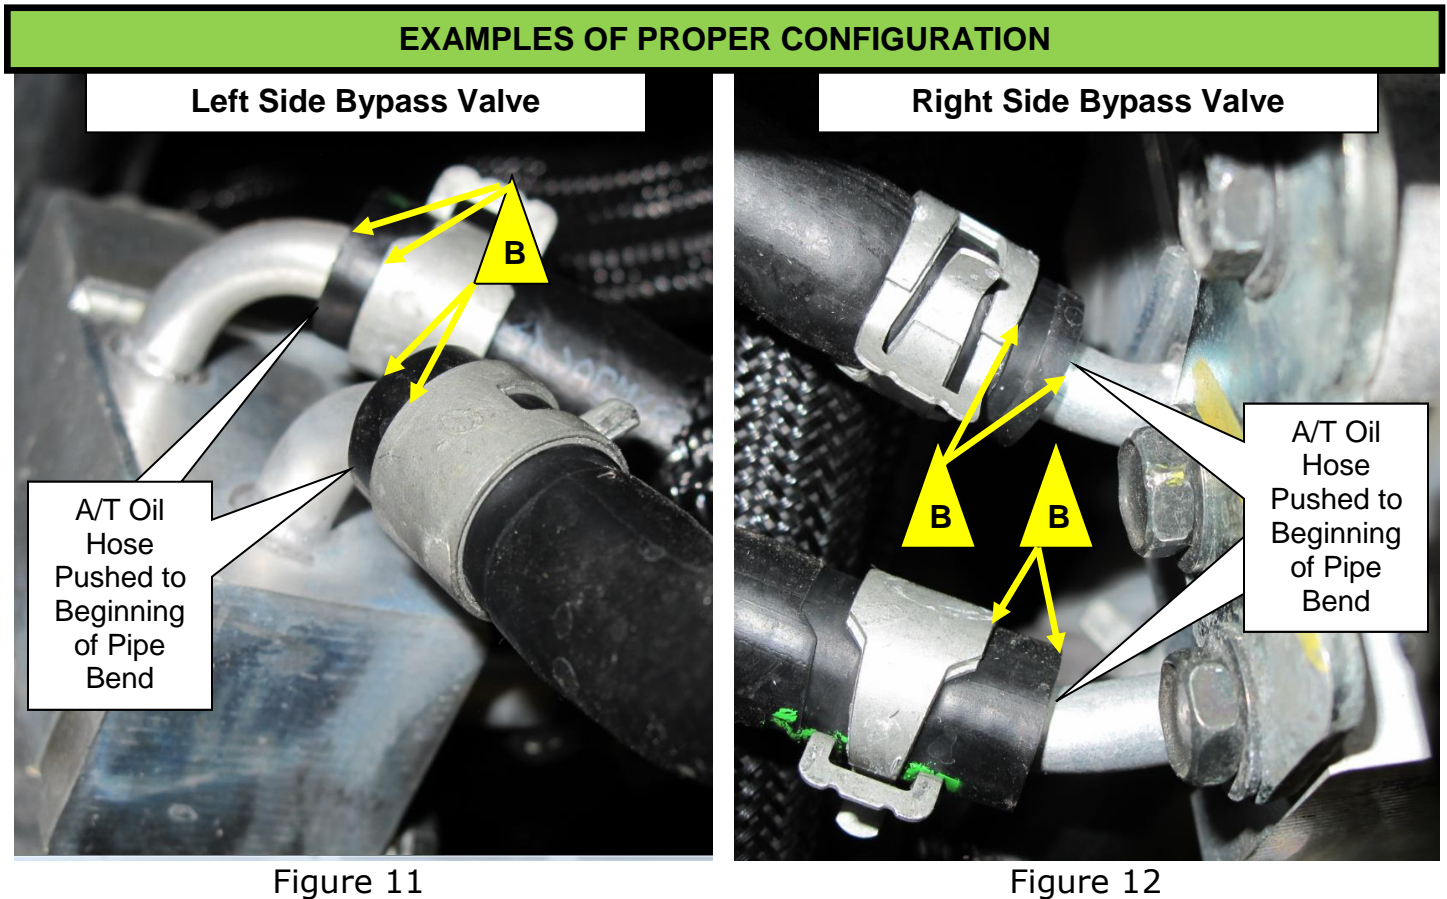
9. Inspect **four** bypass valve hoses for proper configuration (Figure 11, 12).

A. Bent tube hose placement: hose pushed to beginning of pipe bend.

B. Clamp placement **B**: clamp located 7.5MM +or- 2.5MM (3/16 to 3/8 inch) from the end of the hose.

11. **CORRECT ANY BYPASS VALVE HOSES THAT ARE NOT PROPERLY INSTALLED, REFERENCE STEP 9 (FIGURE 11, 12).**

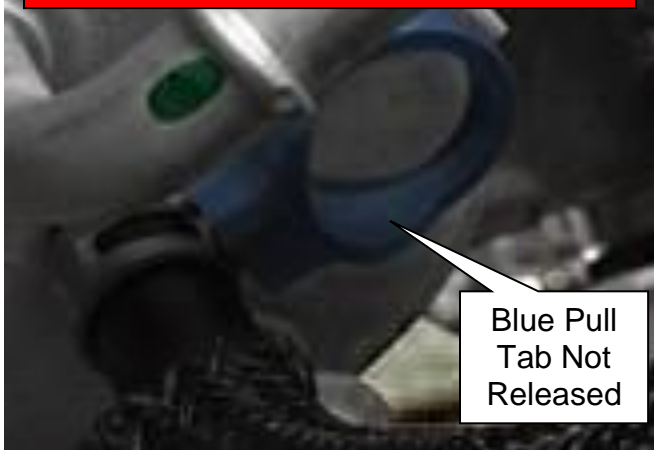
Figure 13

Blue Pull Tab Clamp Not Released

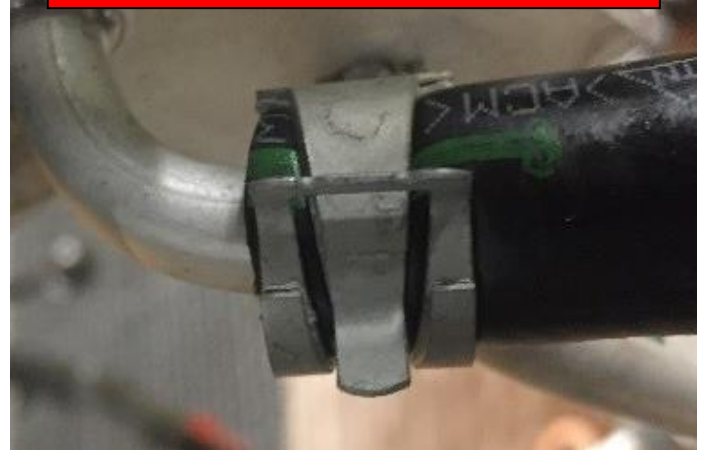
Figure 14

Clamp Not Seated Properly on Hose

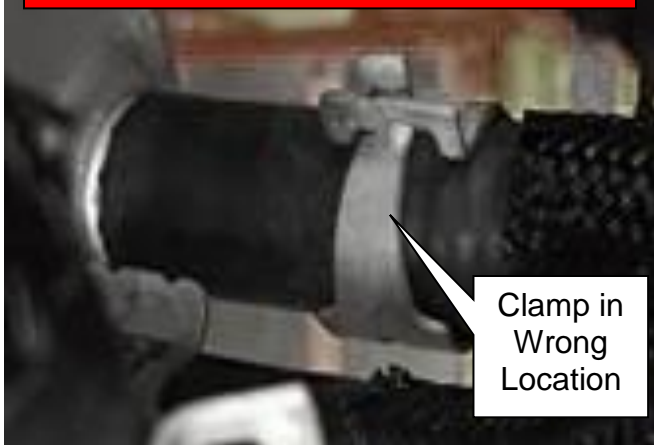
Figure 15

Clamp Not Seated Properly on Hose

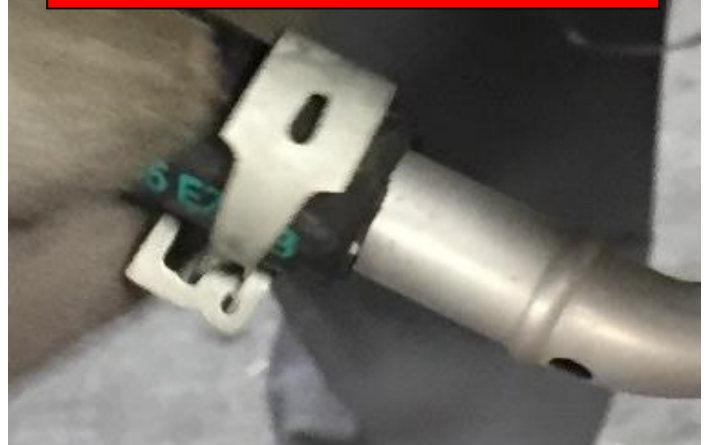
Figure 16

Hose Not Seated Properly on Barb

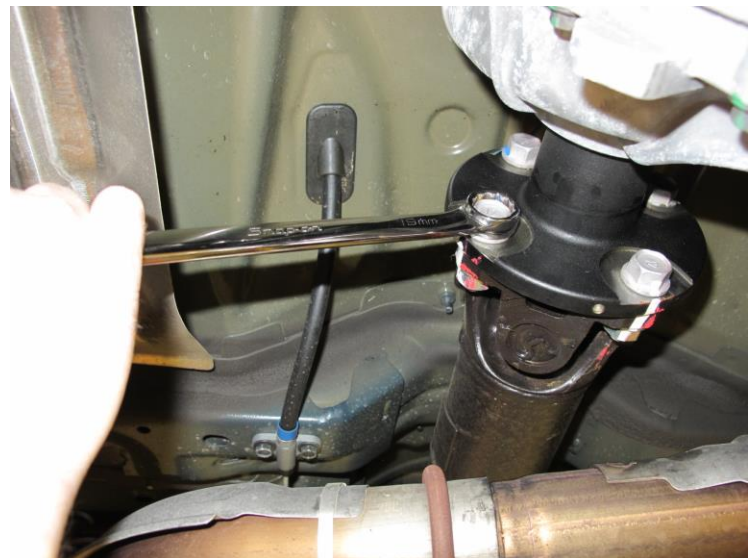
Figure 2

2. Using a suitable tool apply LIGHT to Moderate force to one of the 19MM bolts, repeat on the other three bolts (Figure 2).

A. If **any** of the bolts move (NOT the prop shaft) **replace all 4** of the rear prop shaft bolts and nuts, (see Parts Information below).

- Torque NEW Rear Prop Shaft bolts and nuts:
105N·m (77 ft-lb)

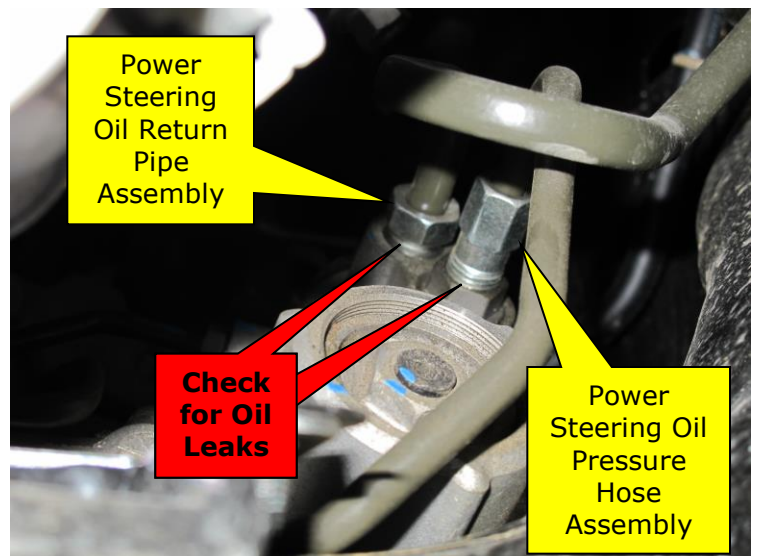
Figure 3

3. Inspect for **LEAKS** between the Steering Gear and Power Steering Oil Return Pipe and Power Steering Oil Pressure Hose connections (Figure 3).

4. Clean area and re-torque both lines to ensure O-Ring is fully seated/sealed (Figure 4).

- Torque Power Steering Oil Return Pipe connection to:
19.7N·m (15 ft-lb)
- Torque Power Steering Oil Pressure Hose connection to:
33.4N·m (25 ft-lb)
