CAMPAIGN BULLETIN

Automatic Transmission Dealer Inventory

Reference: PC563

PC563 – TITAN XD (A61G, 2WD) MULTI-POINT INSPECTION

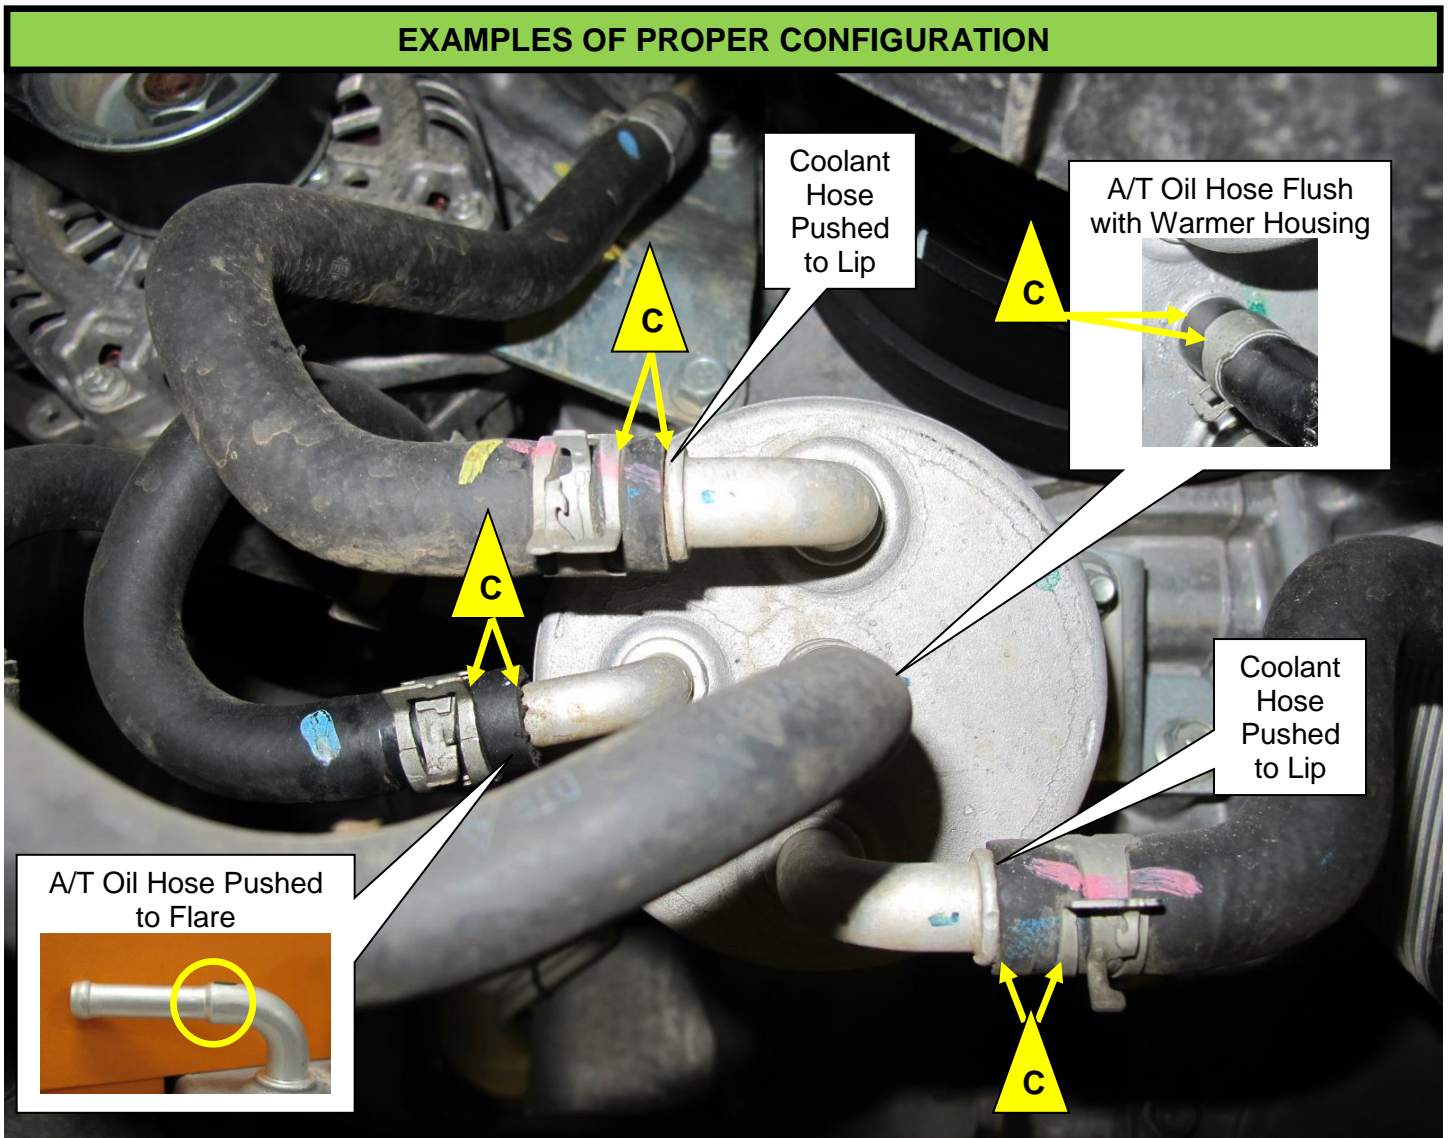
Figure 6

6. Inspect **four** A/T Warmer Hoses for proper configuration (Figure 6).

A. Straight tube hose placement: hose pushed all the way until flush with warmer housing.

B. Bent tube hose placement: hose pushed all the way to stop/lip or outward flare.

C. Clamp placement

; clamp located 5MM +or- 2MM (1/8th to 1/4 inch) from end of hose.

8. CORRECT ANY HOSES NOT PROPERLY INSTALLED, REFERENCE STEP 6 (FIGURE 6).

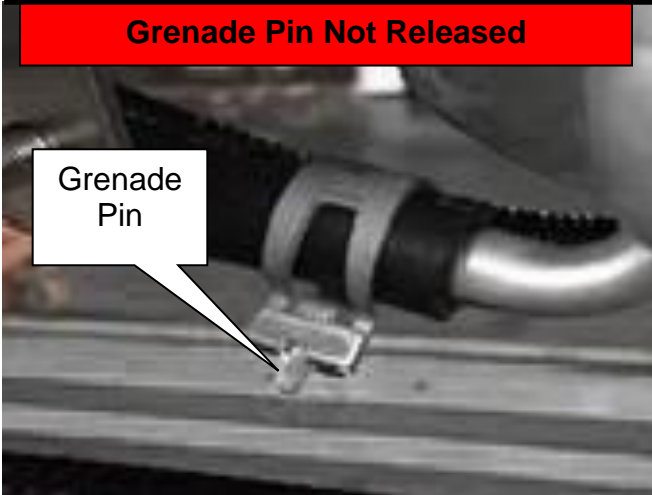
Figure 7

Grenade Pin Not Released

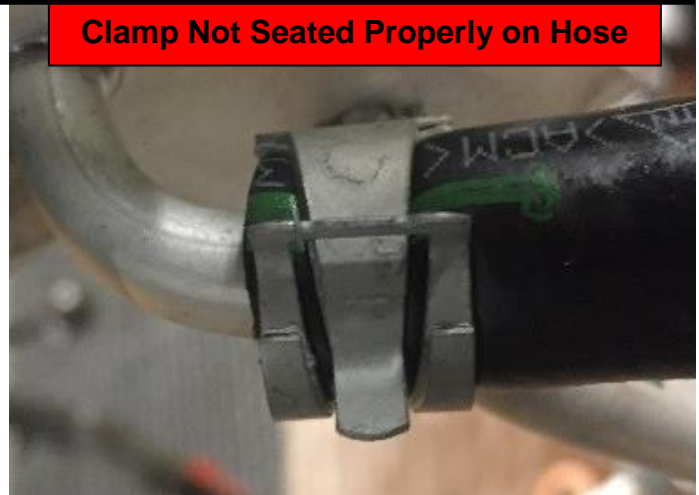
Figure 8

Clamp Not Seated Properly on Hose

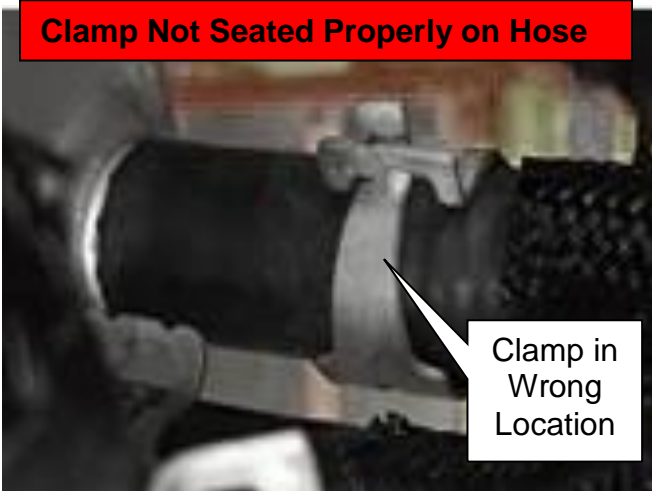
Figure 9

Clamp Not Seated Properly on Hose

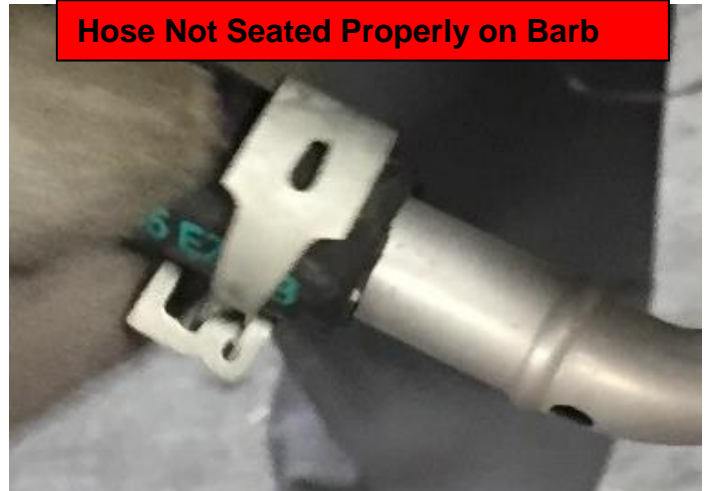
Figure 10

Hose Not Seated Properly on Barb

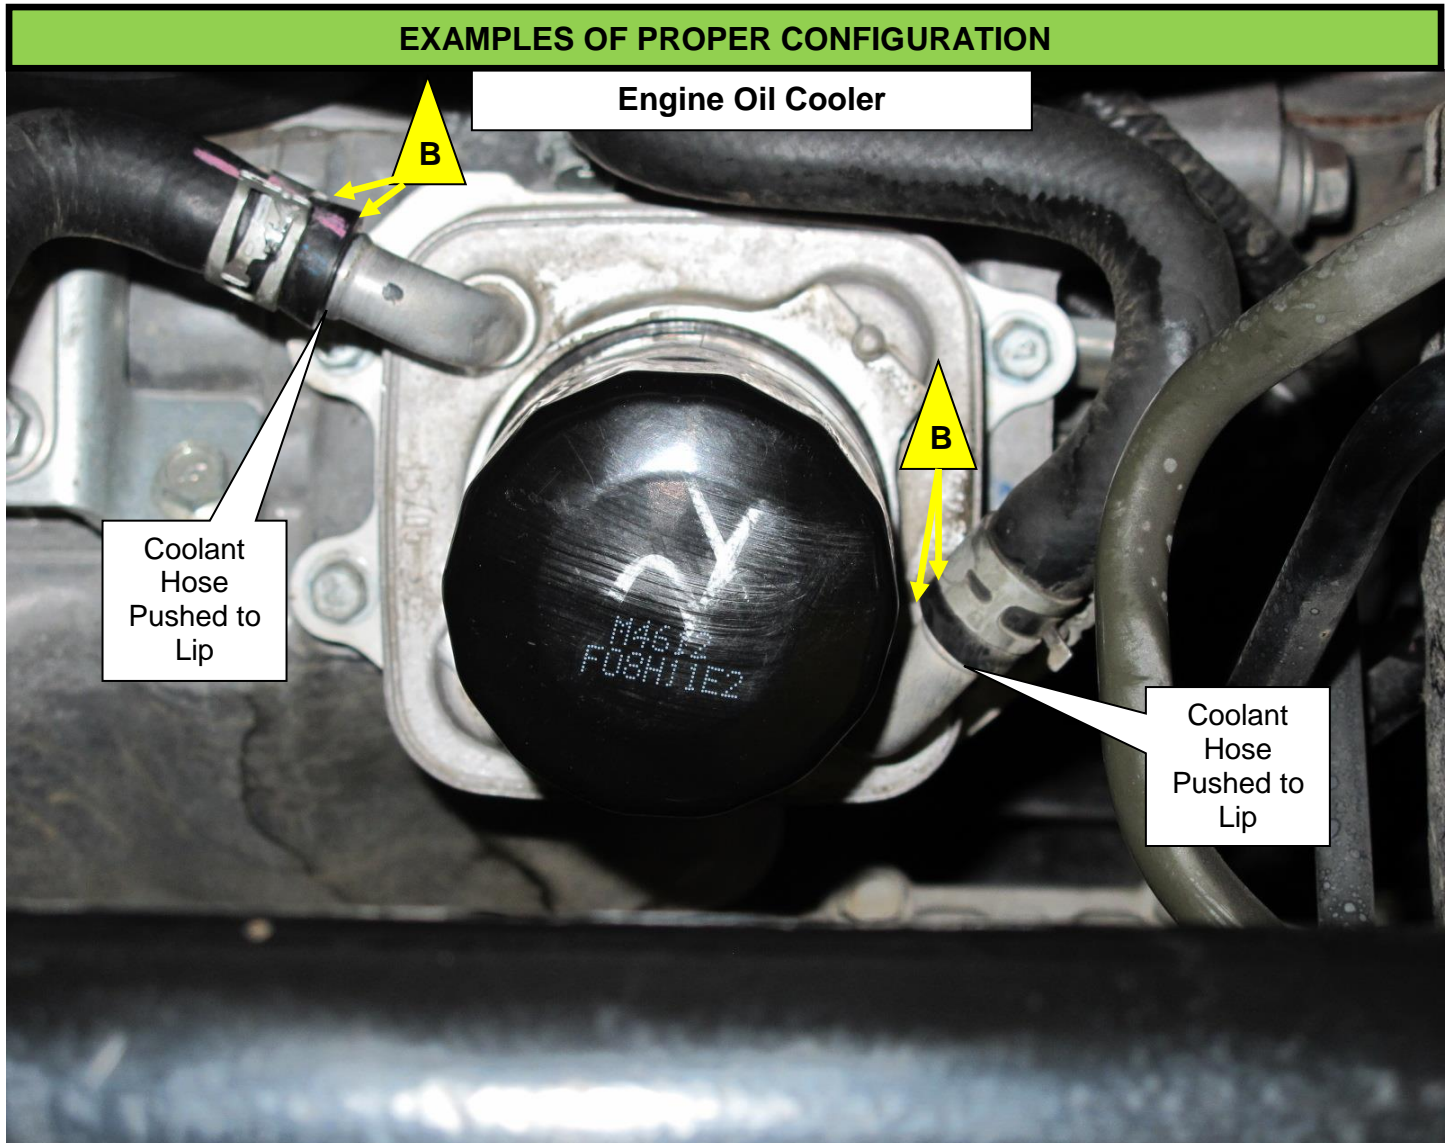
Figure 11

9. Inspect **two** engine oil cooler hoses for proper configuration (Figure 11).

A. Bent tube hose placement: hose pushed to the lip on the oil cooler pipe.

B. Clamp placement **B**: clamp located 7MM +or- 2MM or approximately (3/16 to 3/8 inch) from the end of the hose.

11. CORRECT ANY ENGINE OIL COOLER HOSES NOT PROPERLY INSTALLED, REFERENCE STEP 9 (FIGURE 11).

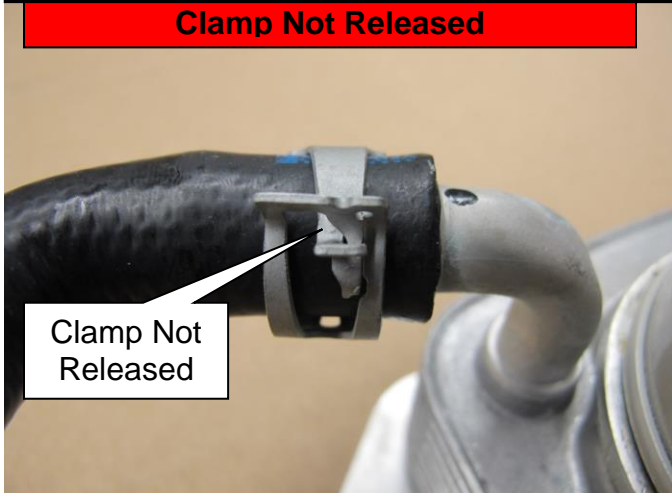
Figure 12

Clamp Not Released

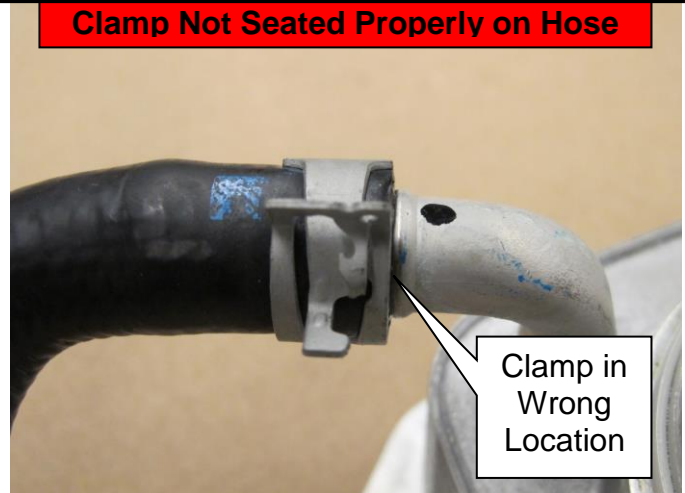
Figure 13

Clamp Not Seated Properly on Hose

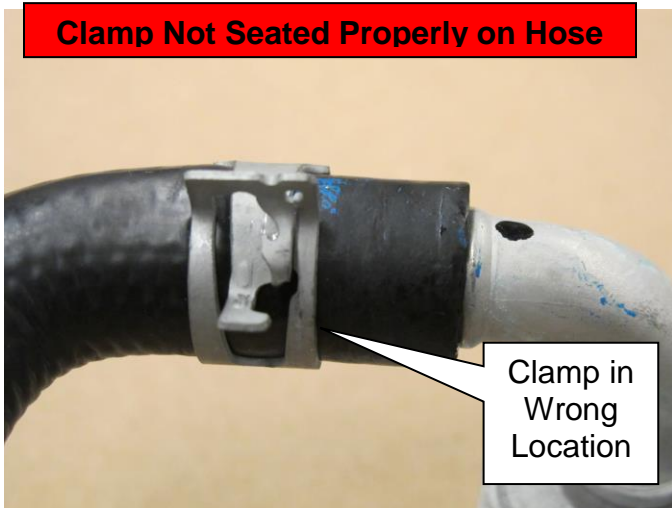
Figure 14

Clamp Not Seated Properly on Hose

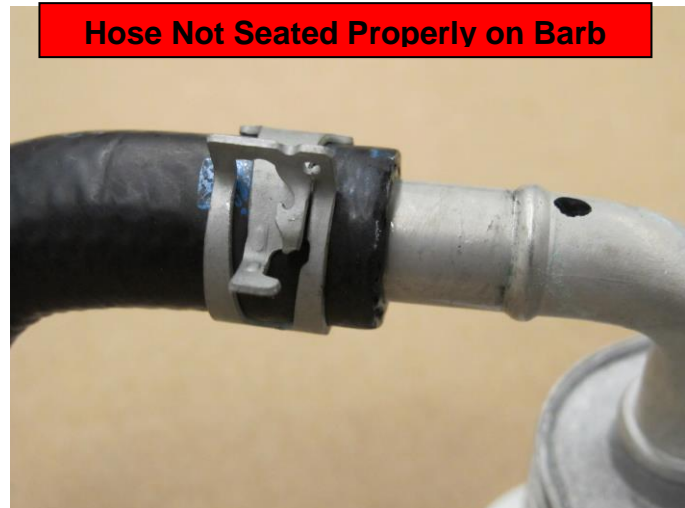
Figure 15

Hose Not Seated Properly on Barb

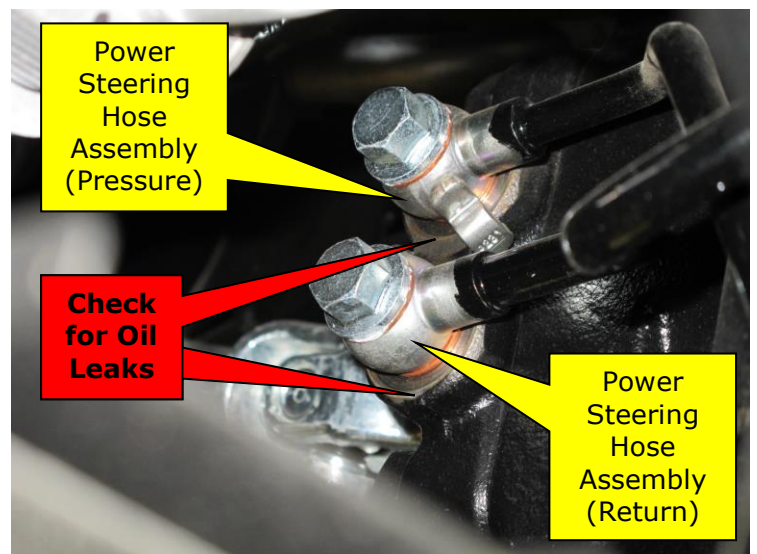
Figure 3

2. Inspect for **LEAKS** between the Steering Gear Box and Power Steering Hose Assembly (Pressure) and Power Steering Hose Assembly (Return) connections. (Figure 3).

- If **NO LEAK** found, inspection is complete, proceed to step 9 to install front under cover.
- If **LEAK** found, proceed to step 3.
